McHenry County

Hebron Township

McHenry County Intensive Rural Structures Field Survey Form

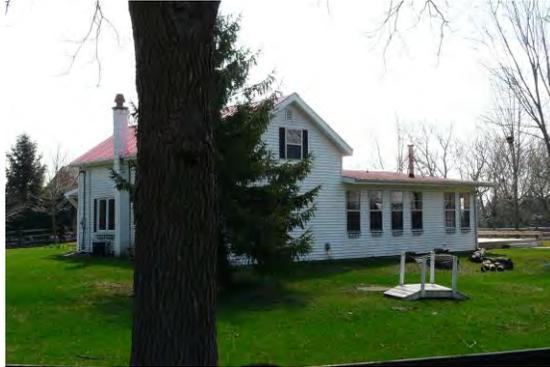
HE-3-1: 10309 Button Road – Residence

Foundation materials: concrete
block

Other distinguishing features
attached long gabled section

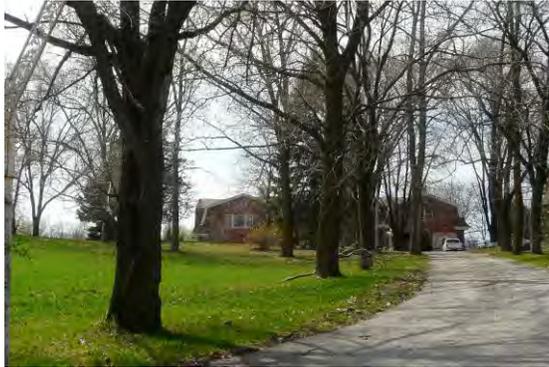
HE-8-4: 12607 Hebron Road – Residence

Foundation materials: unknown

Other distinguishing features: three front bays. Converted/re-modeled - may be contemporary with residence but hard to tell

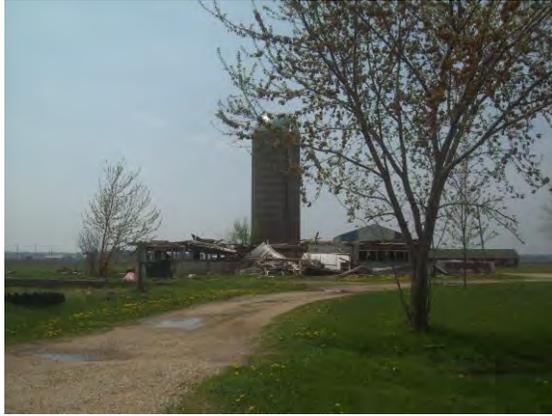
HE-14-1: Greenwood Road – Barn, Silo, Pole Building, Shed

Other distinguishing features
Mostly demolished

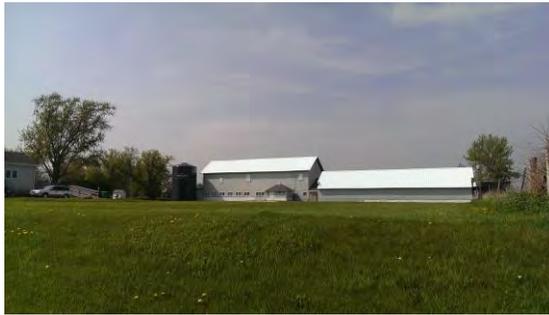
HE-18-1: 13218 Illinois Route 173 – Barns, Silo, Coop

Foundation materials: concrete

Other distinguishing features
attached pyramid roof
milkhouse

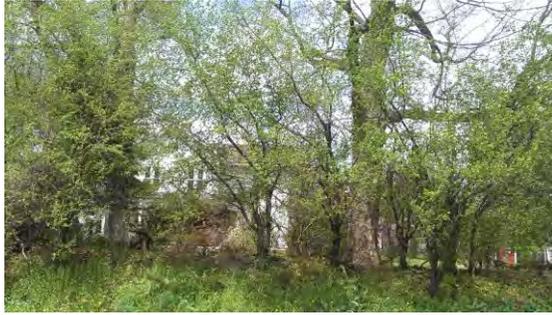
HE-25-3: 8914 Tryon Grove Road – Residence

Other distinguishing features
wood roof top vents

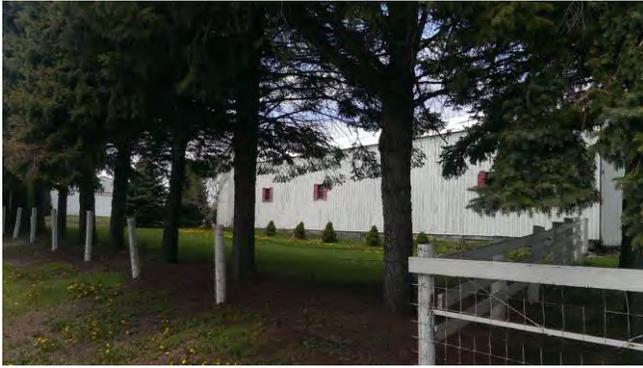
HE-25-5: 8702 Tryon Grove Road – Pole Buildings

Foundation materials: concrete

Other distinguishing features
rooftop vents
sets of multi-pane windows

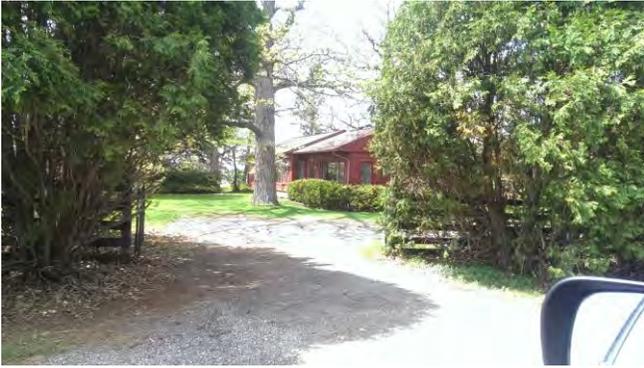
HE-27-2: 7415 Stewart Road - Residence

Other distinguishing features
rooftop vents
attached round roof milkhouse

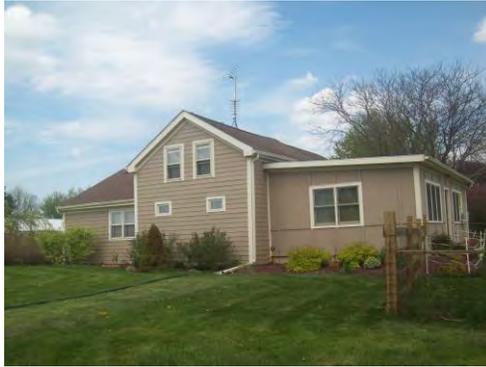
HE-28-3: 11401 Van Der Karr Road – Residence

Foundation materials: concrete

Other distinguishing features
multi-pane windows
