Alden Road Improvement

McHenry County Division of Transportation

Pavement Condition Summary Stakeholder Group Meeting on May 24, 2010

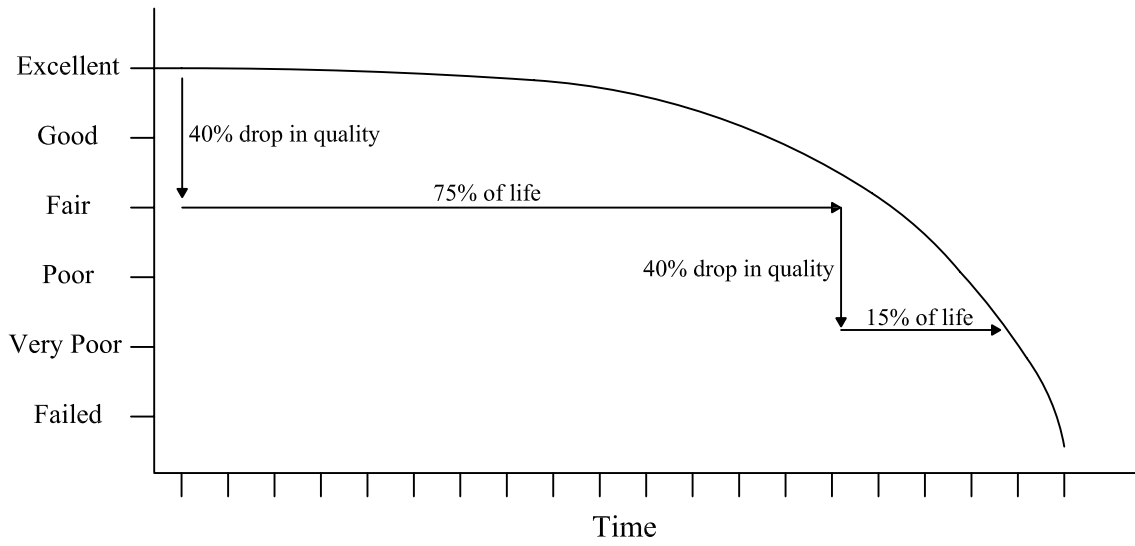
Typical Pavement
Life Cycle Curve

Visually, the pavement appears to be in better condition than it actually is due to frequent resurfacing. The current deteriorated condition of Alden Road's subbase makes it a priority to the County to avoid repetitive resurfacing and higher repair costs down the road. When the reconstruction is completed, proper drainage will increase the time between resurfacing to a 10-15 year interval rather than the 3-5 years presently required.

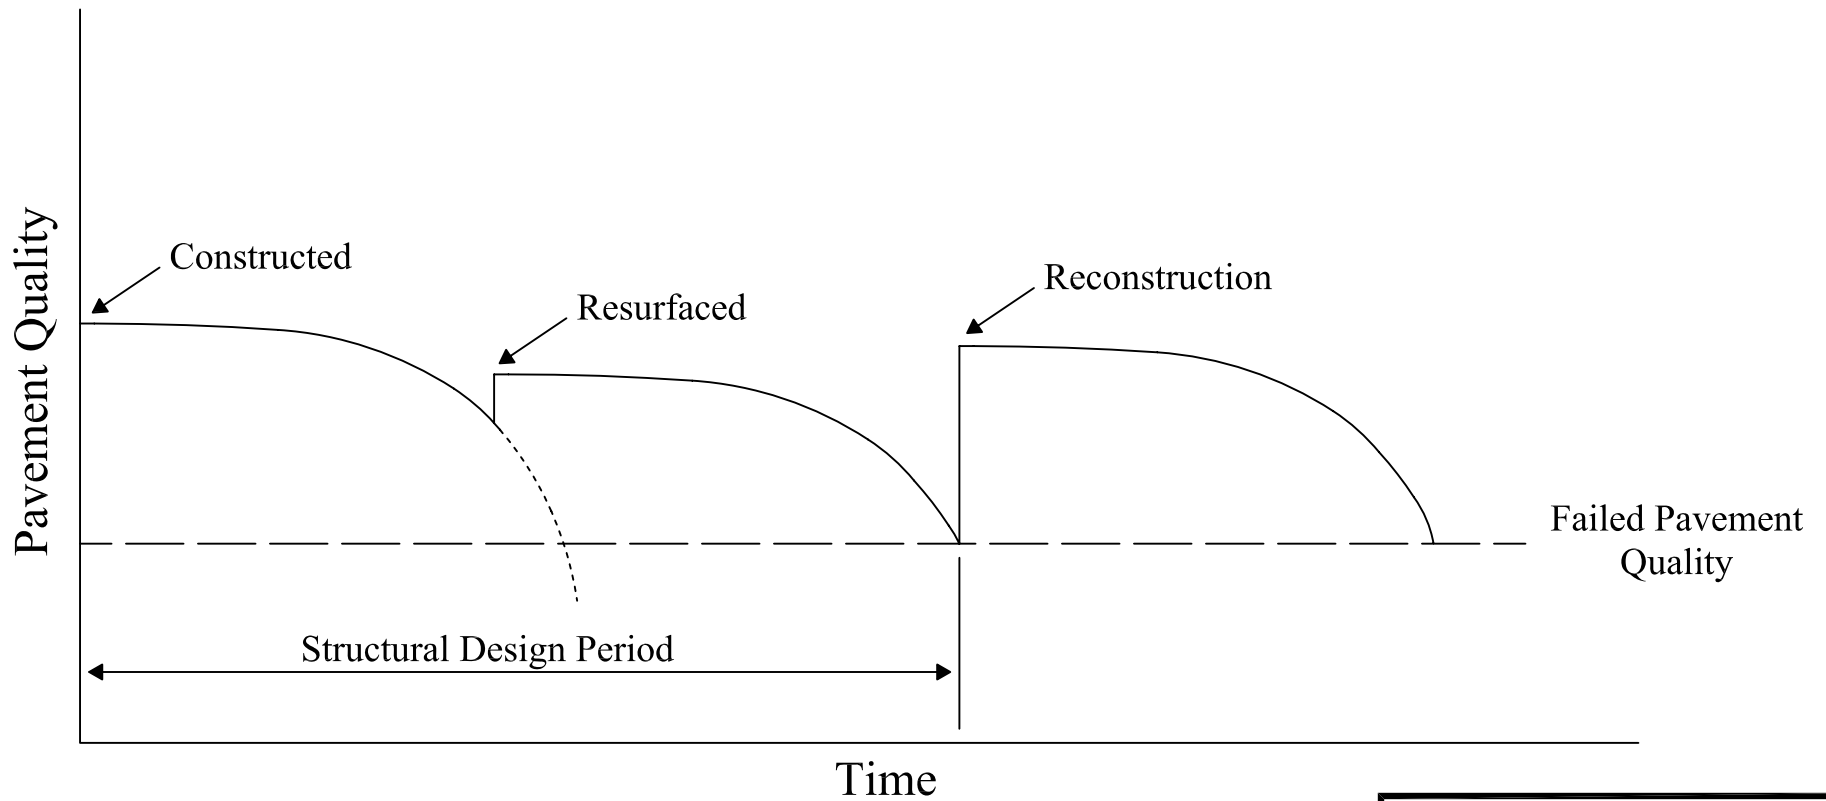
Typical Pavement
Life Cycle Curve
With Resurfacing
