McHenry County

Rural Survey

***Nunda Township***

***FIELD DATA SHEETS***

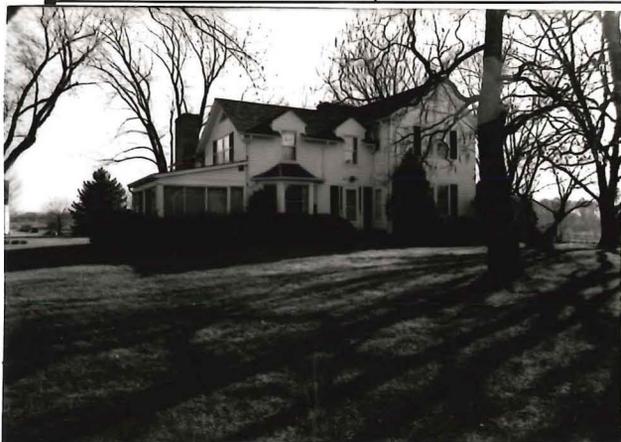
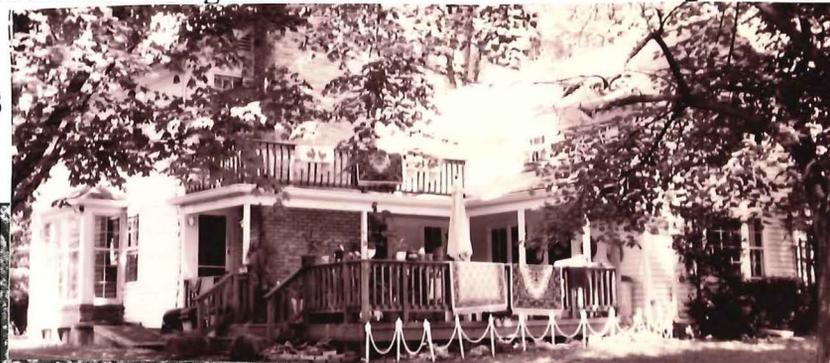
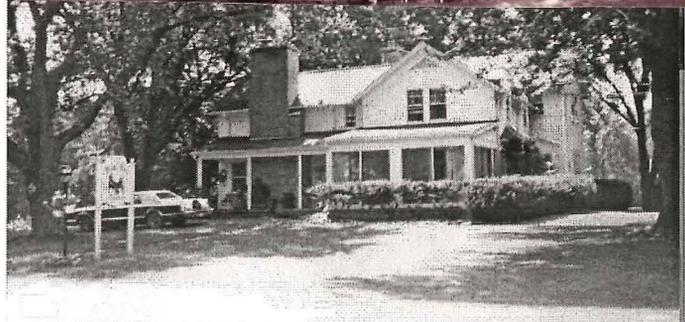
**Roll No./Neg.No.:** W27&W28

<b>Function:</b>	<b>Vernacular Type:</b>	<b>Arch. Style:</b>	<b>Alterations:</b>
Residence	"T"-Plan		Major additions

<b>Circa:</b> 1860 - 1880	<b>Condition:</b> Good	<b>Integrity:</b> Poor
------------------------------	---------------------------	---------------------------

<b>Materials:</b>	<b>HISTORY:</b>
<b>Foundation:</b> Concrete	"Fryslan Farm"
<b>Walls:</b> Clapboard	2 large brick chimney
<b>Roof:</b> Wood shingle	Has original cooking hearth inside
<b>Porch:</b> Enclosed	Formerly the Sutton Farm, who owned Morain Hills
	Owner believes the "smoke house" shaped buildings was one of the original buildings in the McHenry land grant
	Home was in the Sutton Farm for 4 generations <span style="float: right;"><i>additional 1998 view</i> ↘</span>
	Previous site = 4723

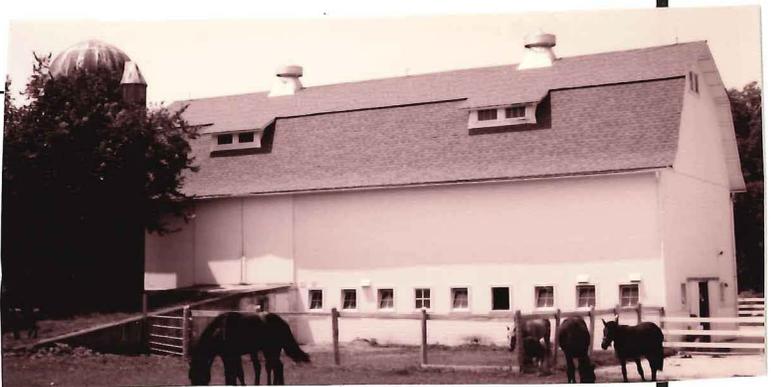
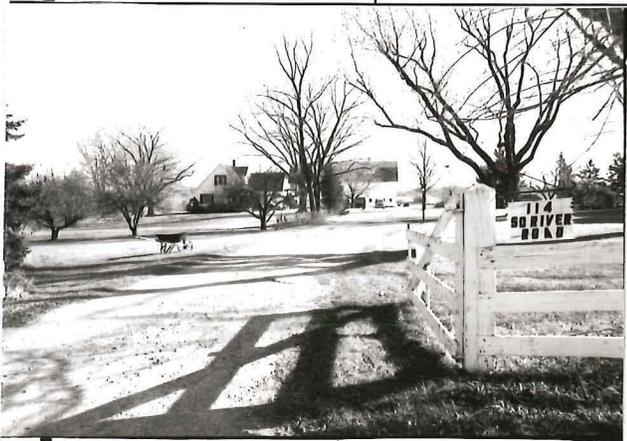
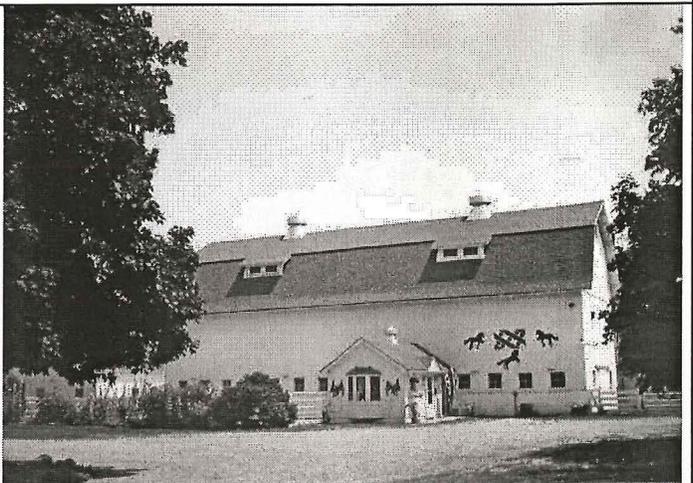
**Roll No./Neg.No.:** X1&X2

Circa:	Condition:	Integrity:
1890 - 1920	Excellent	Good

Materials:	HISTORY:
<b>Foundation:</b> Concrete <b>Walls:</b> Vertical plank <b>Roof:</b> Asphalt shingle <b>Porch:</b>	<p>Milk house is now the farm office.</p> <p>2 vents</p> <p>2 dormered windows</p> <p>Ramped has feed room beneath it</p> <p>Now used as horse stable exclusively</p> <p>Silo is staved with metal dome top</p>

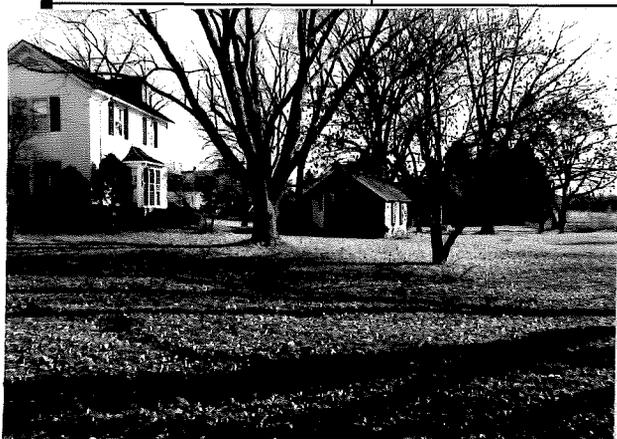
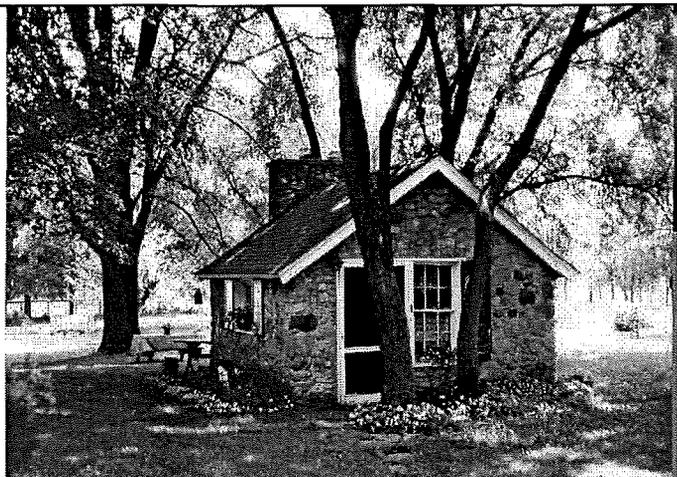
**Roll No./Neg.No.:** W29

<b>Circa:</b> 1860	<b>Condition:</b> Excellent	<b>Integrity:</b> Good
-----------------------	--------------------------------	---------------------------

<b>Materials:</b>	<b>HISTORY:</b>
<b>Foundation:</b> Stone	Large stone chimney
<b>Walls:</b> Fieldstone	New brick inside hearth
<b>Roof:</b> Asphalt shingle	Owner suggests not a smokehouse but one of the original houses in land track grant
<b>Porch:</b>

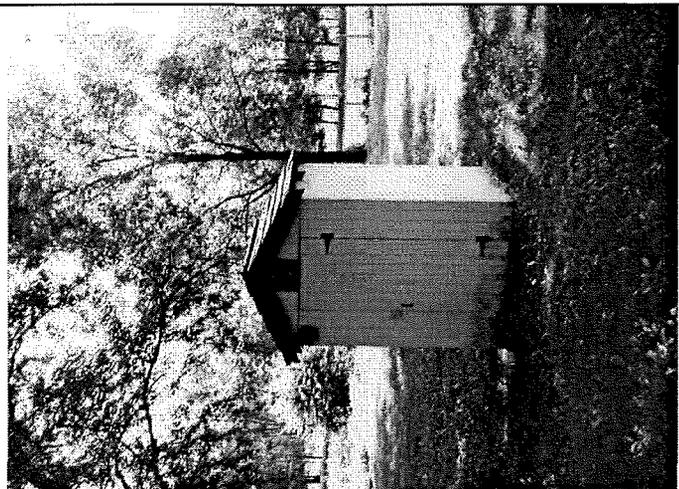
**Roll No./Neg.No.:** W30

<b>Circa:</b> 1920	<b>Condition:</b> Good	<b>Integrity:</b> Good
-----------------------	---------------------------	---------------------------

<b>Materials:</b>	<b>HISTORY:</b>
<b>Foundation:</b> Concrete <b>Walls:</b> Vertical plank <b>Roof:</b> Wood shingle <b>Porch:</b>	1 seater

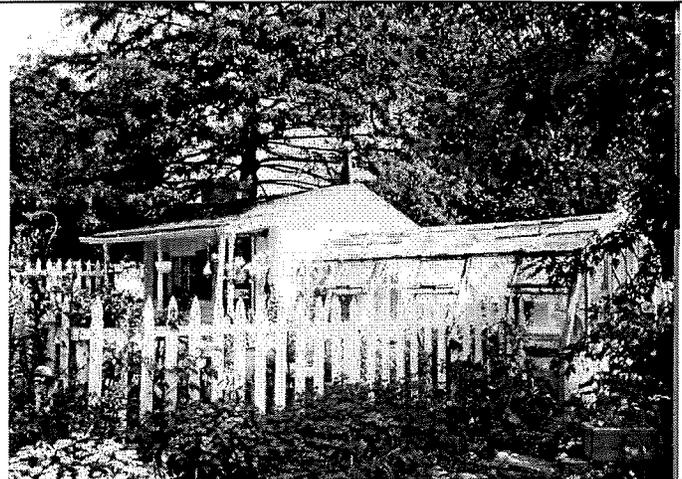
**Roll No./Neg.No.:** W31

<b>Circa:</b> 1915	<b>Condition:</b> Excellent	<b>Integrity:</b> Poor
-----------------------	--------------------------------	---------------------------

<b>Materials:</b>	<b>HISTORY:</b>
<b>Foundation:</b> Concrete	Added glass house for green house
<b>Walls:</b> Clapboard	Has wood burning fireplace
<b>Roof:</b> Asphalt shingle	Little porch w/pillars
<b>Porch:</b>	Gardens here since 1915

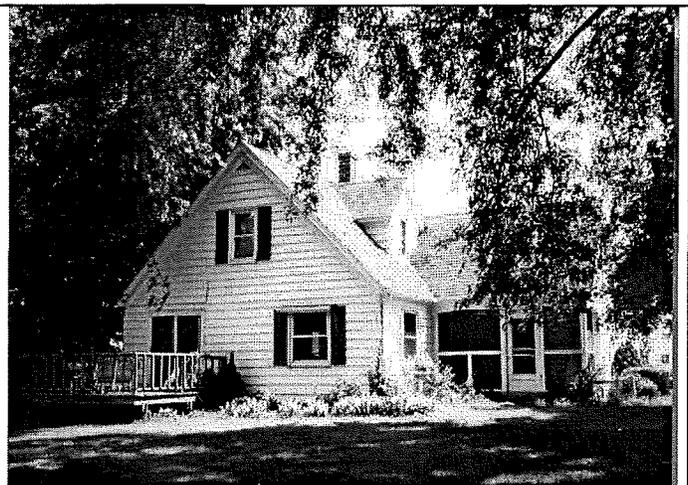
**Roll No./Neg.No.:** W32

<b>Circa:</b> 1930	<b>Condition:</b> Excellent	<b>Integrity:</b> Poor
-----------------------	--------------------------------	---------------------------

<b>Materials:</b>	<b>HISTORY:</b>
<b>Foundation:</b> Concrete <b>Walls:</b> Clapboard <b>Roof:</b> Asphalt shingle <b>Porch:</b> enclosed	Gable dormer in corner of ell with single chimney

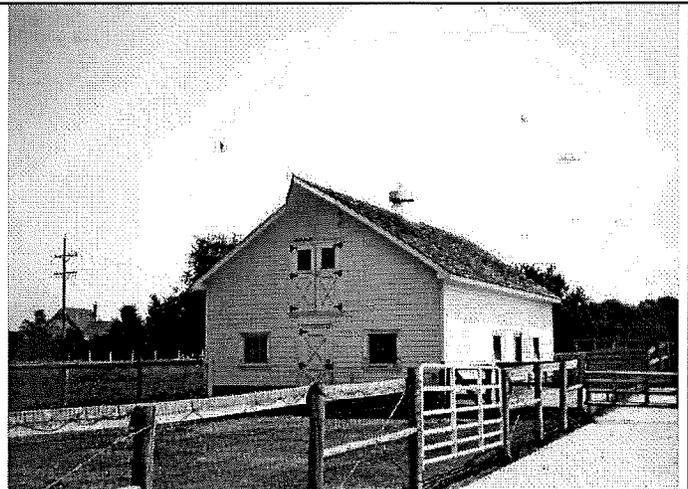
**Roll No./Neg.No.:** W36

<b>Circa:</b> 1900	<b>Condition:</b> Excellent	<b>Integrity:</b> Good
-----------------------	--------------------------------	---------------------------

<b>Materials:</b>	<b>HISTORY:</b>
<b>Foundation:</b> Concrete	Single metal vent with loft
<b>Walls:</b> Clapboard	Projecting eave, "Dutch Uncle" for grappling protection
<b>Roof:</b> Wood shingle	
<b>Porch:</b>

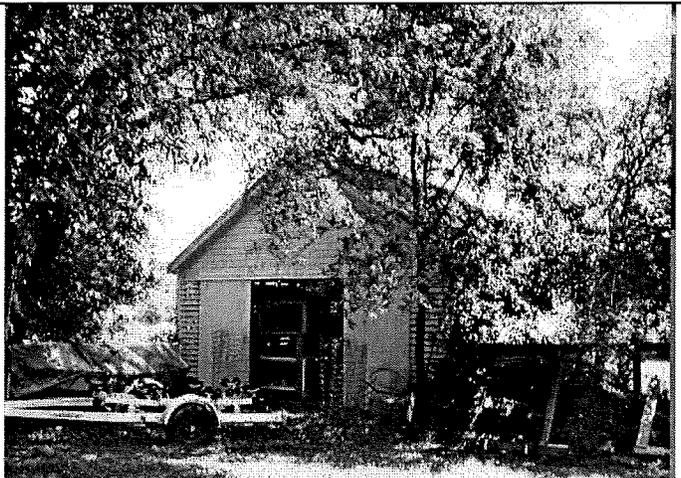
**Roll No./Neg.No.:** W35      **Surveyed by:** LM&KD      **Date:** 7-14-98

<b>Circa:</b> 1910	<b>Condition:</b> Good	<b>Integrity:</b> Good
-----------------------	---------------------------	---------------------------

<b>Materials:</b>	<b>HISTORY:</b>  No remarkable features
<b>Foundation:</b> Concrete	
<b>Walls:</b> Open clapboard slats	
<b>Roof:</b> Asphalt shingle	
<b>Porch:</b>

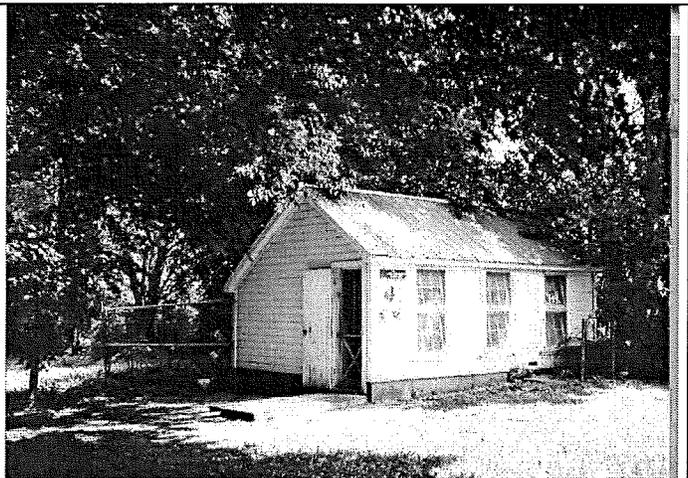
**Roll No./Neg.No.:** W34

<b>Circa:</b> 1940	<b>Condition:</b> Good	<b>Integrity:</b> Good
-----------------------	---------------------------	---------------------------

<b>Materials:</b>	<b>HISTORY:</b>
<b>Foundation:</b> Concrete <b>Walls:</b> Clapboard <b>Roof:</b> Batten metal <b>Porch:</b>	3 windows

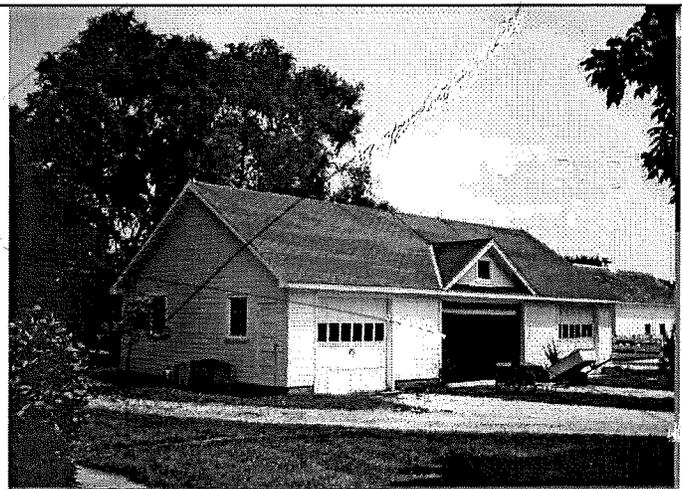
**Roll No./Neg.No.:** W33      **Surveyed by:** LM&KD      **Date:** 7-14-98

<b>Circa:</b> 1940	<b>Condition:</b> Good	<b>Integrity:</b> Good
-----------------------	---------------------------	---------------------------

<b>Materials:</b>	<b>HISTORY:</b>
<b>Foundation:</b> Concrete <b>Walls:</b> Clapboard <b>Roof:</b> Asphalt shingle <b>Porch:</b>	3 car garage with projecting dormer

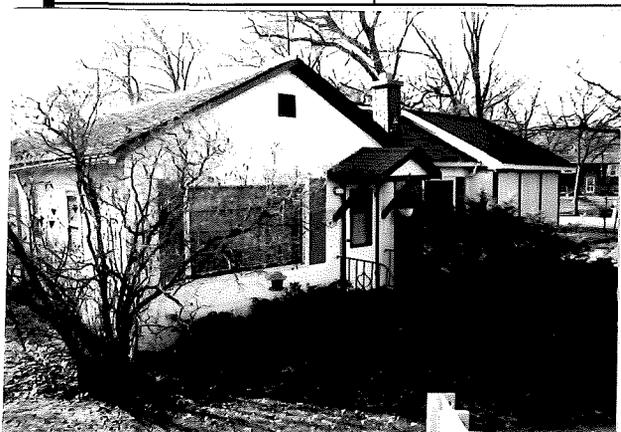
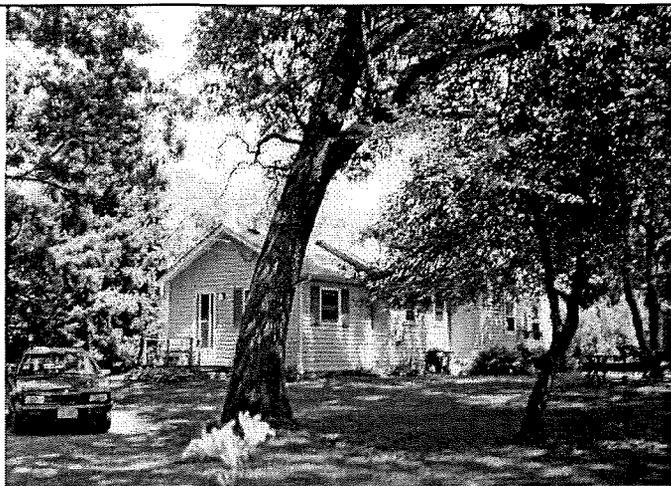
**Roll No./Neg.No.:** X3

<b>Circa:</b> 1870 - 1890	<b>Condition:</b> Excellent	<b>Integrity:</b> Poor
------------------------------	--------------------------------	---------------------------

<b>Materials:</b>	<b>HISTORY:</b>
<b>Foundation:</b> Stone and concrete	1 story
<b>Walls:</b> Asbestos	The picture was taken from rear, too much new growth in front
<b>Roof:</b> Asphalt shingle	
<b>Porch:</b>	
	Previous site = 4725

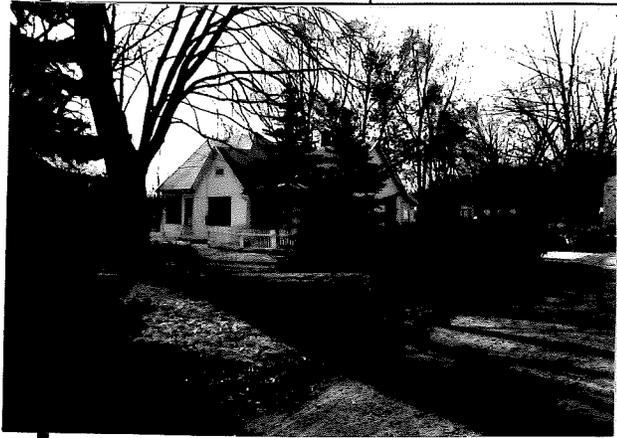
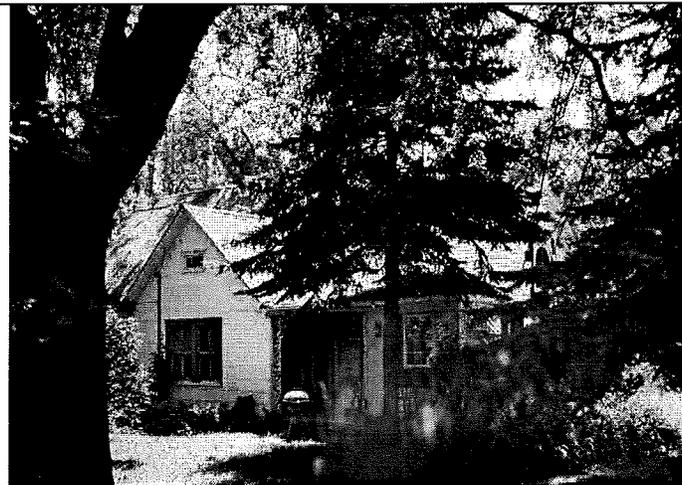
**Roll No./Neg.No.:** X5

<b>Circa:</b> 1900-1930	<b>Condition:</b> Poor	<b>Integrity:</b> Good
----------------------------	---------------------------	---------------------------

<b>Materials:</b>	<b>HISTORY:</b>
<b>Foundation:</b> Concrete <b>Walls:</b> Asbestos <b>Roof:</b> Asphalt shingle <b>Porch:</b>	Brick chimney          Previous site = 4726

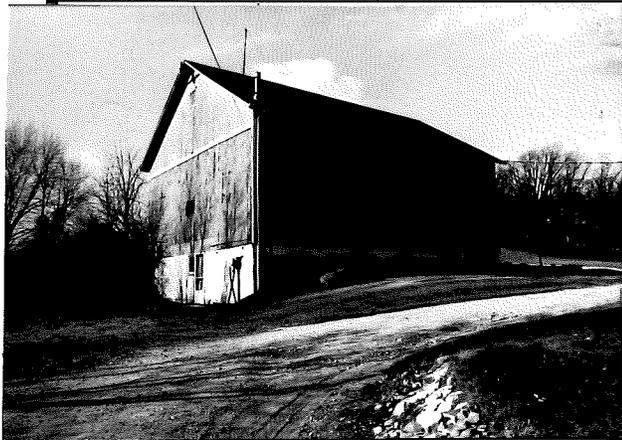
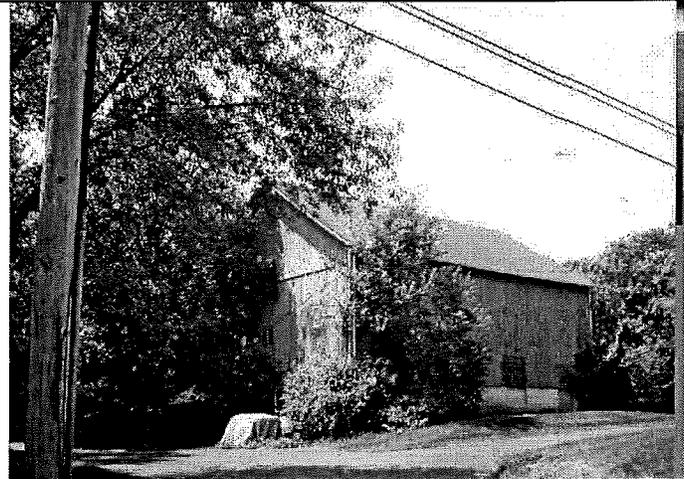
**Roll No./Neg.No.:** X4

<b>Circa:</b> 1880-1910	<b>Condition:</b> Poor	<b>Integrity:</b> Good
----------------------------	---------------------------	---------------------------

<b>Materials:</b>	<b>HISTORY:</b>
<b>Foundation:</b> Concrete	Formerly ramped
<b>Walls:</b> Vertical plank	New up & over garage doors on back
<b>Roof:</b> Asphalt shingle	
<b>Porch:</b>

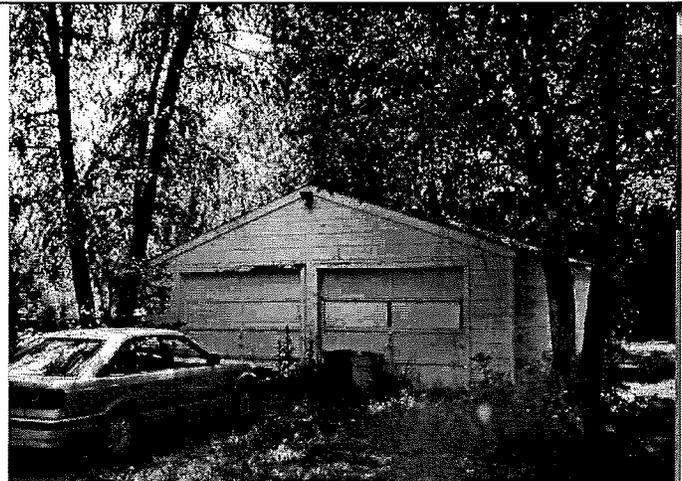
<b>Circa:</b> 1940	<b>Condition:</b> Poor	<b>Integrity:</b> Good
-----------------------	---------------------------	---------------------------

<b>Materials:</b>	<b>HISTORY:</b>
<b>Foundation:</b> Concrete	
<b>Walls:</b> Weather board	
<b>Roof:</b> Asphalt shingle	
<b>Porch:</b>

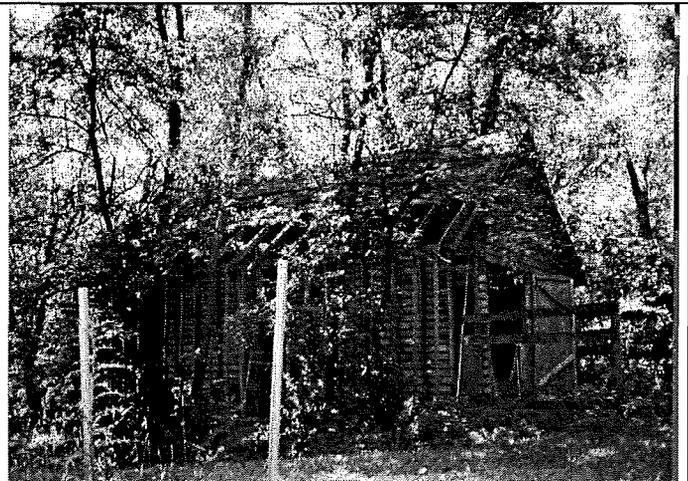
**Roll No./Neg.No.:** X7

<b>Circa:</b> 1880-1910	<b>Condition:</b> Poor	<b>Integrity:</b> Good
----------------------------	---------------------------	---------------------------

<b>Materials:</b>	<b>HISTORY:</b>
<b>Foundation:</b> Concrete <b>Walls:</b> Open slats & weather <b>Roof:</b> Asphalt shingle <b>Porch:</b>	Falling down

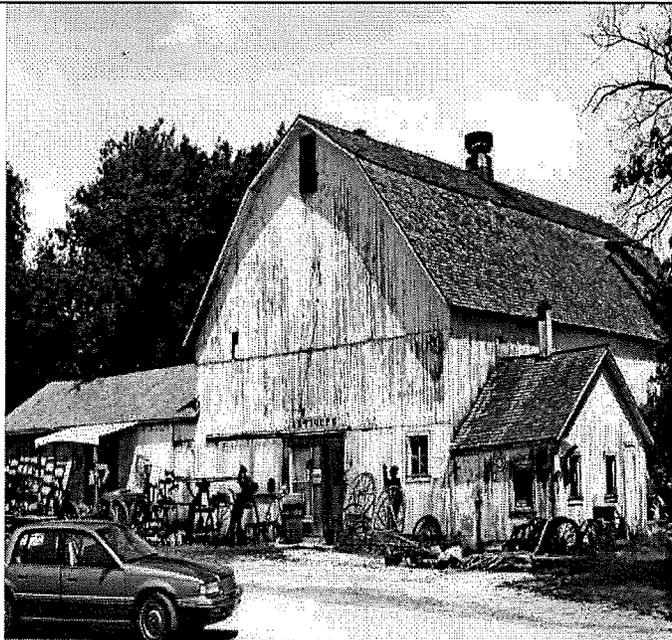
**Roll No./Neg.No.:** U14                      **Surveyed by:** KD&LM                      **Date:** 7-13-98

<b>Circa:</b> 1910-1945	<b>Condition:</b> Poor	<b>Integrity:</b> Poor
----------------------------	---------------------------	---------------------------

<b>Materials:</b> <b>Foundation:</b> Poured <b>Walls:</b> Vertical plank <b>Roof:</b> Wood shingle <b>Porch:</b> Front with columns	<b>HISTORY:</b>  Now an antique store and vegetable stand; single vent, many changes to original structure.
---	---

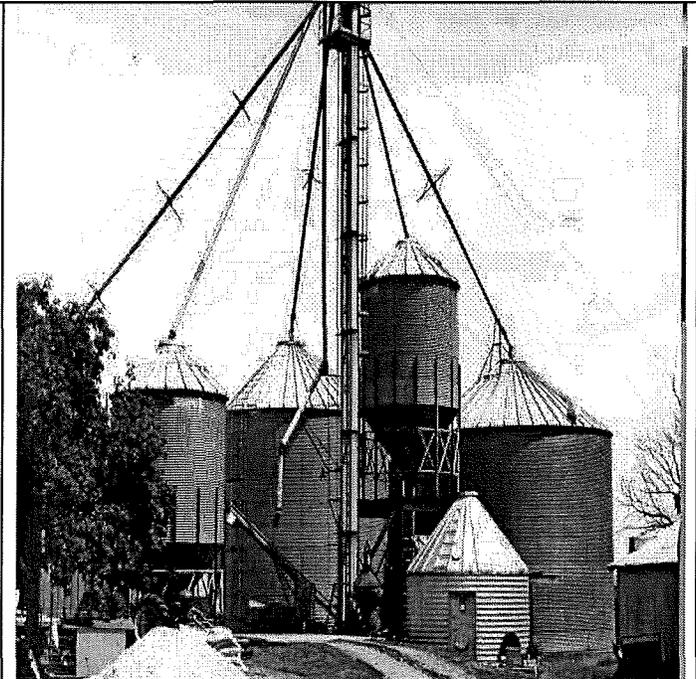
<b>Circa:</b> Post 1945	<b>Condition:</b> Good	<b>Integrity:</b> Good
----------------------------	---------------------------	---------------------------

<b>Materials:</b>	<b>HISTORY:</b>
<b>Foundation:</b> Concrete	
<b>Walls:</b> Metal/ corrugated	
<b>Roof:</b> Metal	
<b>Porch:</b>

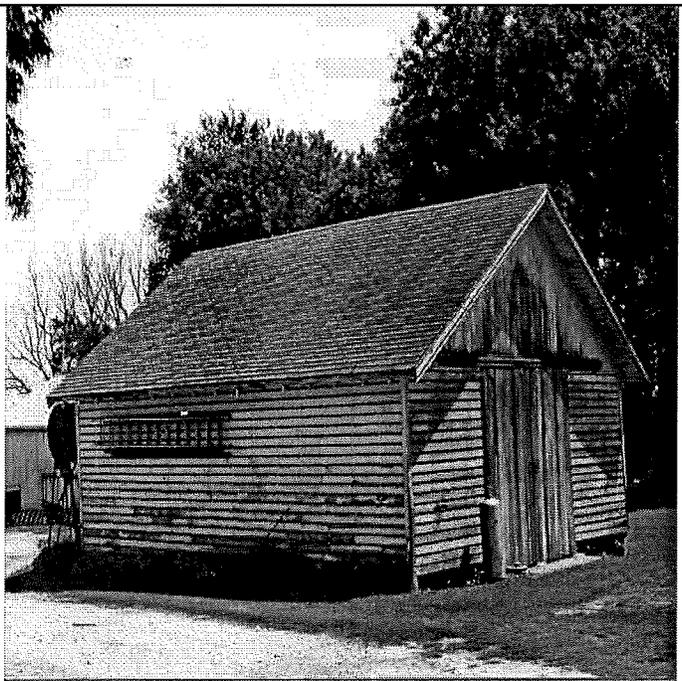
<b>Circa:</b> 1940	<b>Condition:</b> Good	<b>Integrity:</b> Excellent
-----------------------	---------------------------	--------------------------------

<b>Materials:</b>	<b>HISTORY:</b>  Transverse aisle
<b>Foundation:</b> Concrete	
<b>Walls:</b> Open slats clapboards	
<b>Roof:</b> Asphalt shingle	
<b>Porch:</b>	<i>↙ Note: Photo elongated ↘</i>

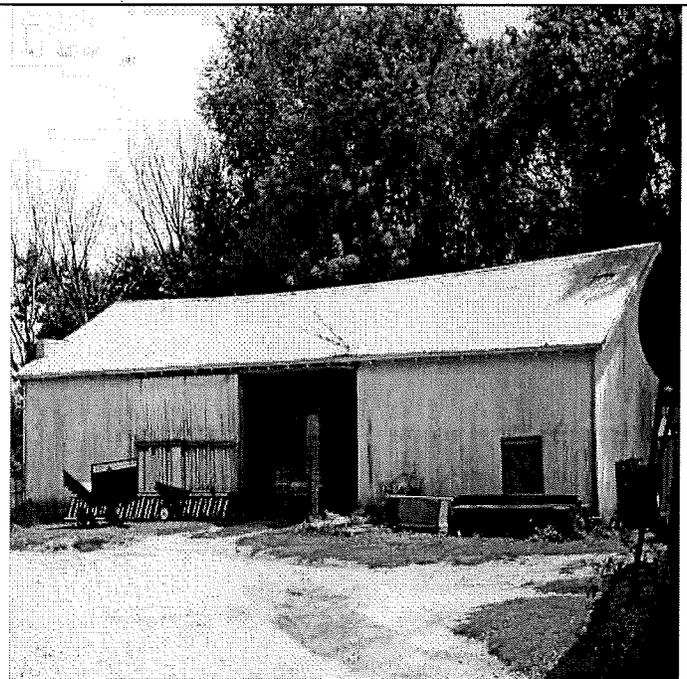
**Roll No./Neg.No.:** U17

<b>Circa:</b> 1940	<b>Condition:</b> Good	<b>Integrity:</b> Good
-----------------------	---------------------------	---------------------------

<b>Materials:</b>	<b>HISTORY:</b>
<b>Foundation:</b> Concrete	Used as a garage
<b>Walls:</b> Vertical plank	
<b>Roof:</b> Sheet metal	
<b>Porch:</b>

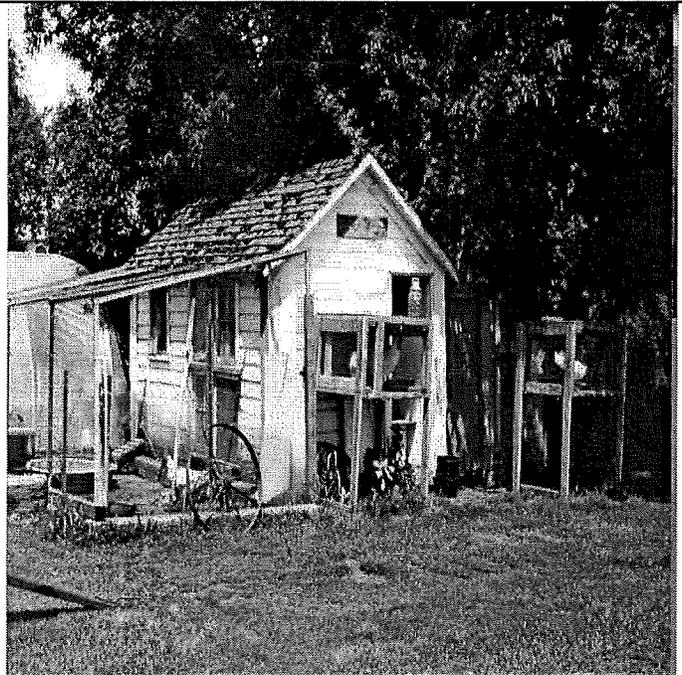
<b>Circa:</b> 1940	<b>Condition:</b> Poor	<b>Integrity:</b> Poor
-----------------------	---------------------------	---------------------------

<b>Materials:</b>	<b>HISTORY:</b>
<b>Foundation:</b> Concrete	Used as chicken coop.
<b>Walls:</b> Clapboard	
<b>Roof:</b> Asphalt shingle	
<b>Porch:</b>

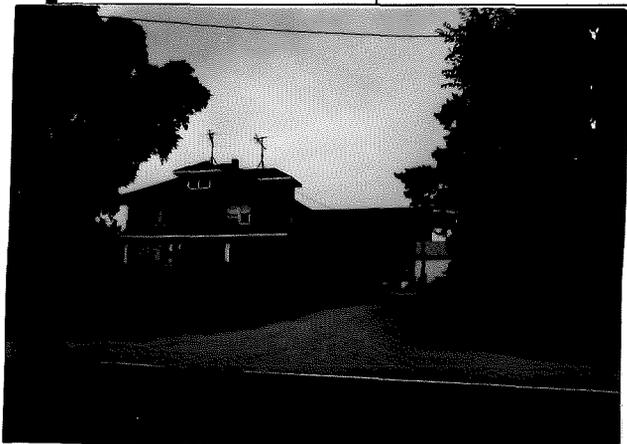
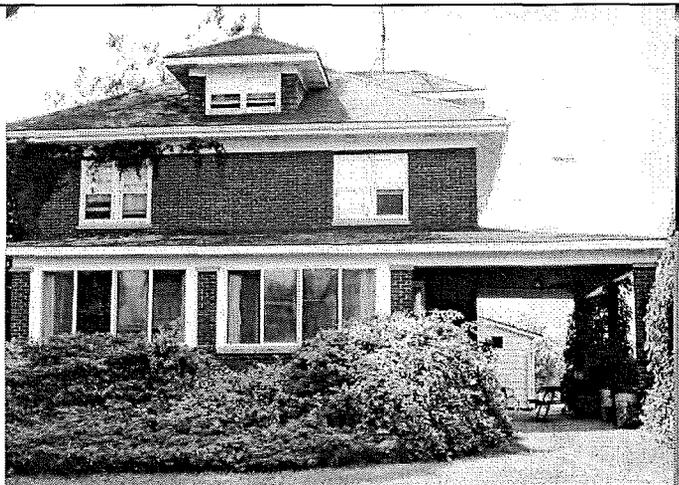
<b>Circa:</b> 1910-1945	<b>Condition:</b> Good	<b>Integrity:</b> Good
----------------------------	---------------------------	---------------------------

<b>Materials:</b>	<b>HISTORY:</b>  Has carport on side     Previous site = 2497
<b>Foundation:</b>	
<b>Walls:</b> Brick	
<b>Roof:</b> Asphalt shingle	
<b>Porch:</b>

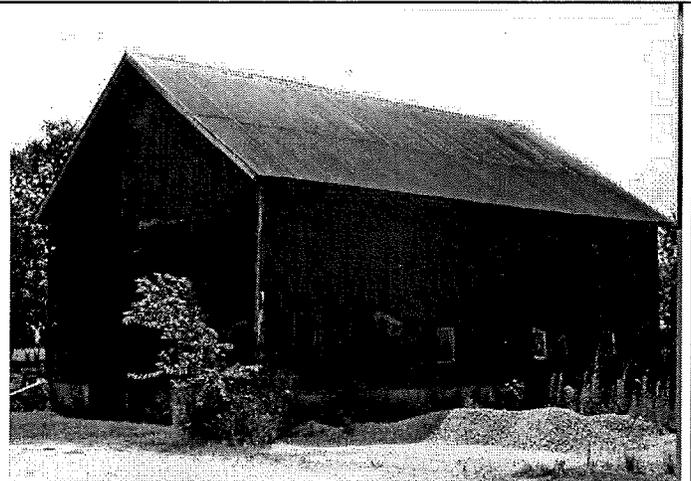
<b>Circa:</b> 1860-1910	<b>Condition:</b> Poor	<b>Integrity:</b> Good
----------------------------	---------------------------	---------------------------

<b>Materials:</b>	<b>HISTORY:</b>  Central aisle
<b>Foundation:</b> Concrete	
<b>Walls:</b> Batten vertical plank	
<b>Roof:</b> Corrugated metal	
<b>Porch:</b>

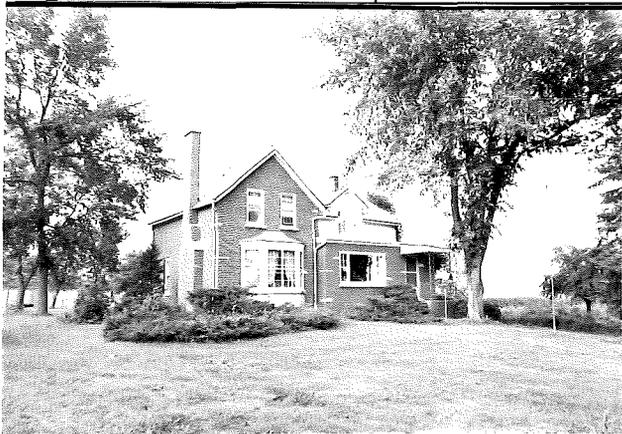
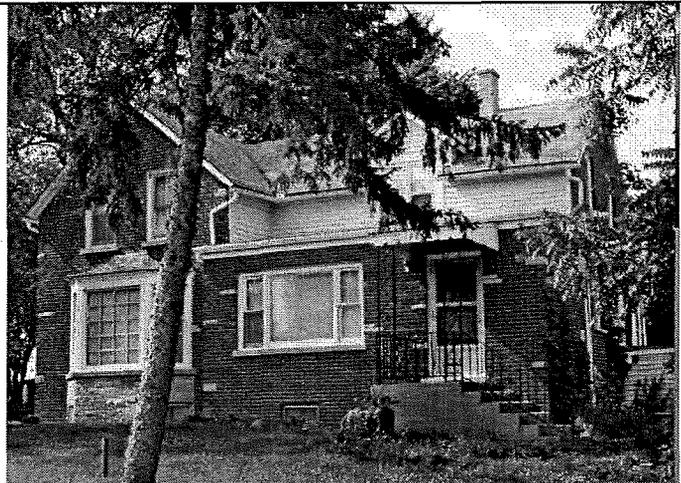
**Roll No./Neg.No.:** V10

<b>Circa:</b> 1870 – 1880	<b>Condition:</b> Good	<b>Integrity:</b> Poor
------------------------------	---------------------------	---------------------------

<b>Materials:</b>	<b>HISTORY:</b>
<b>Foundation:</b> Poured concrete and concrete block	
<b>Walls:</b> Brick and synthetic siding	
<b>Roof:</b> Asphalt shingle	
<b>Porch:</b> <i>Enclosed</i>

Some additions

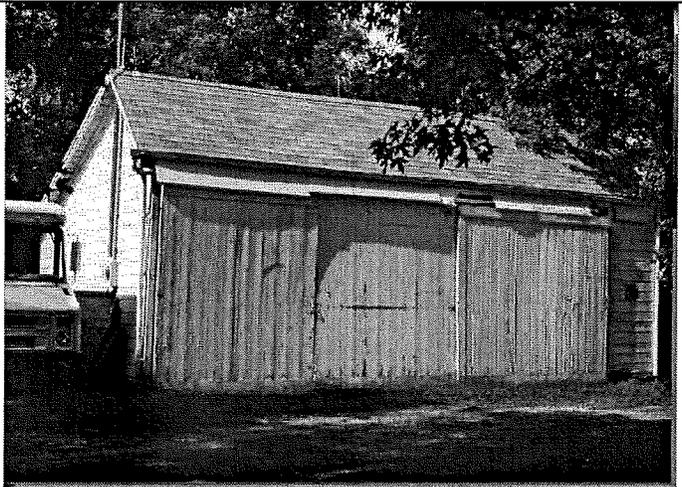
**Roll No./Neg.No.:** V11

<b>Circa:</b> 1890 - 1910	<b>Condition:</b> Poor	<b>Integrity:</b> Poor
------------------------------	---------------------------	---------------------------

<b>Materials:</b>	<b>HISTORY:</b>  Sliding door with saltbox shaped roof
<b>Foundation:</b> Concrete	
<b>Walls:</b> Vertical plank and clapboard	
<b>Roof:</b> Asphalt shingle	
<b>Porch:</b>

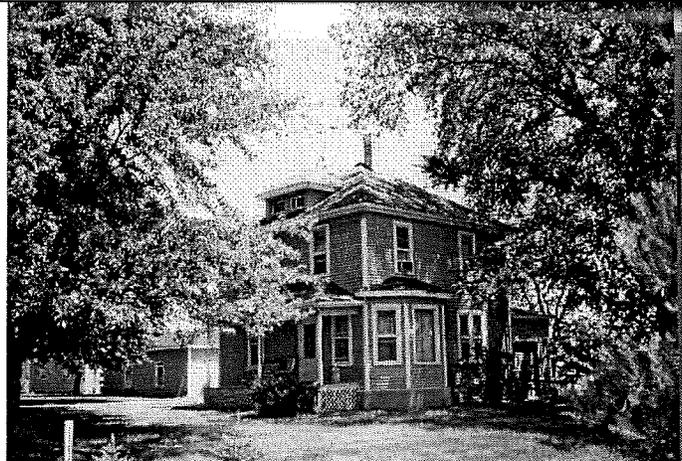
<b>Circa:</b> 1908 ( <i>as per resident</i> )	<b>Condition:</b> Excellent	<b>Integrity:</b> Good
--	--------------------------------	---------------------------

<b>Materials:</b>	<b>HISTORY:</b> From street some buildings seem to be hidden by trees. Originally the "Draper Family Farm," now a landscaping business. Built with running water in 1908 with an indoor bathroom. Resident has a picture of original house and newspaper article. Original farmstead house was moved. Wood from original house is at Woodstock opera house.  Previous site = 2276
<b>Foundation:</b> Stone	
<b>Walls:</b> Synthetic siding	
<b>Roof:</b> Asphalt shingle	
<b>Porch:</b> Front not enclosed

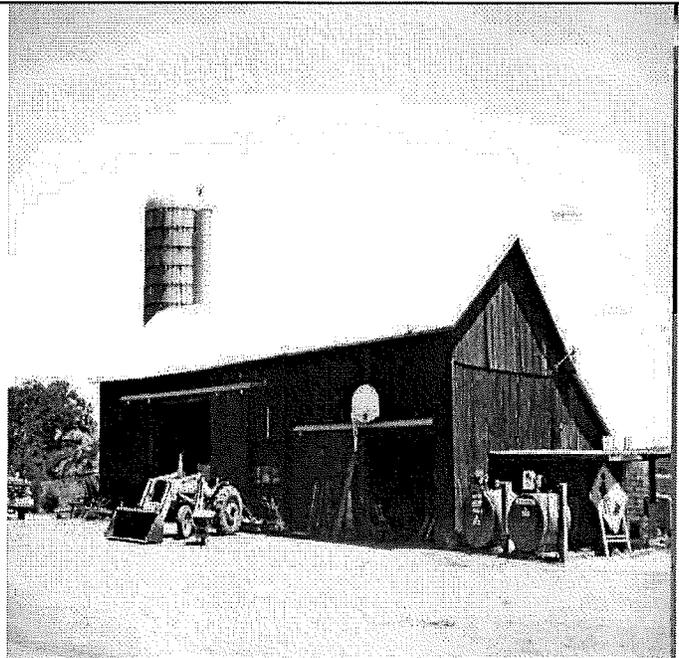
<b>Circa:</b> 1890	<b>Condition:</b> Good	<b>Integrity:</b> Good
-----------------------	---------------------------	---------------------------

<b>Materials:</b>	<b>HISTORY:</b> Original Draper family barn
<b>Foundation:</b> Concrete	
<b>Walls:</b> Vertical plank	
<b>Roof:</b> Asphalt shingle	
<b>Porch:</b>

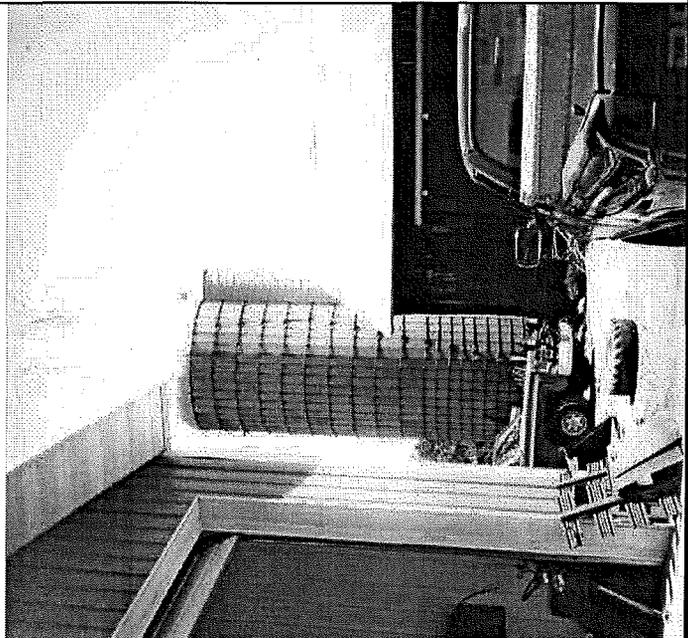
**Roll No./Neg.No.:** Y25

<b>Circa:</b> 1920	<b>Condition:</b> Excellent	<b>Integrity:</b> Excellent
-----------------------	--------------------------------	--------------------------------

<b>Materials:</b>	<b>HISTORY:</b>
<b>Foundation:</b> Concrete	Staved concrete
<b>Walls:</b> Staved concrete	Domed top
<b>Roof:</b> Metal dome	
<b>Porch:</b>

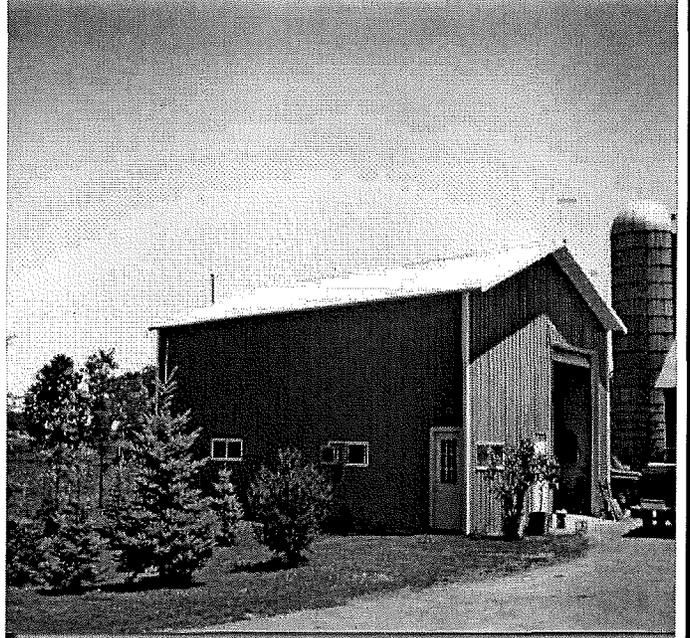
**Roll No./Neg.No.:** Y26

<b>Circa:</b> Post 1945	<b>Condition:</b> Excellent	<b>Integrity:</b> Excellent
----------------------------	--------------------------------	--------------------------------

<b>Materials:</b>	<b>HISTORY:</b>  Up-and-over door, houses landscaping business' offices
<b>Foundation:</b> Concrete	
<b>Walls:</b> Metal	
<b>Roof:</b> Metal	
<b>Porch:</b>

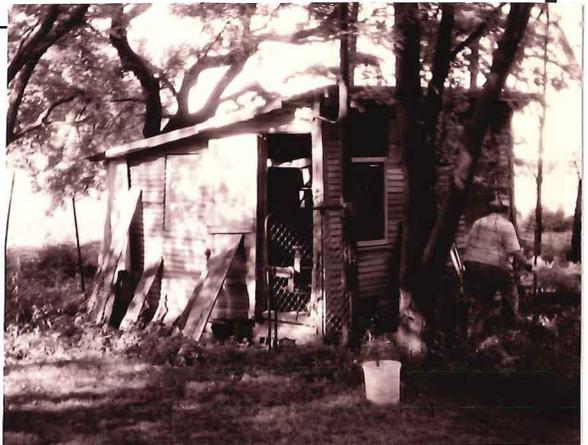
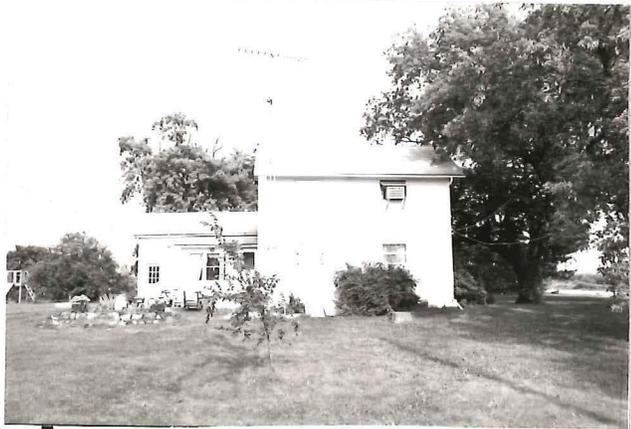
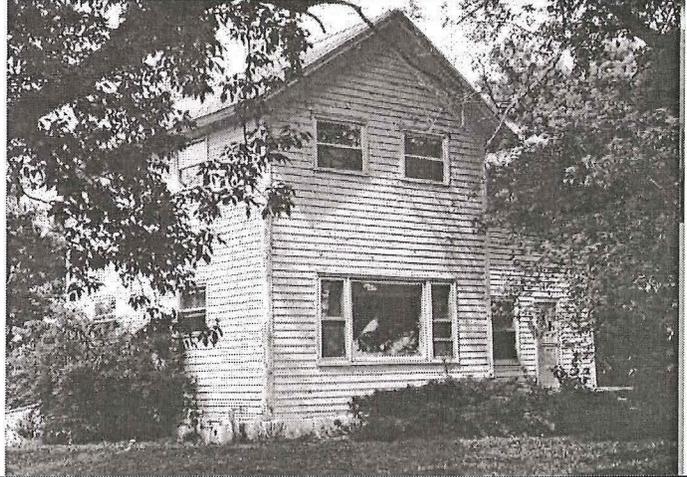
**Roll No./Neg.No.:** U30

<b>Circa:</b> 1860-1910	<b>Condition:</b> Poor	<b>Integrity:</b> Poor
----------------------------	---------------------------	---------------------------

**Foundation:**  
Concrete and brick

1998  
view  
of  
add'l  
ceap

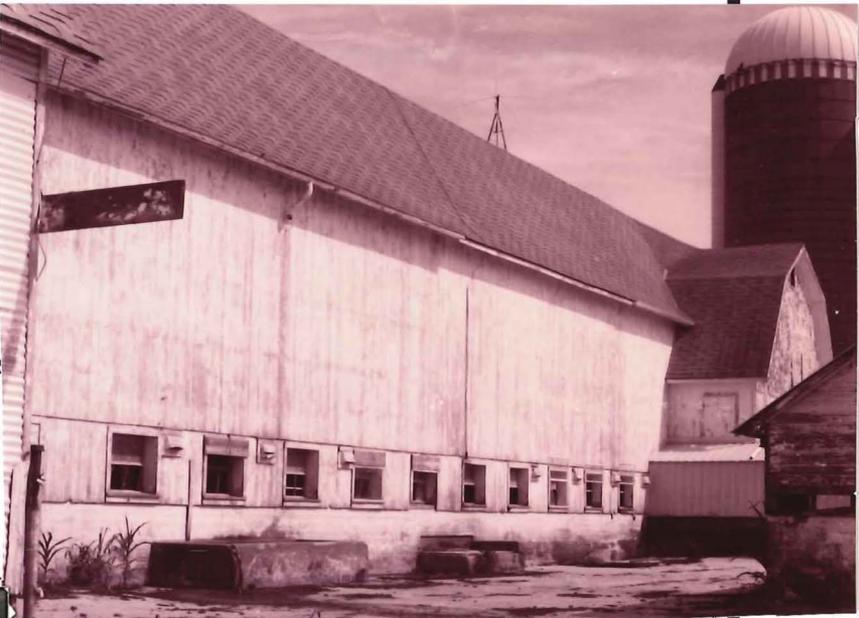
**Roll No./Neg.No.:** U32 &V1

<b>Materials:</b>	<b>HISTORY:</b>
<b>Foundation:</b> Poured	In disrepair
<b>Walls:</b> Vertical plank	Interesting shape
<b>Roof:</b> Asphalt shingle	With addition on <i>side</i>
<b>Porch:</b>	<i>additional 1998 view</i>

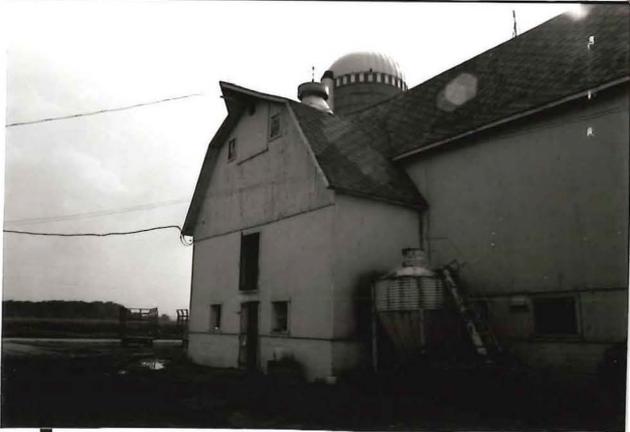
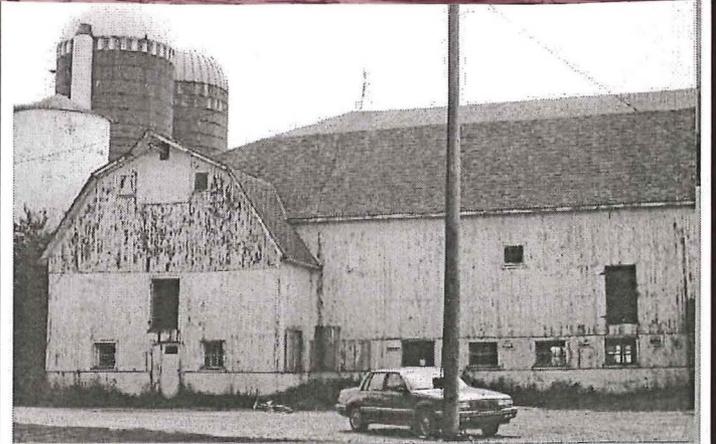
<b>Circa:</b> 1860-1910	<b>Condition:</b> Poor	<b>Integrity:</b> Good
----------------------------	---------------------------	---------------------------

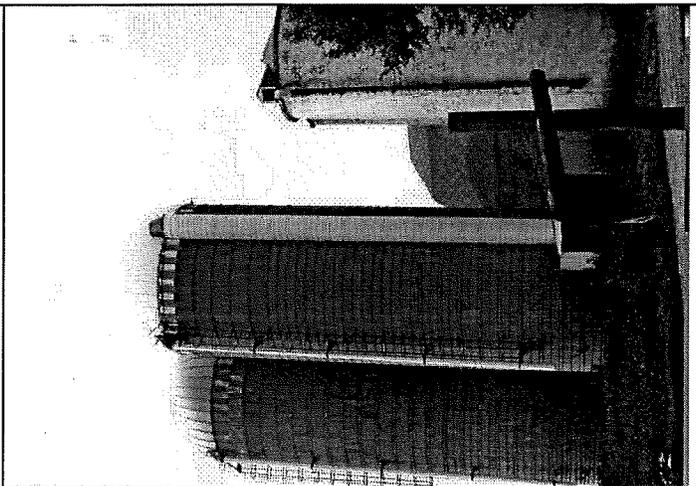
**Roll No./Neg.No.:** U31      **Surveyed by:** KD&LM      **Date:** 7-13-98

<b>Materials:</b>	<b>HISTORY:</b>
<b>Foundation:</b> Concrete <b>Walls:</b> Staved concrete(2) & poured concrete <b>Roof:</b> Metal dome <b>Porch:</b>	The 2 staved silos have decorated tops and ladders and viewing platforms attached

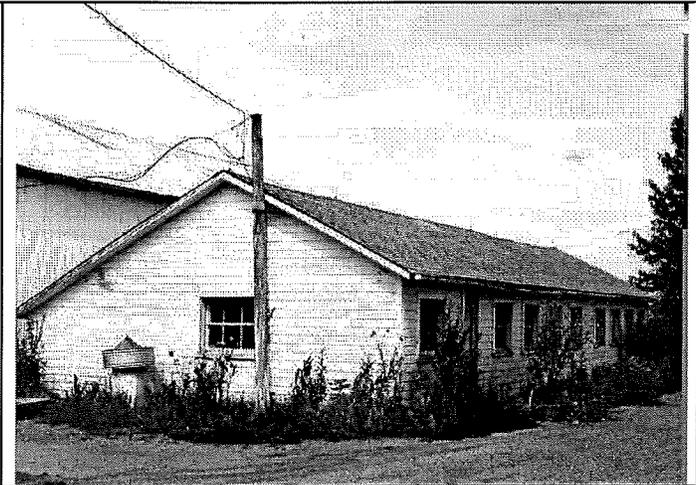
**Roll No./Neg.No.:** U33      **Surveyed by:** KD&LM      **Date:** 7-13-98

<b>Materials:</b>	<b>HISTORY:</b>
<b>Foundation:</b> Concrete <b>Walls:</b> Weather board <b>Roof:</b> Asphalt shingle <b>Porch:</b>	Coop

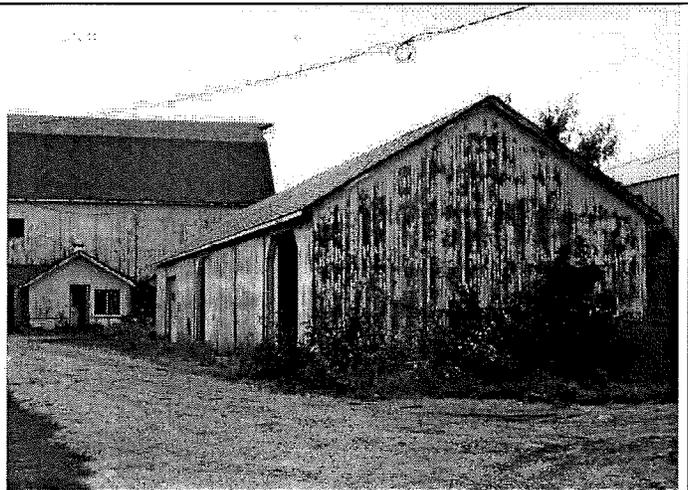
**Roll No./Neg.No.:** U34

<b>Circa:</b> 1890	<b>Condition:</b> Poor	<b>Integrity:</b> Good
-----------------------	---------------------------	---------------------------

<b>Materials:</b>	<b>HISTORY:</b>  Sliding doors along front length of building
<b>Foundation:</b> Concrete	
<b>Walls:</b> Vertical plank	
<b>Roof:</b> Asphalt shingle	
<b>Porch:</b>

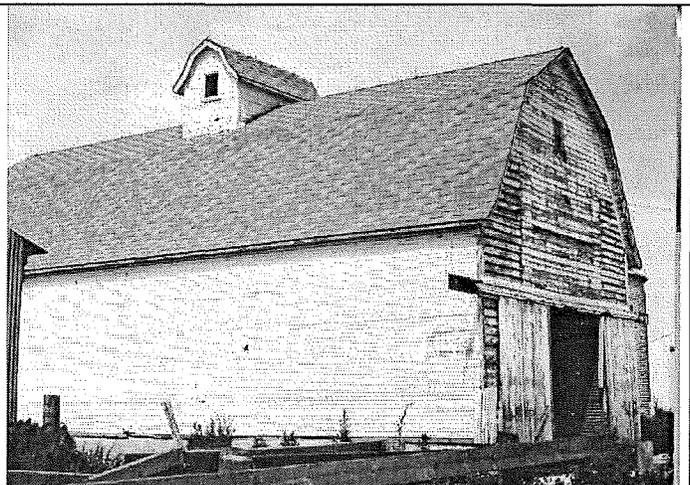
**Roll No./Neg.No.:** U35      **Surveyed by:** KD&LM      **Date:** 7-13-98

<b>Circa:</b> 1900 - 1920	<b>Condition:</b> Poor	<b>Integrity:</b> Good
------------------------------	---------------------------	---------------------------

<b>Materials:</b>	<b>HISTORY:</b>
<b>Foundation:</b> Concrete <b>Walls:</b> Clapboard <b>Roof:</b> Asphalt shingle <b>Porch:</b>	Has gambrel, roofed cupola perpendicular to the gambrel roof

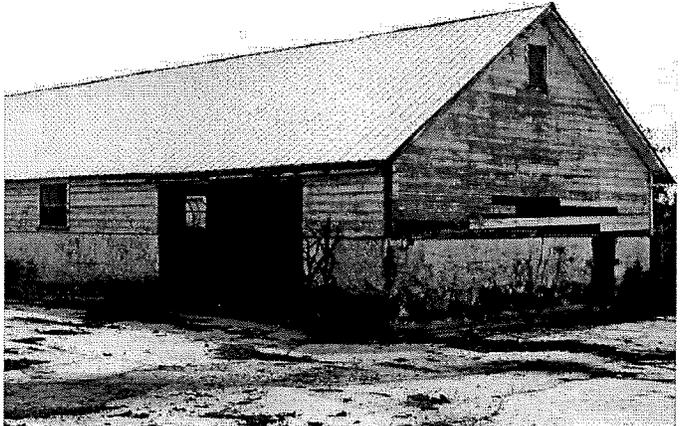
**Roll No./Neg.No.:** U36      **Surveyed by:** KD&LM      **Date:** 7-13-98

<b>Circa:</b> 1900	<b>Condition:</b> Poor	<b>Integrity:</b> Poor
-----------------------	---------------------------	---------------------------

<b>Materials:</b>	<b>HISTORY:</b>  Structure in bad shape
<b>Foundation:</b> Concrete	
<b>Walls:</b> Clapboard	
<b>Roof:</b> Batten Metal	
<b>Porch:</b>

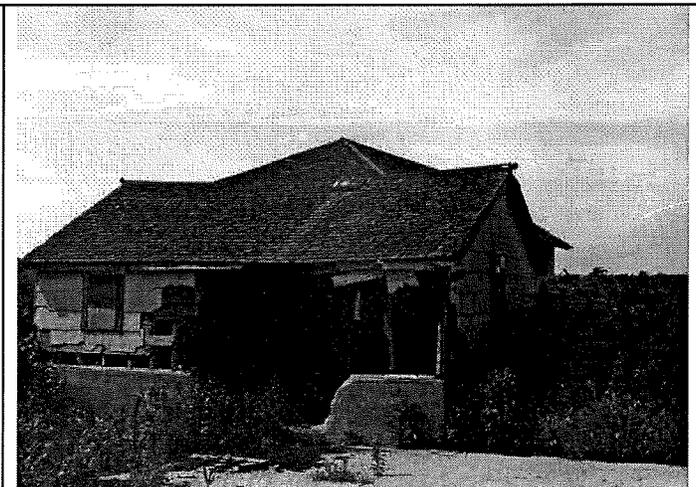
<b>Materials:</b>	<b>HISTORY:</b>
<b>Foundation:</b> Concrete	
<b>Walls:</b> Clapboard and asbestos	
<b>Roof:</b> Wood shingle	
<b>Porch:</b>

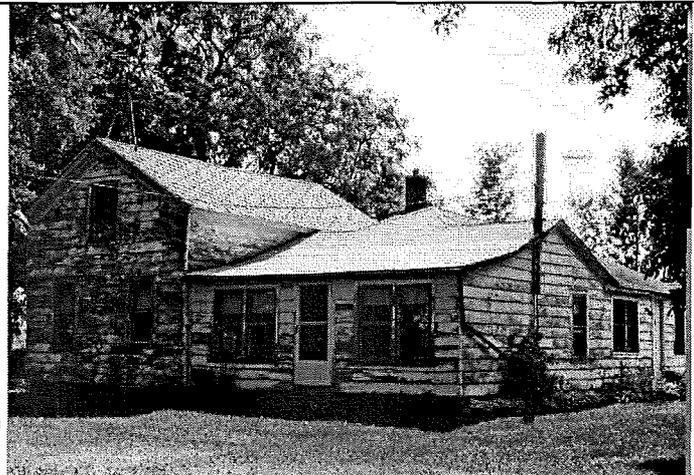
**Roll No./Neg.No.:** U21

<b>Circa:</b> 1850 - 1870	<b>Condition:</b> Poor	<b>Integrity:</b> Poor
------------------------------	---------------------------	---------------------------

<b>Materials:</b>	<b>HISTORY:</b>
<b>Foundation:</b> Concrete on addition and brick	Property appears to be abandoned
<b>Walls:</b> Clapboard	Fairly run down "James Lurran Jr." is owner & resident all building in close proximity
<b>Roof:</b> Asphalt shingle	
<b>Porch:</b>	Previous site = 2265

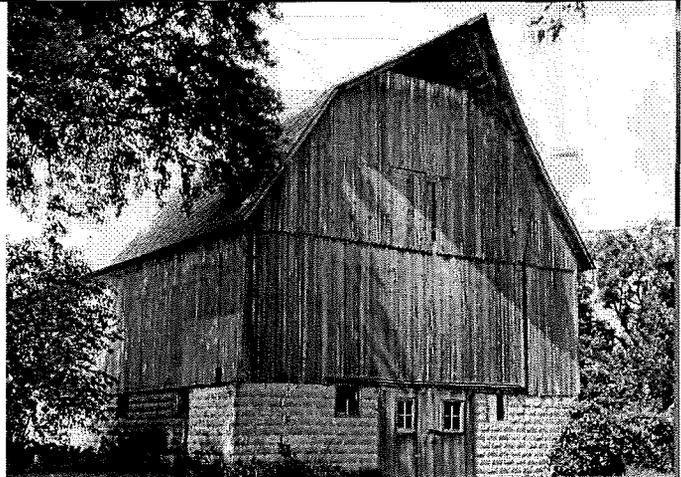
**Roll No./Neg.No.:** U27

<b>Circa:</b> 1910 - 1930	<b>Condition:</b> Poor	<b>Integrity:</b> Good
------------------------------	---------------------------	---------------------------

<b>Materials:</b>	<b>HISTORY:</b>
<b>Foundation:</b> Rounded concrete block	Exterior needs work
<b>Walls:</b> Vertical plank	Transverse aisle
<b>Roof:</b> Asphalt shingle	Scalloped edge on upper level vertical plank over laps lower level
<b>Porch:</b>

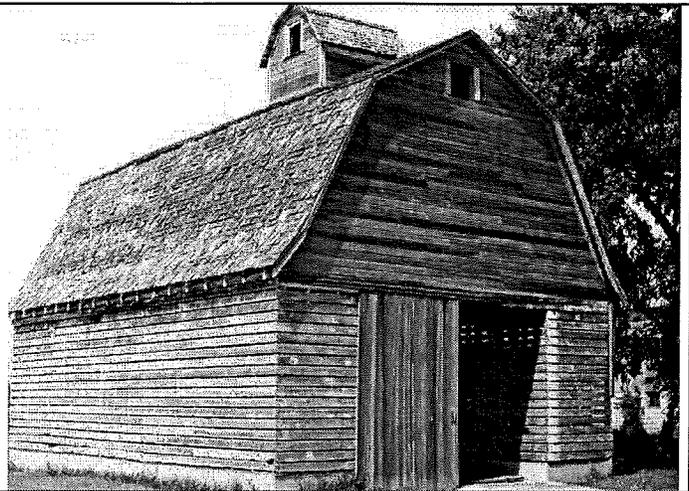
**Roll No./Neg.No.:** U25      **Surveyed by:** LM&KD      **Date:** 7-14-98

<b>Materials:</b>	<b>HISTORY:</b>
<b>Foundation:</b> Concrete	
<b>Walls:</b> Wood Slat and clapboard	
<b>Roof:</b> Wood shingles	
<b>Porch:</b>

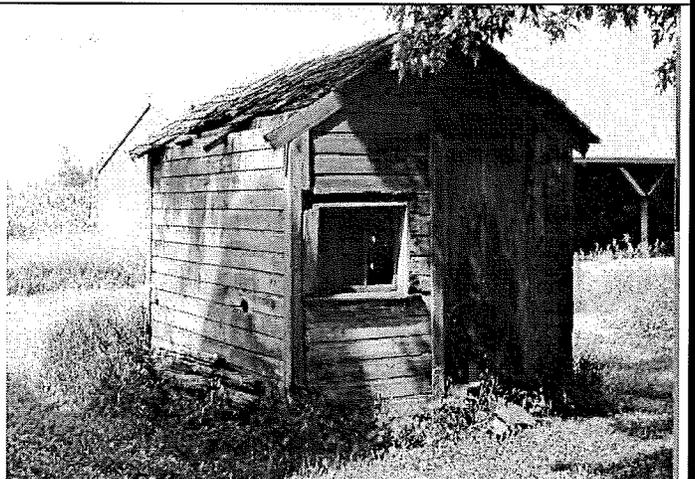
**Roll No./Neg.No.:** U26

<b>Circa:</b> 1920	<b>Condition:</b> Poor	<b>Integrity:</b> Good
-----------------------	---------------------------	---------------------------

<b>Materials:</b>	<b>HISTORY:</b>  Falling apart
<b>Foundation:</b> Stone	
<b>Walls:</b> Beveled clapboard	
<b>Roof:</b> Wood shingles	
<b>Porch:</b>
