McHenry County

Rural Survey

***Nunda Township***

***FIELD DATA SHEETS***

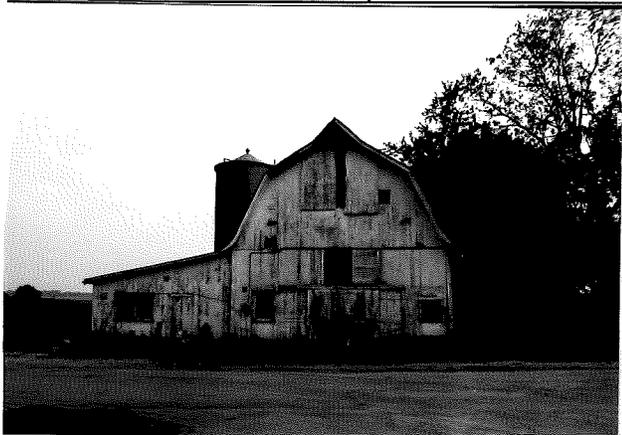
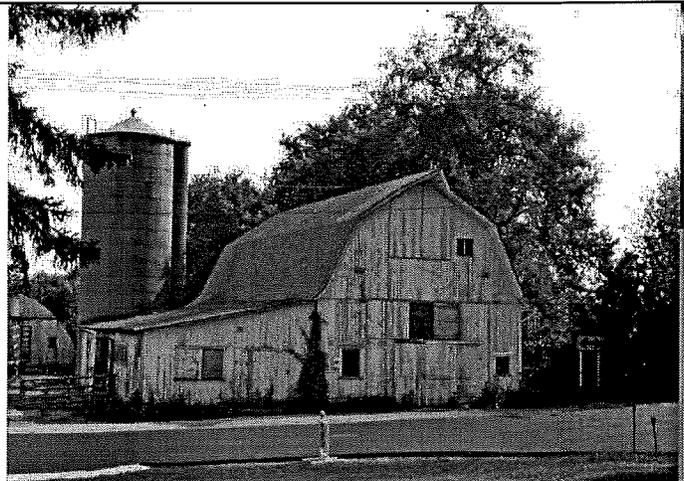
**Roll No./Neg.No.:** V9

<b>Circa:</b> 1910-1945	<b>Condition:</b> Poor	<b>Integrity:</b> Poor
----------------------------	---------------------------	---------------------------

<b>Materials:</b>	<b>HISTORY:</b>
<b>Foundation:</b> Poured	Still being used for hay
<b>Walls:</b> Vertical plank	Scalloped edges on vertical plank overlap
<b>Roof:</b> Asphalt shingle	
<b>Porch:</b>	Previous site = 2268

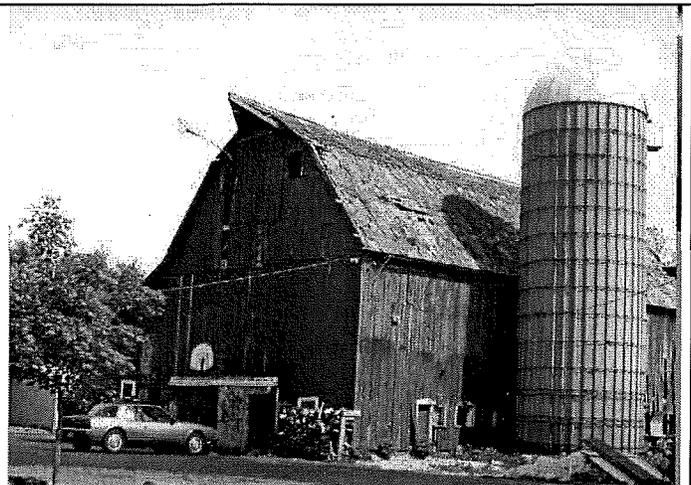
**Roll No./Neg.No.:** V7

<b>Circa:</b> 1880 - 1900	<b>Condition:</b> Poor	<b>Integrity:</b> Good
------------------------------	---------------------------	---------------------------

<b>Materials:</b>	<b>HISTORY:</b>
<b>Foundation:</b> Concrete	Built in 1880's according to resident
<b>Walls:</b> Vertical plank	Resident would like help restoring the barn
<b>Roof:</b> Wood shingles	
<b>Porch:</b>

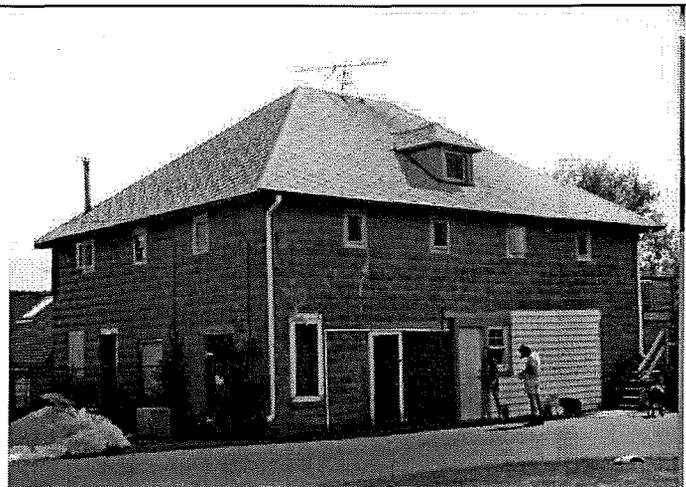
**Roll No./Neg.No.:** V5

<b>Circa:</b> 1930	<b>Condition:</b> Good	<b>Integrity:</b> Poor
-----------------------	---------------------------	---------------------------

<b>Materials:</b>	<b>HISTORY:</b>
<b>Foundation:</b> Concrete	Coach house with horse stalls in rear
<b>Walls:</b> Molded concrete block	Hipped roof
<b>Roof:</b> Asphalt	Upstairs grainery
<b>Porch:</b>

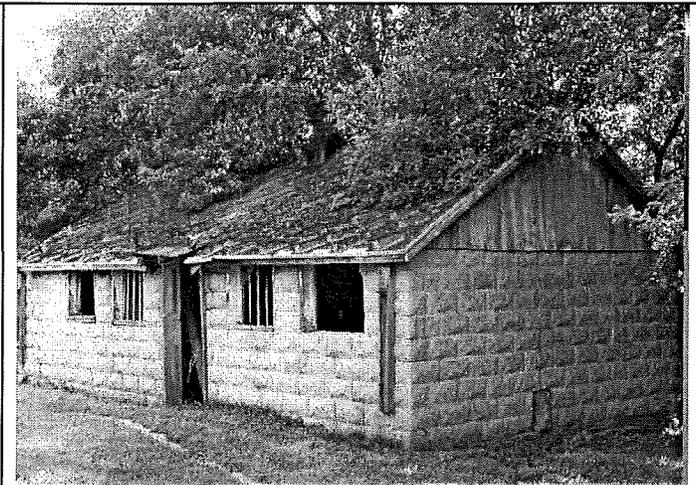
**Roll No./Neg.No.:** V6

<b>Materials:</b>	<b>HISTORY:</b>
<b>Foundation:</b> Concrete <b>Walls:</b> <i>Molded</i> Concrete block <b>Roof:</b> Asphalt shingle <b>Porch:</b>	Chicken coop with one vent

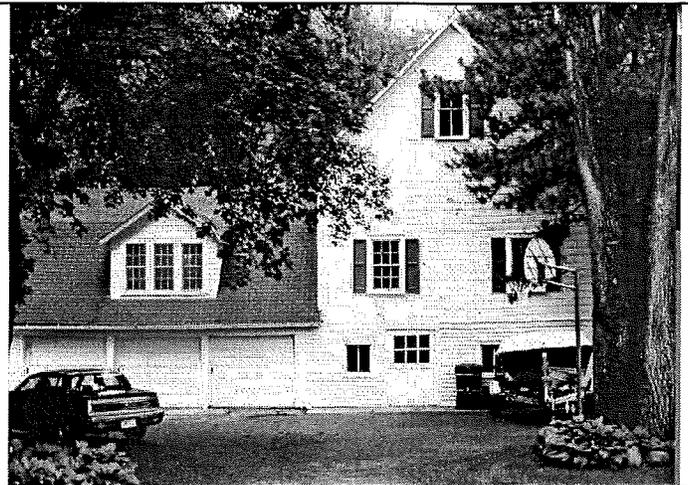
<b>Circa:</b> 1910	<b>Condition:</b> Poor	<b>Integrity:</b> Good
-----------------------	---------------------------	---------------------------

<b>Materials:</b>	<b>HISTORY:</b>
<b>Foundation:</b> Concrete <b>Walls:</b> Clapboard <b>Roof:</b> Asphalt shingle <b>Porch:</b>	May have been converted from a barn

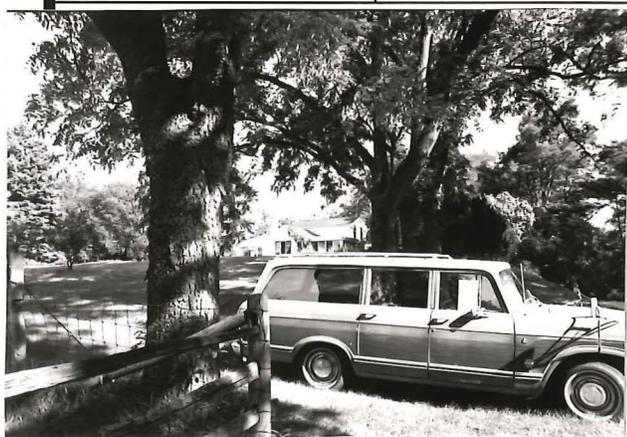
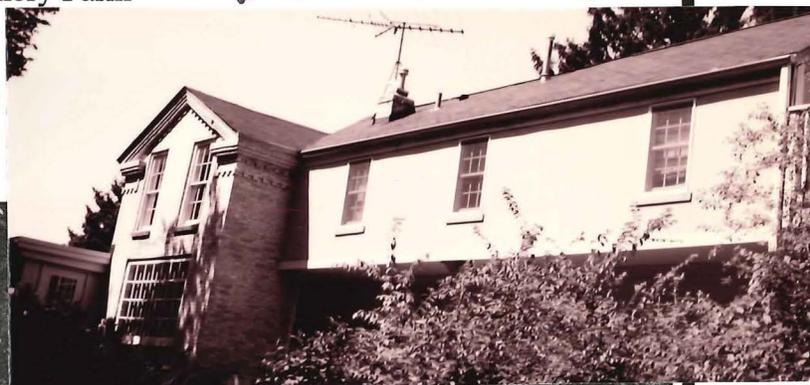
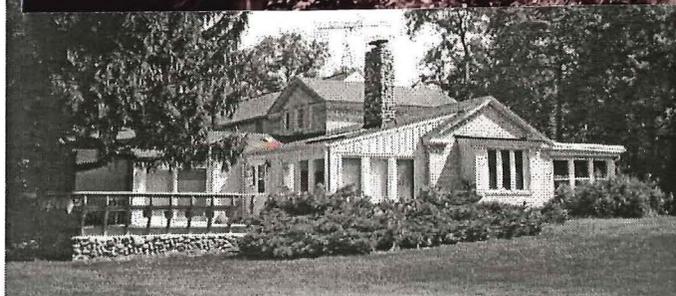
<b>Circa:</b> 1860 - 1870	<b>Condition:</b> Excellent	<b>Integrity:</b> Poor
------------------------------	--------------------------------	---------------------------

<b>Materials:</b>	<b>HISTORY:</b>
<b>Foundation:</b> Stone	Decorative brickwork forms cornice returns and detail
<b>Walls:</b> Brick	Stone chimney and brick chimney, residence is obscured by trees & bushes. "Fond Memory Farm" <i>additional 1998 view ↘</i>
<b>Roof:</b> Asphalt shingle	
<b>Porch:</b> Side, screened	Previous site = 2277

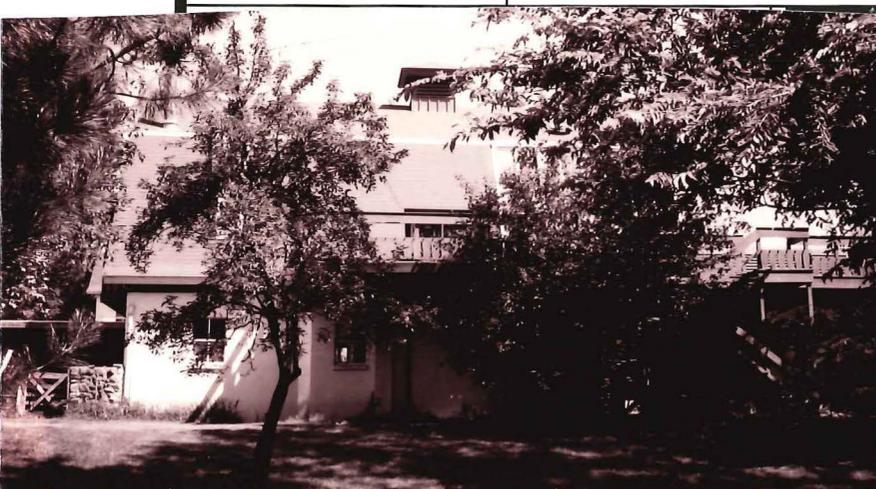
**Roll No./Neg.No.:** X30

<b>Materials:</b>	<b>HISTORY:</b>
<b>Foundation:</b> Concrete	Ramped (stone ramp), has been converted into a residence
<b>Walls:</b> Vertical plank-modern	Silo has a room at the top. Two cupolas, transverse aisle – excellent condition, has an indoor pool inside of barn
<b>Roof:</b> Asphalt shingle	
<b>Porch:</b> Side: screened

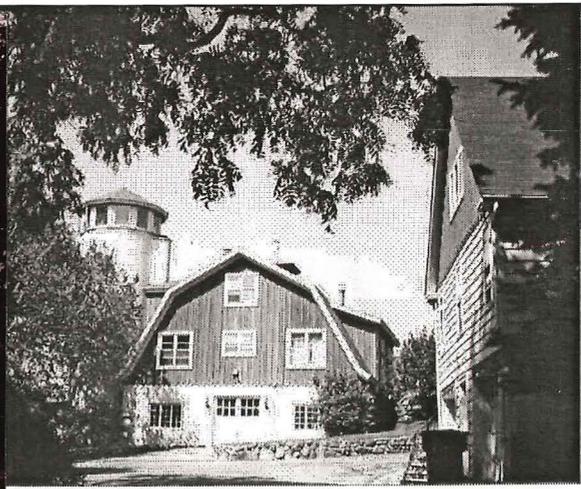
<b>Circa:</b> 1920	<b>Condition:</b> Excellent	<b>Integrity:</b> Poor
-----------------------	--------------------------------	---------------------------

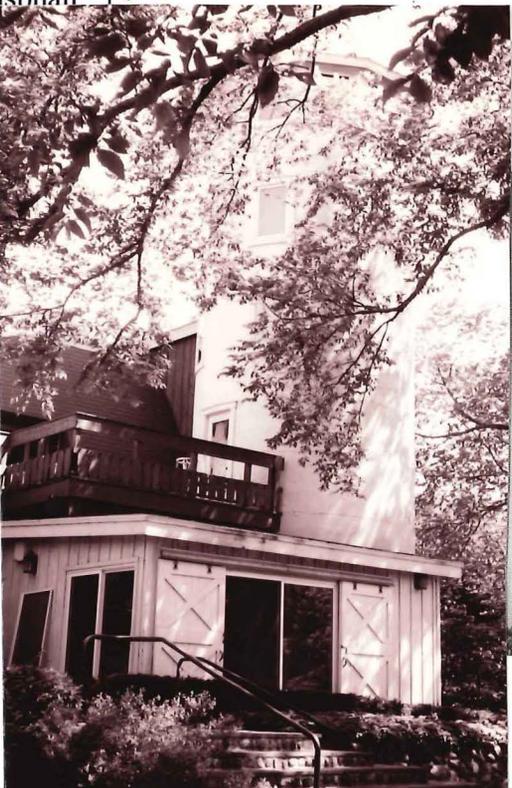
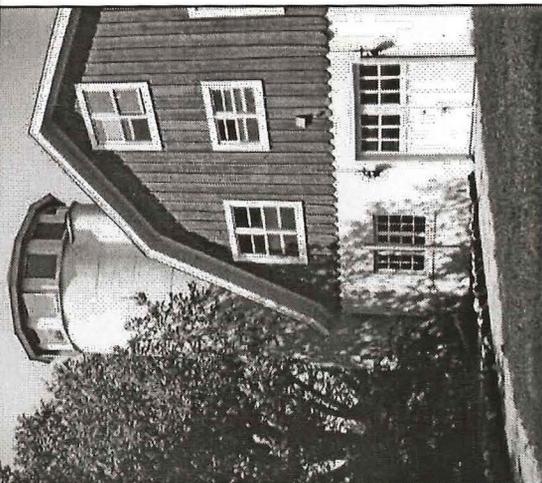
**Roll No./Neg.No.:** X31

<b>Circa:</b> 1920	<b>Condition:</b> Excellent	<b>Integrity:</b> Poor
-----------------------	--------------------------------	---------------------------

<b>Materials:</b>	<b>HISTORY:</b>  Has been converted to a room with 360 degrees of windows.
<b>Foundation:</b> Concrete	
<b>Walls:</b> Concrete	
<b>Roof:</b> Concrete with asphalt shingle

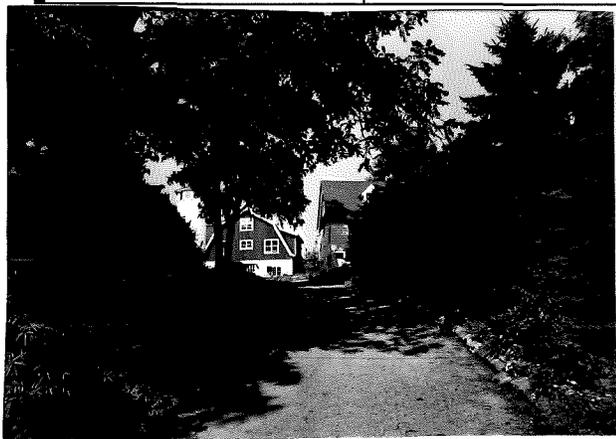
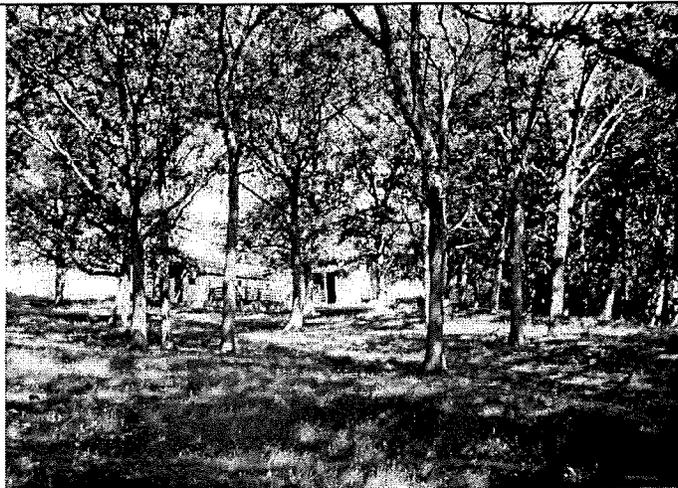
**Roll No./Neg.No.:** X34

<b>Circa:</b> 1910-1930	<b>Condition:</b> Good	<b>Integrity:</b> Good
----------------------------	---------------------------	---------------------------

<b>Materials:</b>	<b>HISTORY:</b>  Picture from far away because of electrified fence.    Previous site = 2278
<b>Foundation:</b> Concrete	
<b>Walls:</b> Concrete block and vertical plank	
<b>Roof:</b> Asphalt shingle	
<b>Porch:</b>

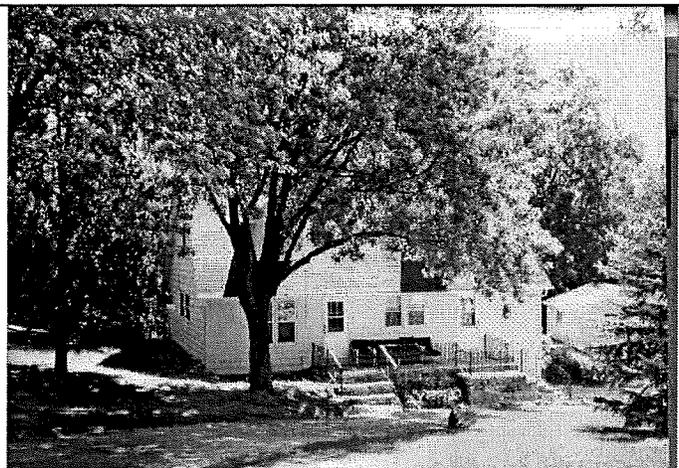
**Roll No./Neg.No.:** X35

<b>Circa:</b> 1900-1940	<b>Condition:</b> Excellent	<b>Integrity:</b> Poor
----------------------------	--------------------------------	---------------------------

<b>Materials:</b> <b>Foundation:</b> Stone <b>Walls:</b> Synthetic siding <b>Roof:</b> Asphalt shingle <b>Porch:</b> Fieldstone porch added	<b>HISTORY:</b>  Converted from a gable barn, has 2 car garage underneath
---	---

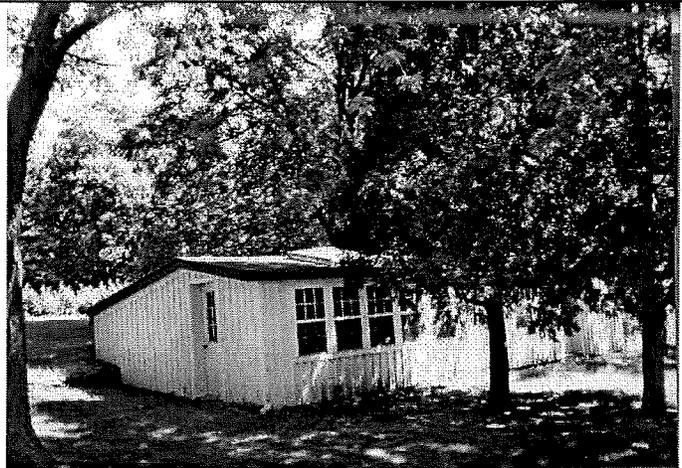
<b>Circa:</b> 1900-1940	<b>Condition:</b> Good	<b>Integrity:</b> Good
----------------------------	---------------------------	---------------------------

<b>Materials:</b>	<b>HISTORY:</b>  Former coop, has been converted to living space
<b>Foundation:</b> Stone <b>Walls:</b> Vertical plank <b>Roof:</b> Asphalt shingle <b>Porch:</b>

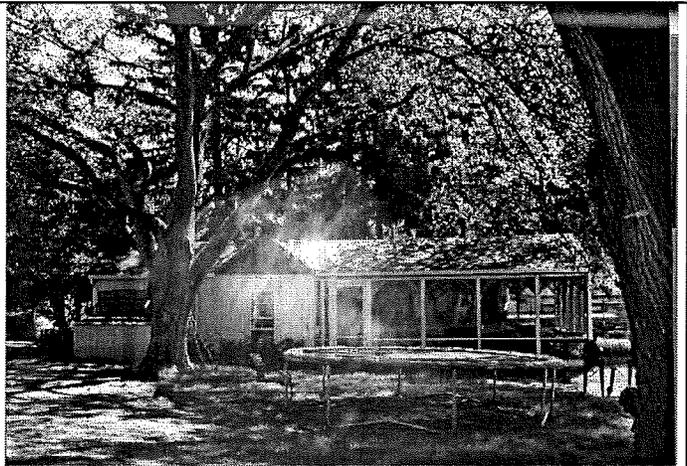
**Roll No./Neg.No.:** Y01

<b>Circa:</b> 1940	<b>Condition:</b> Excellent	<b>Integrity:</b> Poor
-----------------------	--------------------------------	---------------------------

<b>Materials:</b>	<b>HISTORY:</b>  Screened-in patio overlooking pond, brick chimney
<b>Foundation:</b> Concrete	
<b>Walls:</b> Vertical plank -modern	
<b>Roof:</b> Asphalt shingle	
<b>Porch:</b> Screened

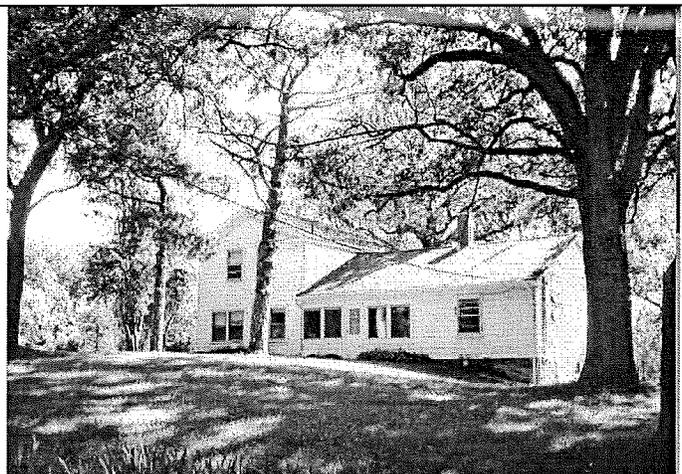
**Roll No./Neg.No.:** X29

<b>Function:</b>	<b>Vernacular Type:</b>	<b>Arch. Style:</b>	<b>Alterations:</b>
Residence	Upright and wing	Greek revival	Many additions and modernization's Replacement windows

<b>Circa:</b> 1850 - 1870	<b>Condition:</b> Good	<b>Integrity:</b> Poor
------------------------------	---------------------------	---------------------------

<b>Materials:</b>	<b>HISTORY:</b>
<b>Foundation:</b> Stone and concrete	Not on previous survey, but a farmstead is shown at this location
<b>Walls:</b> Synthetic siding	
<b>Roof:</b> Asphalt shingle	
<b>Porch:</b> Enclosed

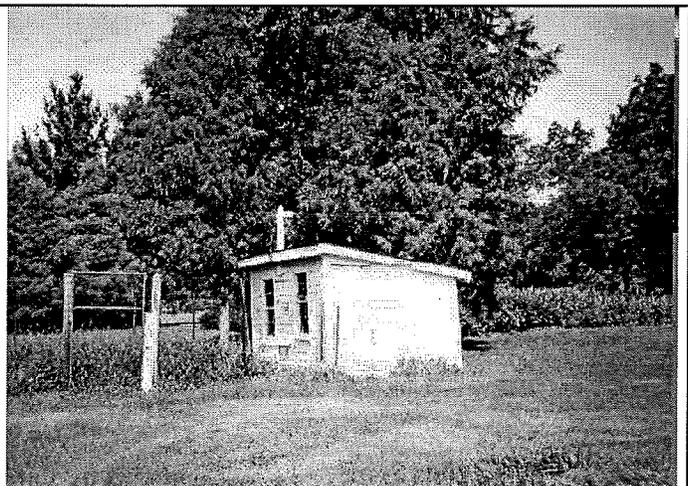
**Roll No./Neg.No.:** X26

<b>Circa:</b> 1910	<b>Condition:</b> Poor	<b>Integrity:</b> Good
-----------------------	---------------------------	---------------------------

<b>Materials:</b>	<b>HISTORY:</b>  Coop
<b>Foundation:</b> Concrete	
<b>Walls:</b> Synthetic siding	
<b>Roof:</b> Asphalt shingle	
<b>Porch:</b>

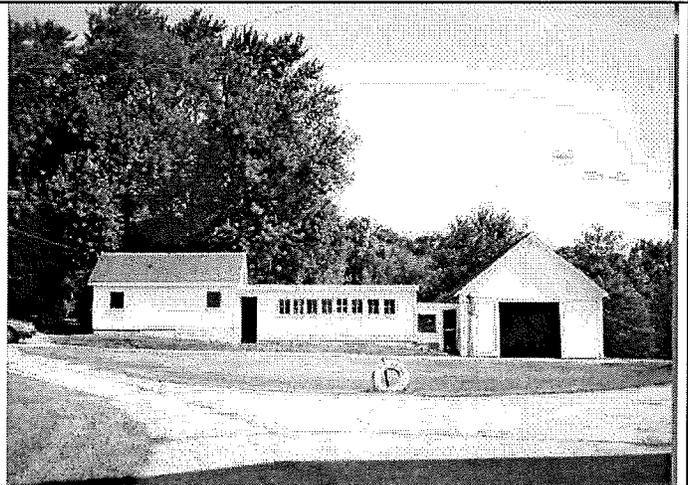
**Roll No./Neg.No.:** X27

<b>Circa:</b> 1920	<b>Condition:</b> Excellent	<b>Integrity:</b> Poor
-----------------------	--------------------------------	---------------------------

<b>Materials:</b>	<b>HISTORY:</b>  Garage and tool shed
<b>Foundation:</b> Concrete	
<b>Walls:</b> Clapboard	
<b>Roof:</b> Asphalt shingle	
<b>Porch:</b>

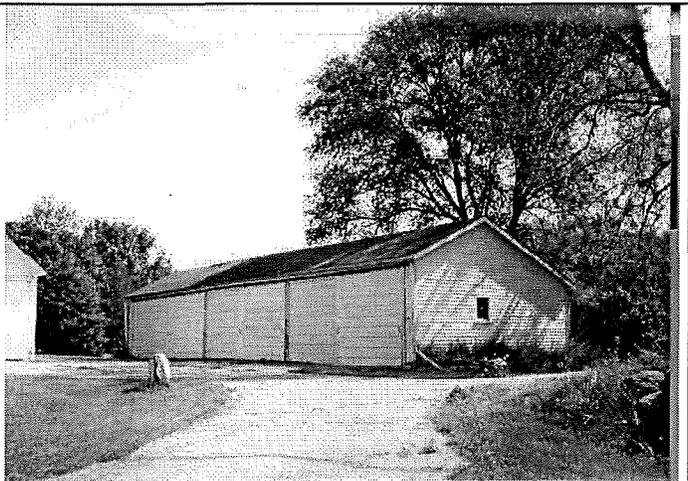
**Roll No./Neg.No.:** X28

<b>Circa:</b> 1900	<b>Condition:</b> <i>Fair</i>	<b>Integrity:</b> <i>Fair</i>
-----------------------	----------------------------------	----------------------------------

<b>Materials:</b>	<b>HISTORY:</b>  Multiple sliding doors  Machine shed
<b>Foundation:</b> Concrete	
<b>Walls:</b> Clapboard	
<b>Roof:</b> Asphalt shingle	
<b>Porch:</b>

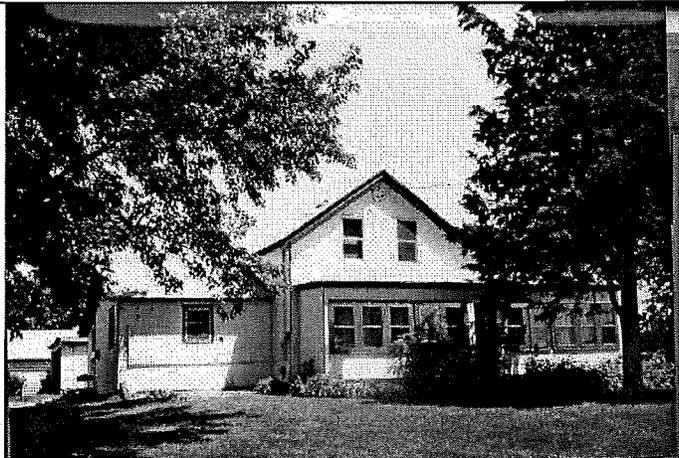
**Roll No./Neg.No.:** Y18

<b>Circa:</b> 1850-1860	<b>Condition:</b> Good	<b>Integrity:</b> Poor
----------------------------	---------------------------	---------------------------

<b>Materials:</b>	<b>HISTORY:</b>
<b>Foundation:</b> Stone	Previous survey note says house 1840 & barn 1939
<b>Walls:</b> Asbestos	Newer brick chimney; additions on both sides
<b>Roof:</b> Asphalt shingle	
<b>Porch:</b> Front enclosed	
	Previous site = 2270

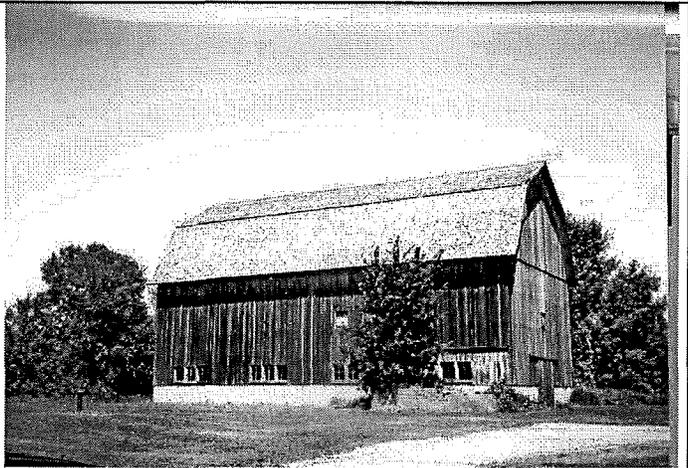
**Roll No./Neg.No.:** Y19

<b>Circa:</b> 1910-1945 (1939)	<b>Condition:</b> Good	<b>Integrity:</b> Excellent
-----------------------------------	---------------------------	--------------------------------

<b>Materials:</b>	<b>HISTORY:</b>  Transverse aisle  Only foundation of milkhouse remains
<b>Foundation:</b> Poured	
<b>Walls:</b> Vertical plank	
<b>Roof:</b> Wood shingle	
<b>Porch:</b>

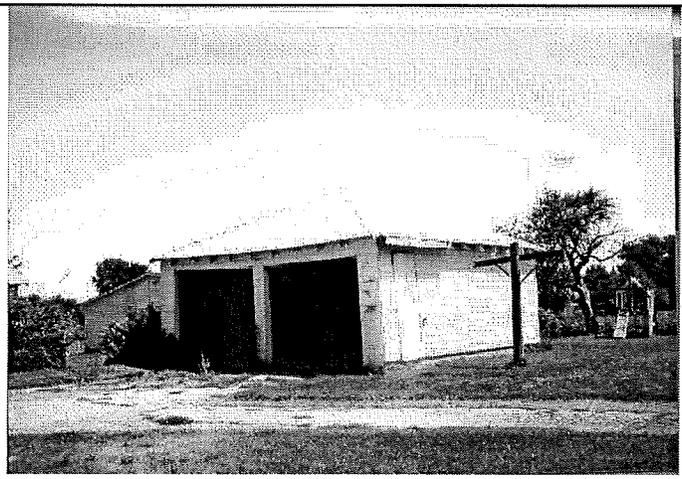
**Roll No./Neg.No.:** Y20

<b>Circa:</b> 1930 - 1950	<b>Condition:</b> Poor	<b>Integrity:</b> Good
------------------------------	---------------------------	---------------------------

<b>Materials:</b>	<b>HISTORY:</b>  2 car garage ; pyramidal roof
<b>Foundation:</b> Poured	
<b>Walls:</b> Clapboard	
<b>Roof:</b> Asphalt shingle	
<b>Porch:</b>

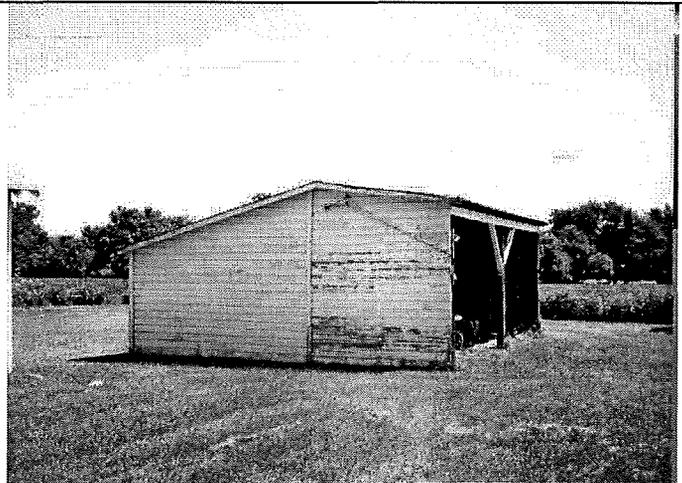
**Roll No./Neg.No.:** Y22

<b>Circa:</b> 1930-1940	<b>Condition:</b> Good	<b>Integrity:</b> Good
----------------------------	---------------------------	---------------------------

<b>Materials:</b>	<b>HISTORY:</b>  Open sided shed
<b>Foundation:</b> Concrete	
<b>Walls:</b> Clapboard	
<b>Roof:</b> Asphalt shingle	
<b>Porch:</b>

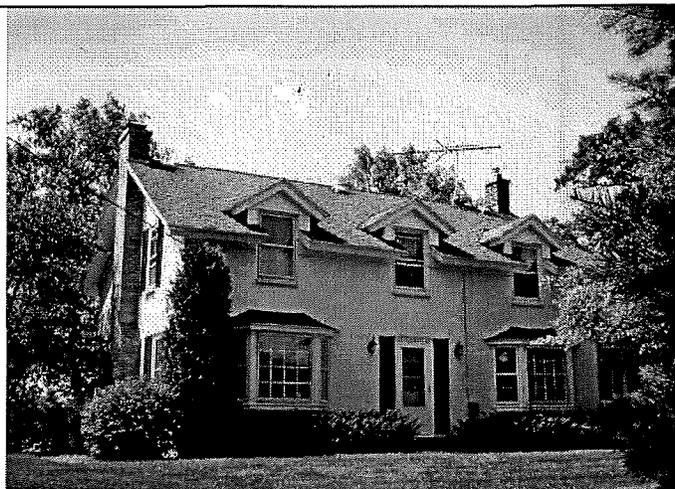
**Roll No./Neg.No.:** Y6

<b>Circa:</b> 1880	<b>Condition:</b> Excellent	<b>Integrity:</b> Poor
-----------------------	--------------------------------	---------------------------

<b>Materials:</b>	<b>HISTORY:</b>
<b>Foundation:</b> Stone, concrete on addition	Brick chimneys at ends, old school foundation is next door, (Cherry Valley School House 1880, original wainscotting in the schoolroom area). History of McHenry has an article about structure. Original size of schoolroom = 36' x 24', 2 doors used to be on side. Attached 2 car garage. Note: resident has pictures.
<b>Walls:</b> Brick	
<b>Roof:</b> Asphalt shingle	
<b>Porch:</b>	
	Previous site = 2161

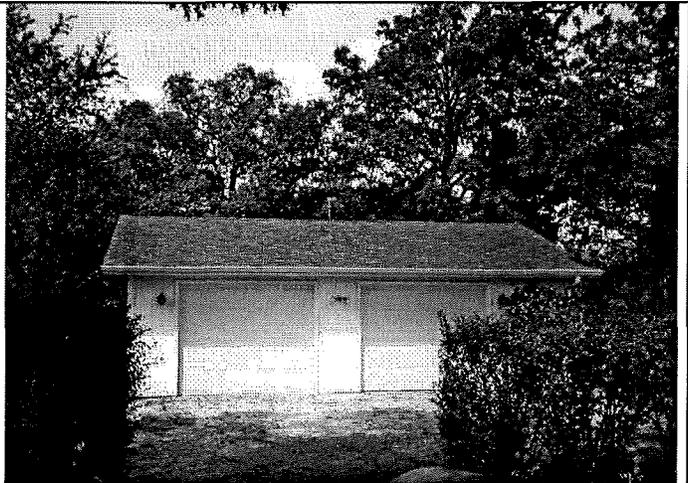
**Roll No./Neg.No.:** Y7

<b>Circa:</b> Post 1945	<b>Condition:</b> Excellent	<b>Integrity:</b> Not applicable
----------------------------	--------------------------------	-------------------------------------

<b>Materials:</b>	<b>HISTORY:</b>  New 2-car garage
<b>Foundation:</b> Concrete	
<b>Walls:</b> Modern vertical planking	
<b>Roof:</b> Asphalt shingle	
<b>Porch:</b>

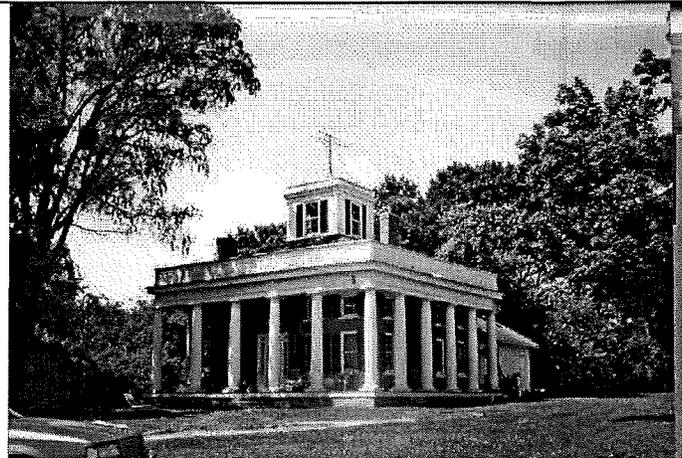
**Roll No./Neg.No.:** Y8

<b>Circa:</b> 1850	<b>Condition:</b> Excellent	<b>Integrity:</b> Excellent
-----------------------	--------------------------------	--------------------------------

<b>Materials:</b>	<b>HISTORY:</b>
<b>Foundation:</b> Poured concrete & stone	<p>"Terwilliger" house</p> <p>House is on national register; historic significance of other buildings is unknown. Home is approximately 155 years old. Cupola, 2 brick chimneys at either end. According to resident original outhouse is also still existing on property.</p> <p>Previous site = 2162</p>
<b>Walls:</b> Brick	
<b>Roof:</b> Asphalt shingle	
<b>Porch:</b> Wrap around with columns

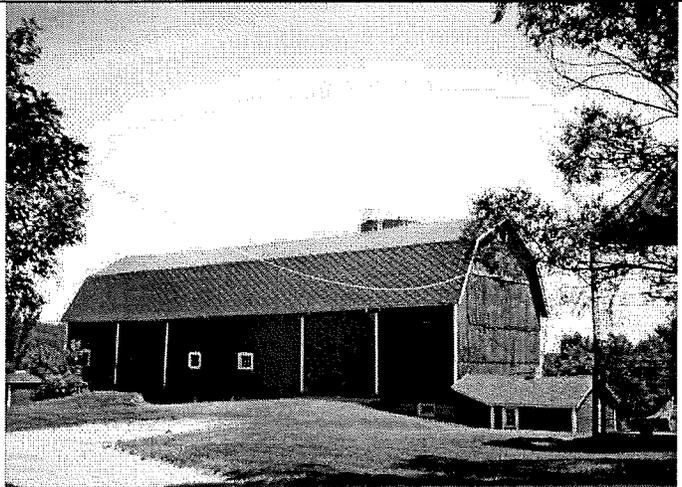
**Roll No./Neg.No.:** Y9

<b>Circa:</b> 1910- 1930	<b>Condition:</b> Good	<b>Integrity:</b> Excellent
--------------------------------	---------------------------	--------------------------------

<b>Materials:</b>	<b>HISTORY:</b>
<b>Foundation:</b> Block <b>Walls:</b> Vertical plank <b>Roof:</b> Asphalt shingle <b>Porch:</b>	Attached milkhouse has two ramps with sliding doors, double banked

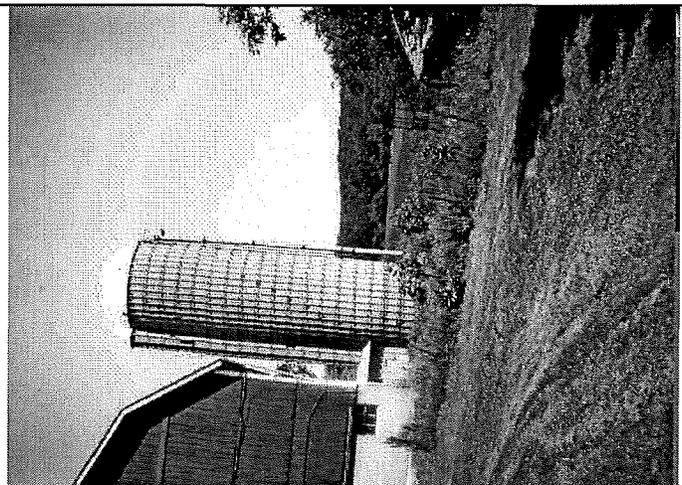
**Roll No./Neg.No.:** Y11

<b>Circa:</b> 1920-1930	<b>Condition:</b> Excellent	<b>Integrity:</b> Excellent
----------------------------	--------------------------------	--------------------------------

<b>Materials:</b>	<b>HISTORY:</b>  Viewing platform and ladder still attached
<b>Foundation:</b> Concrete	
<b>Walls:</b> Staved <i>Concrete</i>	
<b>Roof:</b> Metal dome	
<b>Porch:</b>

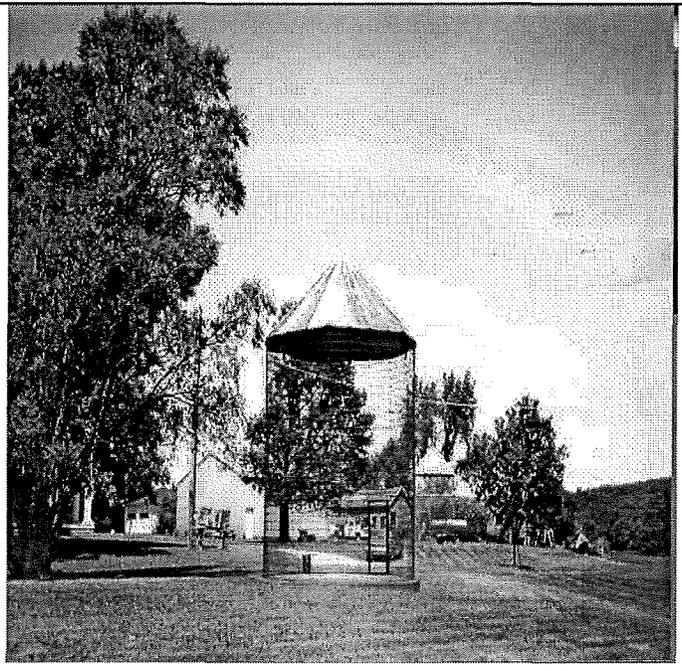
**Roll No./Neg.No.:** Y13

<b>Circa:</b> 1940	<b>Condition:</b> Excellent	<b>Integrity:</b> Excellent
-----------------------	--------------------------------	--------------------------------

<b>Materials:</b>	<b>HISTORY:</b>
<b>Foundation:</b> Concrete	Round, wire mesh
<b>Walls:</b> Metal rod	
<b>Roof:</b> Metal flat-top concrete	
<b>Porch:</b>

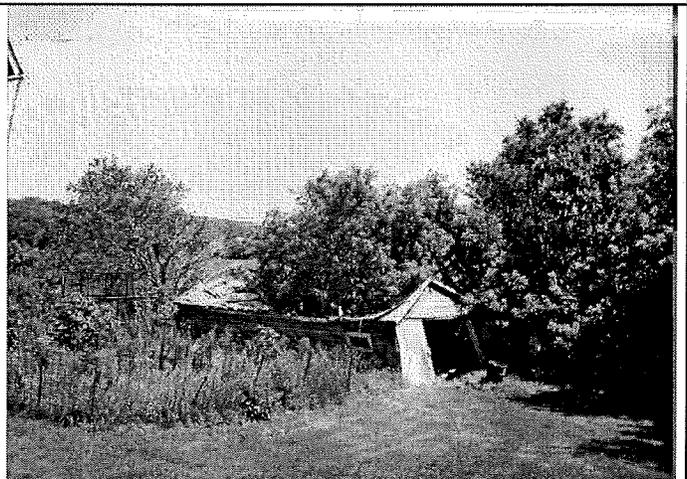
**Roll No./Neg.No.:** Y10

<b>Circa:</b> 1880	<b>Condition:</b> Poor	<b>Integrity:</b> Poor
-----------------------	---------------------------	---------------------------

<b>Materials:</b>	<b>HISTORY:</b>  Collapsed
<b>Foundation:</b> Concrete	
<b>Walls:</b> Clapboard	
<b>Roof:</b> Wood and metal and asphalt shingles	
<b>Porch:</b>

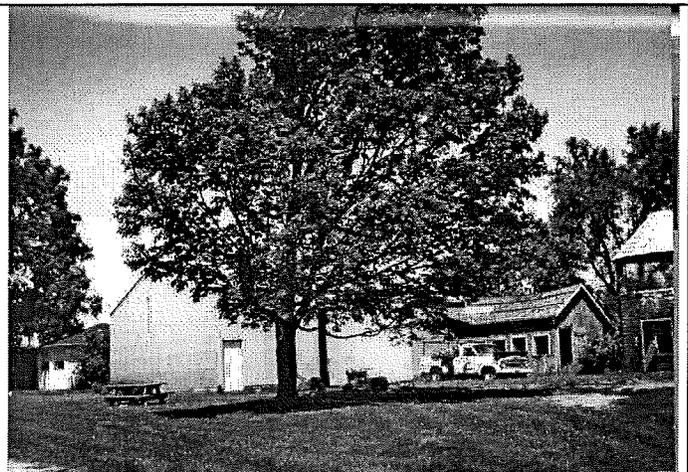
**Roll No./Neg.No.:** Y14

<b>Circa:</b> Post 1945	<b>Condition:</b> Good	<b>Integrity:</b> <i>Fair</i>
----------------------------	---------------------------	----------------------------------

<b>Materials:</b>	<b>HISTORY:</b>  2 buildings connected, metal pole building has batten metal walls, corrugated metal roof, concrete foundation
<b>Foundation:</b> Concrete	
<b>Walls:</b> Vertical plank	
<b>Roof:</b> Wood shingle	
<b>Porch:</b>

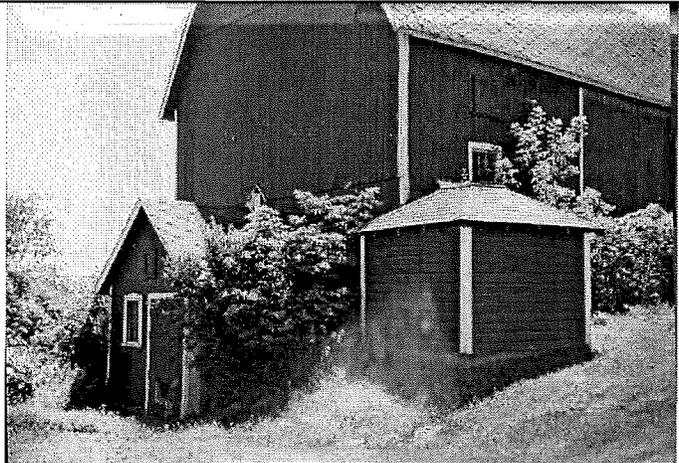
**Roll No./Neg.No.:** Y15

<b>Circa:</b> 1910- 1940	<b>Condition:</b> Good	<b>Integrity:</b> Good
--------------------------------	---------------------------	---------------------------

<b>Materials:</b>	<b>HISTORY:</b>
<b>Foundation:</b> Concrete <b>Walls:</b> Clapboard <b>Roof:</b> Asphalt shingle <b>Porch:</b>	Hipped is unusual structure w/one door, no windows  Windmill removed

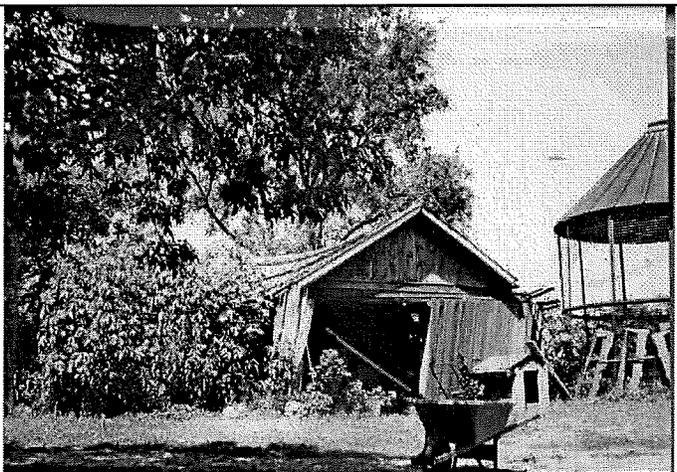
**Roll No./Neg.No.:** Y16

<b>Circa:</b> 1880	<b>Condition:</b> Poor	<b>Integrity:</b> Poor
-----------------------	---------------------------	---------------------------

<b>Materials:</b>	<b>HISTORY:</b>  Front sliding door, holes in roof, slants a couple of feet to right
<b>Foundation:</b> Concrete <b>Walls:</b> Vertical plank <b>Roof:</b> Asphalt shingle <b>Porch:</b>

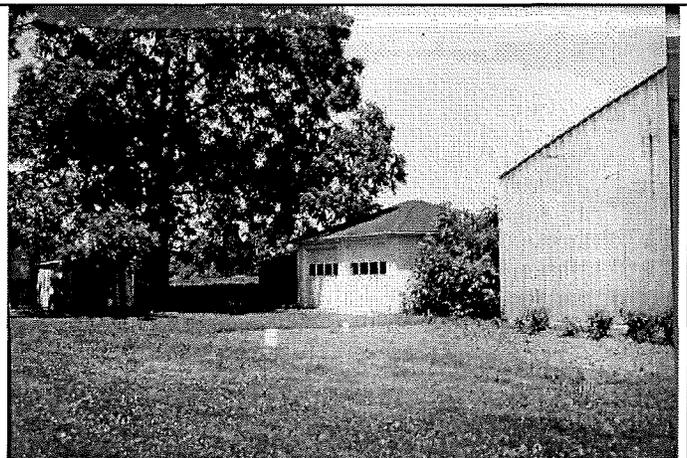
**Roll No./Neg.No.:** Y17

<b>Circa:</b> 1940	<b>Condition:</b> Excellent	<b>Integrity:</b> Excellent
-----------------------	--------------------------------	--------------------------------

<b>Materials:</b>	<b>HISTORY:</b>  2 car garage
<b>Foundation:</b> Concrete	
<b>Walls:</b> Clapboard	
<b>Roof:</b> Asphalt shingle	
<b>Porch:</b>

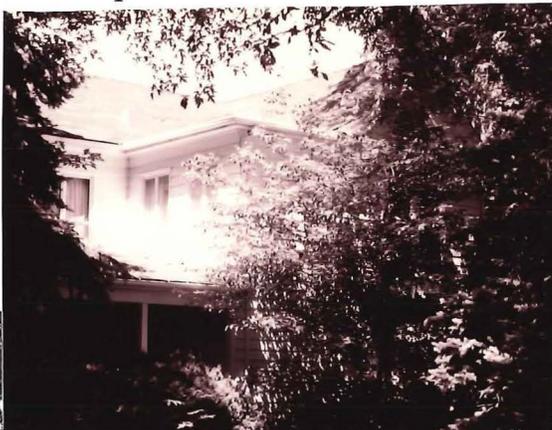
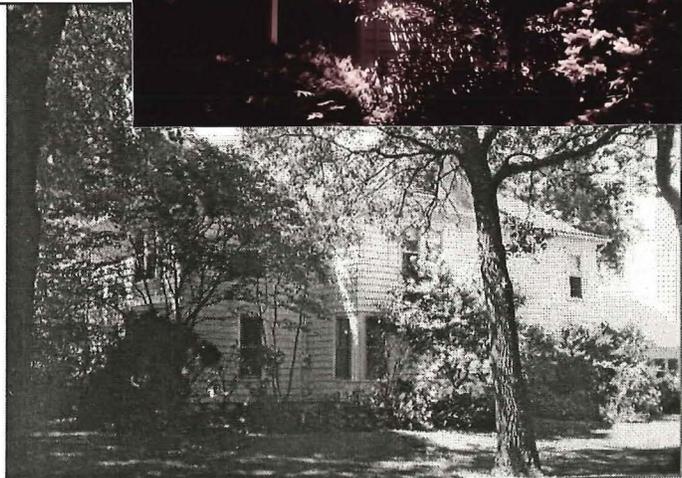
<b>Circa:</b> 1860-1890	<b>Condition:</b> Good	<b>Integrity:</b> Poor
----------------------------	---------------------------	---------------------------

<b>Materials:</b>	<b>HISTORY:</b>		
<b>Foundation:</b> Stone	Over 100 years old, detailing around upstairs windows, looks like miniature columns.		
<b>Walls:</b> Clapboard			
<b>Roof:</b> Asphalt shingle	↗ extra 1998 view ↘		
<b>Porch:</b> Front open			
	Previous site = 2322

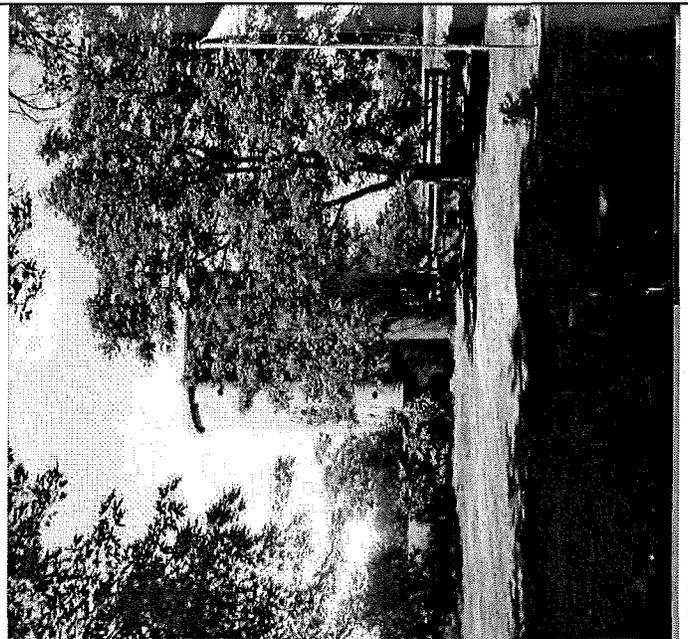
<b>Circa:</b> 1920-1930	<b>Condition:</b> Good	<b>Integrity:</b> Good
----------------------------	---------------------------	---------------------------

<b>Materials:</b>	<b>HISTORY:</b>
<p><b>Foundation:</b> Concrete</p> <p><b>Walls:</b> Poured concrete</p> <p><b>Roof:</b> Concrete cone</p> <p><b>Porch:</b> Front open</p>

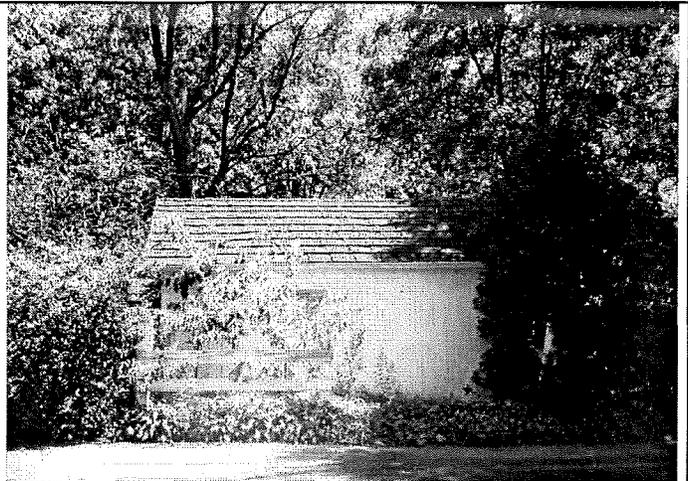
<b>Circa:</b> 1930	<b>Condition:</b> Good	<b>Integrity:</b> Good
-----------------------	---------------------------	---------------------------

<b>Materials:</b>	<b>HISTORY:</b>  <i>Old milkhouse with gable roof</i>
<b>Foundation:</b> Concrete	
<b>Walls:</b> Vertical plank	
<b>Roof:</b> Asphalt shingle	
<b>Porch:</b> Front open

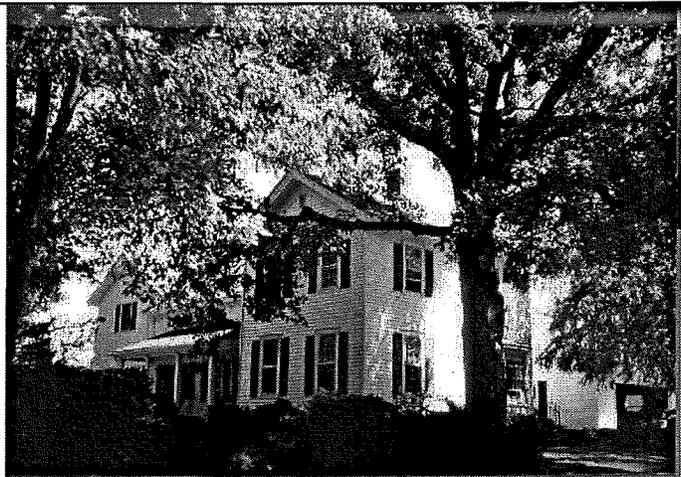
<b>Circa:</b> 1840 - 1850	<b>Condition:</b> Excellent	<b>Integrity:</b> Good
------------------------------	--------------------------------	---------------------------

<b>Materials:</b>  <b>Foundation:</b> Stone and brick <b>Walls:</b> Metal <b>Roof:</b> Asphalt shingle <b>Porch:</b> Open front w/columns	<b>HISTORY:</b>  Built in 1838 according to resident, 2 story addition is on east side.          Previous site = 2321
--	---

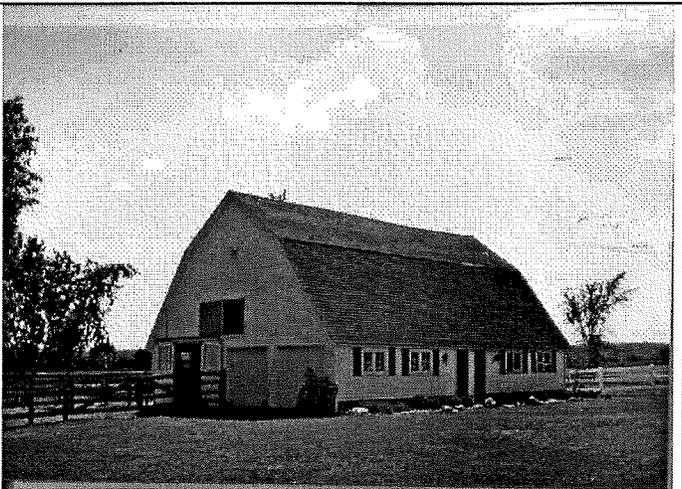
<b>Circa:</b> 1910-1945	<b>Condition:</b> Excellent	<b>Integrity:</b> Poor
----------------------------	--------------------------------	---------------------------

<b>Materials:</b>	<b>HISTORY:</b>
<b>Foundation:</b> Poured <b>Walls:</b> Synthetic siding <b>Roof:</b> Asphalt shingle <b>Porch:</b>	2 garage door, 2 new entrances with possible apartments on 2 <sup>nd</sup> floor.

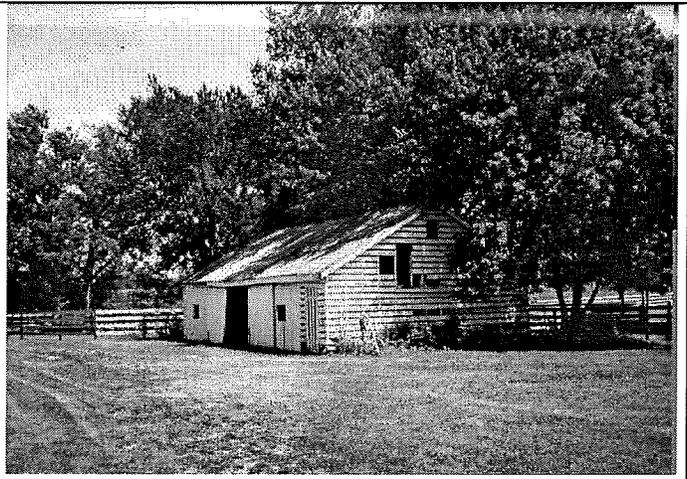
<b>Circa:</b> 1920	<b>Condition:</b> Poor	<b>Integrity:</b> Poor
-----------------------	---------------------------	---------------------------

<b>Materials:</b>	<b>HISTORY:</b>
<b>Foundation:</b> Concrete <b>Walls:</b> Vertical plank and clapboard <b>Roof:</b> Metal <b>Porch:</b>	Sliding doors, used to store hay on one end and corn crib on others

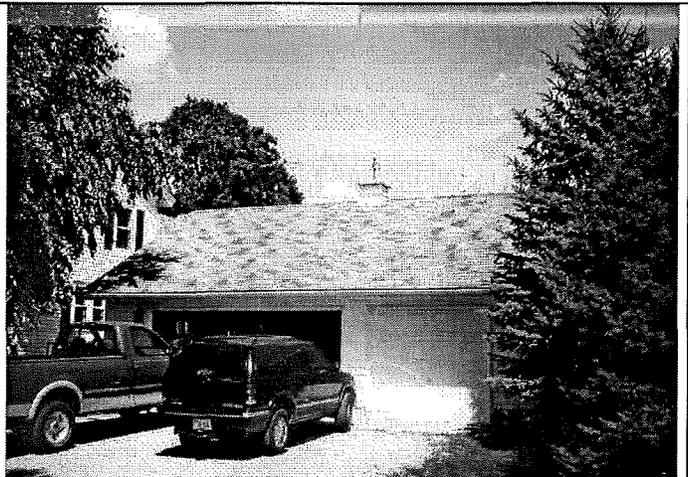
**Roll No./Neg.No.:** Z10

<b>Circa:</b> Post 1945	<b>Condition:</b> Excellent	<b>Integrity:</b> Good
----------------------------	--------------------------------	---------------------------

<b>Materials:</b>	<b>HISTORY:</b>
<b>Foundation:</b> Poured concrete <b>Walls:</b> Synthetic siding <b>Roof:</b> Asphalt shingle <b>Porch:</b>	Newer construction, 3 car garage, weathervane at top.

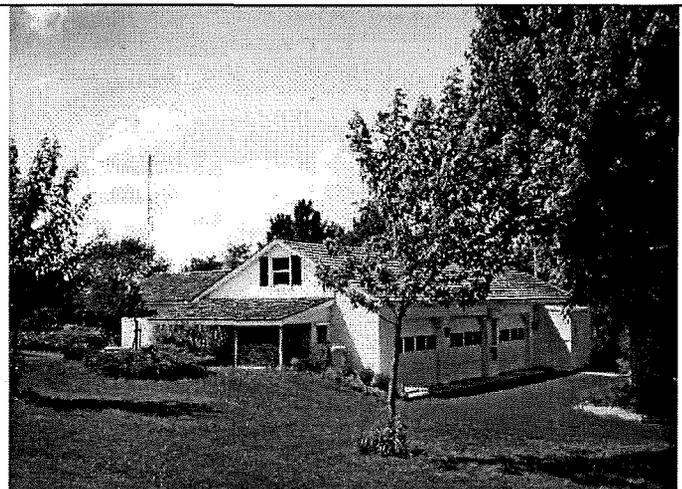
<b>Circa:</b> Post 1945	<b>Condition:</b> Excellent	<b>Integrity:</b> Good
----------------------------	--------------------------------	---------------------------

<b>Materials:</b>	<b>HISTORY:</b>
<b>Foundation:</b> Concrete	Single vent, 3 car garage w/coop on side, milk house in rear and screened in porch on other side
<b>Walls:</b> Clapboard	
<b>Roof:</b> Wood shingle	
<b>Porch:</b>

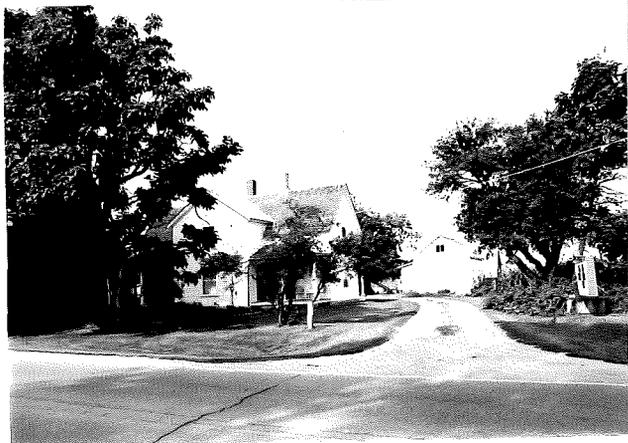
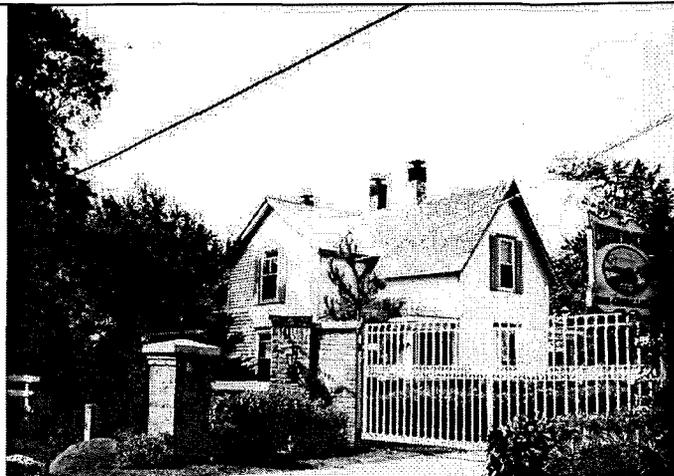
<b>Function:</b> Residence	<b>Vernacular Type:</b> "T"-Plan	<b>Arch. Style:</b>	<b>Alterations:</b>
<b>Circa:</b> 1870 - 1880		<b>Condition:</b> Excellent	<b>Integrity:</b> Good
<b>Source:</b> 1995 Sidwell maps	<b>Landmark Evaluation:</b> TBD		
<b>Architect/Builder:</b> Unknown	<b>Individual:</b> <b>Criteria:</b> /14	<b>Farmstead:</b>	<b>National Register:</b> <b>Local:</b> (See reverse side of criteria listing)
<b>Materials:</b>  <b>Foundation:</b> Stone <b>Walls:</b> Clapboard <b>Roof:</b> Wood shingle <b>Porch:</b> Double enclosed porches	<b>HISTORY:</b>  Century Ridge Farm since 1900, intersecting gables, 2 story, 3 chimneys  The rest of the buildings look modern; inaccessible; could not photograph.  Previous site = 2490 or 2488

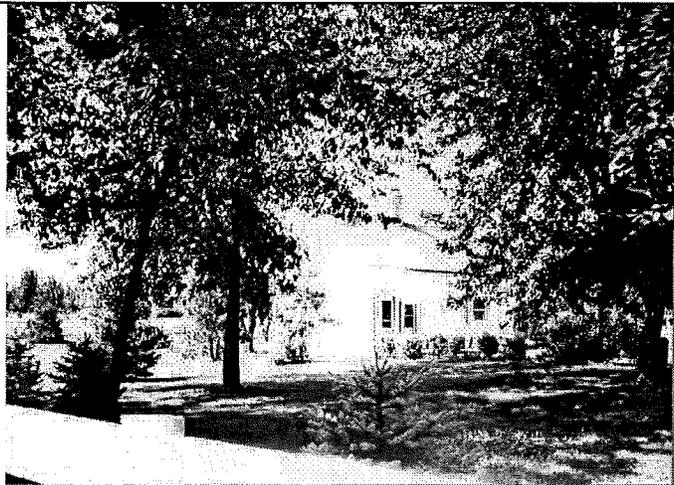
**Roll No./Neg.No.:** BB35

<b>Circa:</b> 1915	<b>Condition:</b> Excellent	<b>Integrity:</b> Good
-----------------------	--------------------------------	---------------------------

<b>Materials:</b>	<b>HISTORY:</b>
<b>Foundation:</b> Concrete <b>Walls:</b> Clapboard <b>Roof:</b> Asphalt shingle <b>Porch:</b>	1 ½ story with 1 chimney

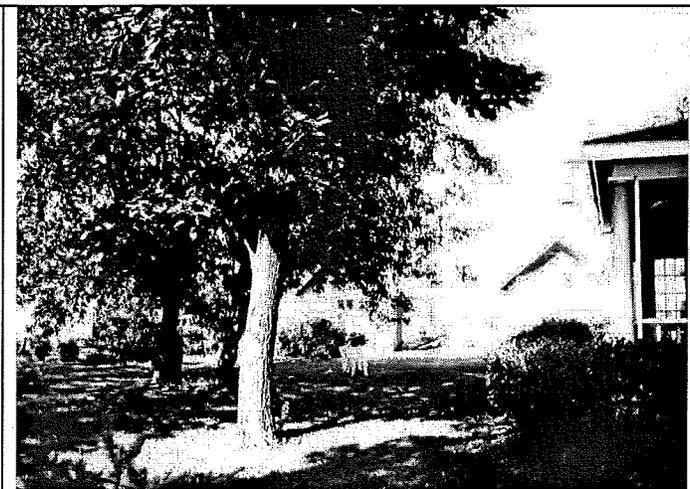
<b>Circa:</b> 1915	<b>Condition:</b> Excellent	<b>Integrity:</b> Good
-----------------------	--------------------------------	---------------------------

<b>Materials:</b>	<b>HISTORY:</b>  2 matching structures, single pen and single brick chimney
<b>Foundation:</b> Concrete	
<b>Walls:</b> Concrete block and wood shingle	
<b>Roof:</b> Metal	
<b>Porch:</b>

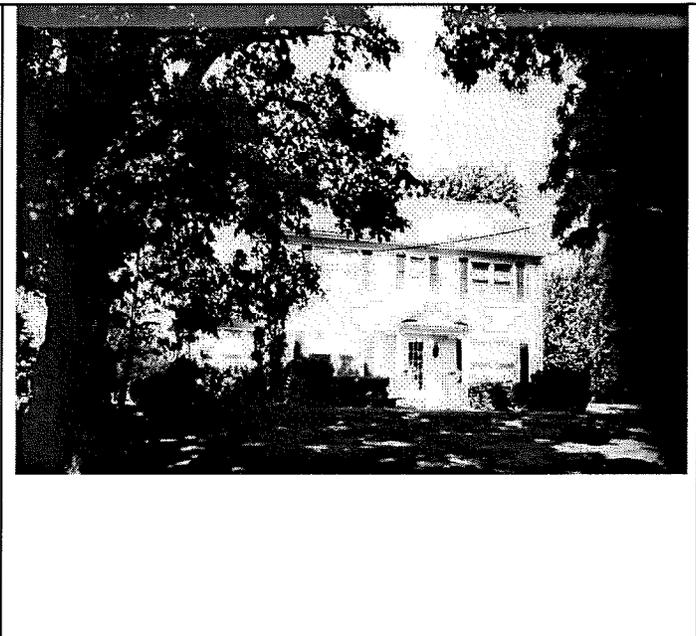
**Roll No./Neg.No.:** CC1

<b>Circa:</b> 1860 - 1880	<b>Condition:</b> Excellent	<b>Integrity:</b> Good
------------------------------	--------------------------------	---------------------------

<b>Materials:</b>	<b>HISTORY:</b>
<b>Foundation:</b> Concrete <b>Walls:</b> Clapboard <b>Roof:</b> Asphalt shingle <b>Porch:</b> Projecting front gable entry	2 story, 4 square, side gabled, views obscured by landscaping

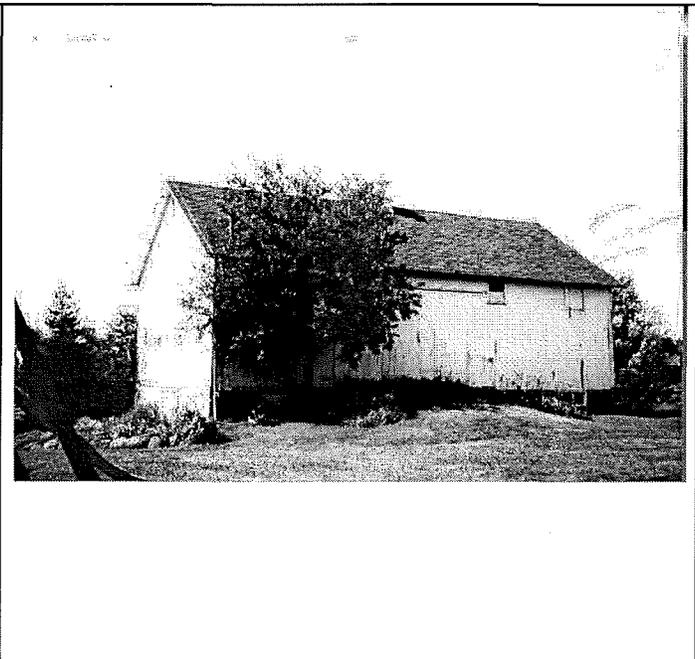
**Roll No./Neg.No.:** CC4

<b>Circa:</b> 1880	<b>Condition:</b> Good	<b>Integrity:</b> Good
-----------------------	---------------------------	---------------------------

<b>Materials:</b>	<b>HISTORY:</b>
<b>Foundation:</b> Concrete and stone <b>Walls:</b> Vertical plank <b>Roof:</b> Asphalt shingle <b>Porch:</b>	Single vent, ramped with transverse aisle

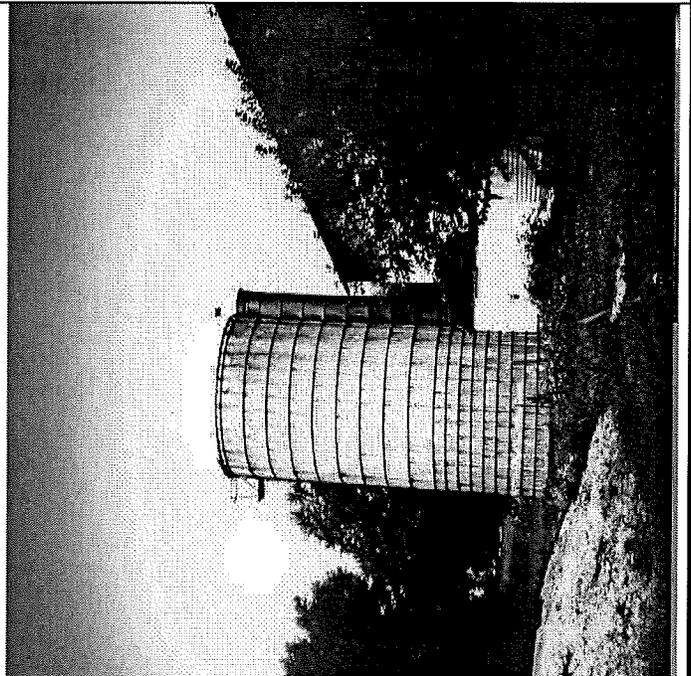
<b>Circa:</b> 1920	<b>Condition:</b> Excellent	<b>Integrity:</b> Excellent
-----------------------	--------------------------------	--------------------------------

<b>Materials:</b>	<b>HISTORY:</b>
<b>Foundation:</b> Concrete <b>Walls:</b> Staved concrete <b>Roof:</b> Metal dome <b>Porch:</b>	Staved concrete, upper viewing platform still attached
