McHenry County

Rural Survey

***Nunda Township***

***FIELD DATA SHEETS***

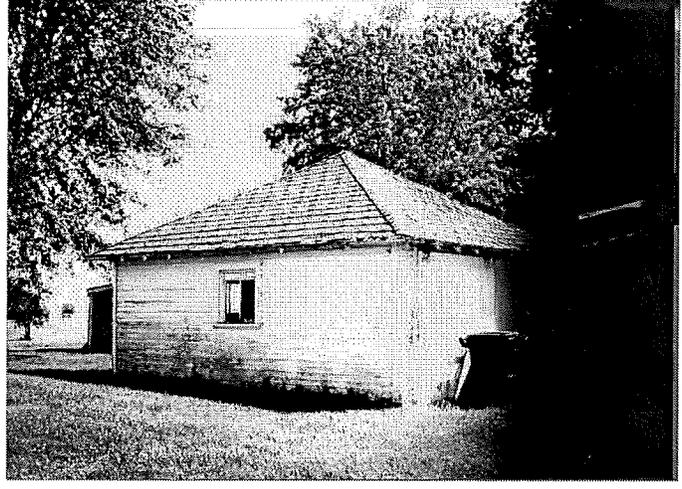
<b>Circa:</b> 1930 -1950	<b>Condition:</b> Good	<b>Integrity:</b> Good
-----------------------------	---------------------------	---------------------------

<b>Materials:</b>	<b>HISTORY:</b>
<b>Foundation:</b> Concrete <b>Walls:</b> Clapboard <b>Roof:</b> Asphalt shingle <b>Porch:</b>	Single car , pyramidal roof

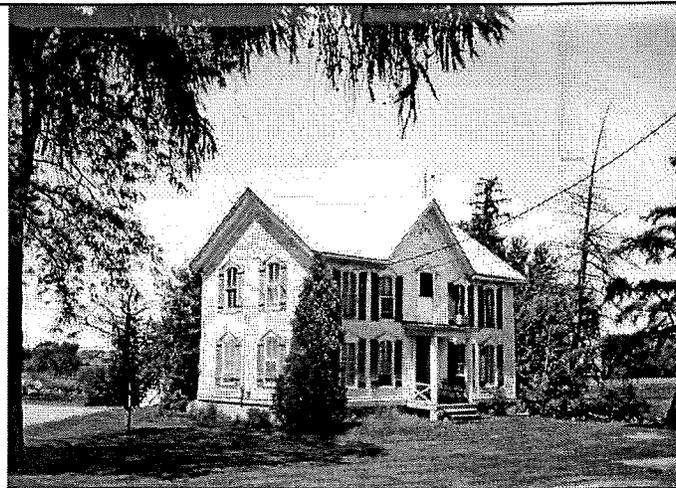
**Roll No./Neg.No.:** Y27

<b>Circa:</b> 1860 - 1880	<b>Condition:</b> Good	<b>Integrity:</b> Excellent
------------------------------	---------------------------	--------------------------------

<b>Materials:</b>	<b>HISTORY:</b>
<p><b>Foundation:</b> Poured</p> <p><b>Walls:</b> Clapboard</p> <p><b>Roof:</b> Asphalt shingle</p> <p><b>Porch:</b> Front stoop</p>	<p>Unique shutters, green with cutout diamonds, moldings and front decorative piece (old attic window), peaked windows, addition has been converted to apartments.</p> <p><i>Original two-over-two windows.</i></p> <p><i>Unique to this area for both it's excellent integrity &amp; for this type of layout.</i></p> <p>Previous site = 2492</p>

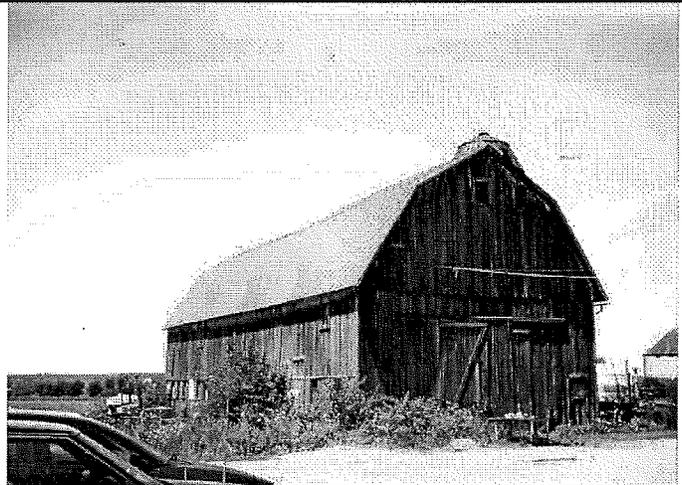
**Roll No./Neg.No.:** Y28

<b>Circa:</b> 1910-1945	<b>Condition:</b> Poor	<b>Integrity:</b> Good
----------------------------	---------------------------	---------------------------

<b>Materials:</b>	<b>HISTORY:</b>  Front sliding doors
<b>Foundation:</b> Poured	
<b>Walls:</b> Vertical plank	
<b>Roof:</b> Asphalt shingle	
<b>Porch:</b>

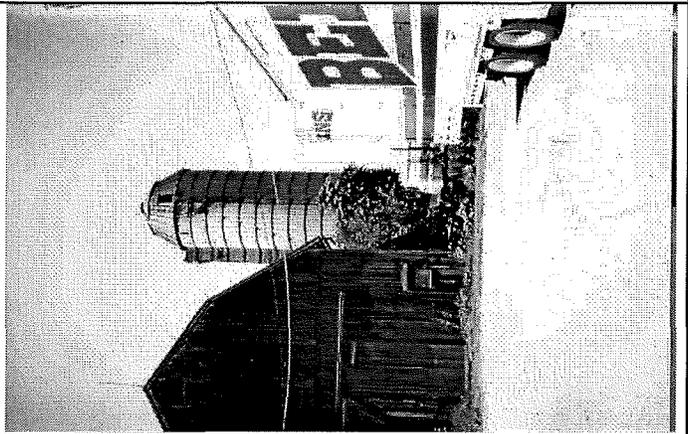
**Roll No./Neg.No.:** Y29

<b>Circa:</b> 1920	<b>Condition:</b> Good	<b>Integrity:</b> Good
-----------------------	---------------------------	---------------------------

<p><b>Materials:</b></p> <p><b>Foundation:</b> Concrete</p> <p><b>Walls:</b> Staved concrete</p> <p><b>Roof:</b> Metal <i>Staved gambrel</i></p> <p><b>Porch:</b></p>	<p><b>HISTORY:</b></p> <p>Mansard-style top (<i>gambrel</i>)</p>
---	--

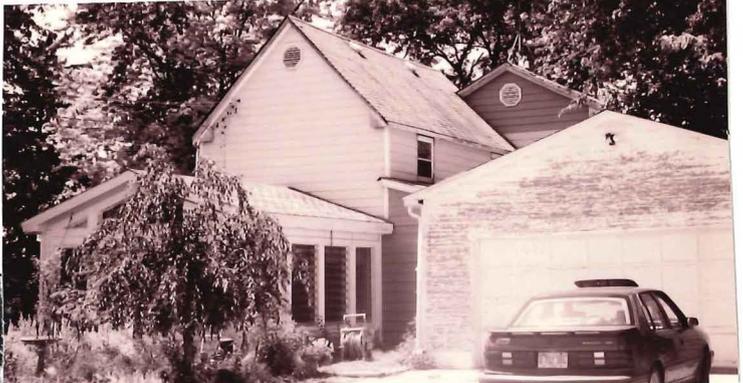
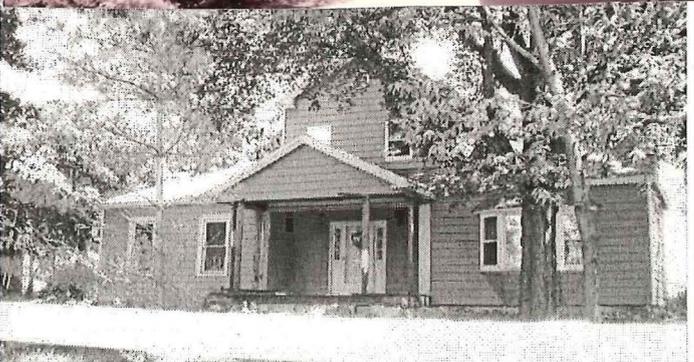
**Roll No./Neg.No.:** Y36

<b>Circa:</b> 1850-1870	<b>Condition:</b> Good	<b>Integrity:</b> Poor
----------------------------	---------------------------	---------------------------

<b>Materials:</b>	<b>HISTORY:</b>
<p><b>Foundation:</b> Poured concrete</p> <p><b>Walls:</b> Synthetic siding</p> <p><b>Roof:</b> Asphalt shingle</p> <p><b>Porch:</b> Front</p>	<p>Has interesting detailing on eaves; major additions in rear, hard to tell what original structure looked like</p> <p style="text-align: center;">↖ extra 1998 view ↗</p> <p>Previous site = 2491</p>

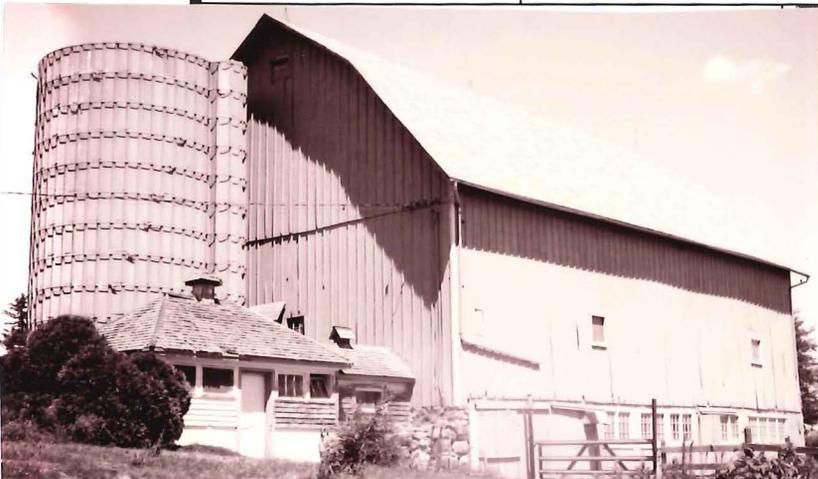
<b>Materials:</b>	<b>HISTORY:</b>
<b>Foundation:</b> Stone	Major additions looks like a residence
<b>Walls:</b> Vertical plank and battens	Ramped at one time, has hipped roof milkhouse
<b>Roof:</b> Asphalt shingle	
<b>Porch:</b>

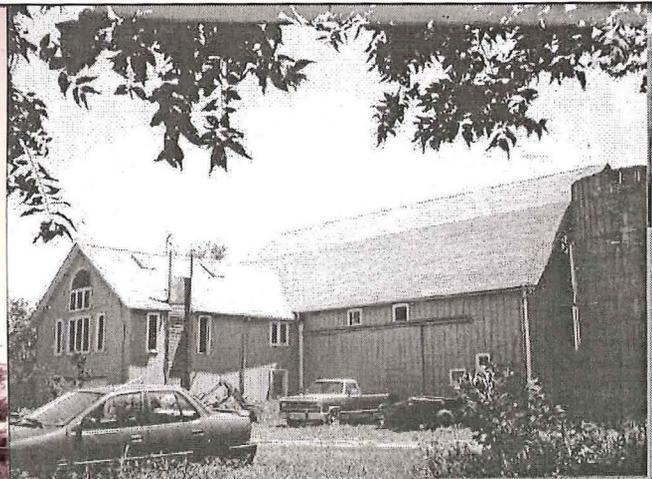
<b>Circa:</b> 1910 -1930	<b>Condition:</b> Good	<b>Integrity:</b> Good
-----------------------------	---------------------------	---------------------------

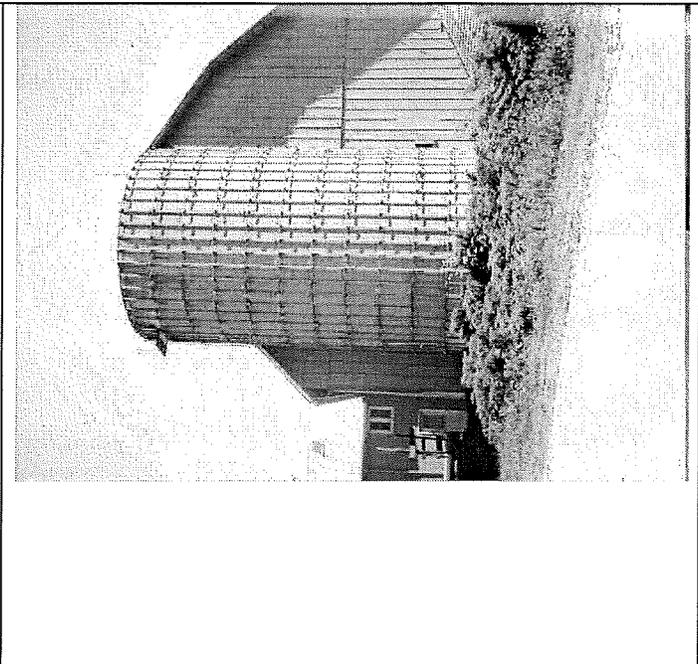
<b>Circa:</b> 1920	<b>Condition:</b> Poor	<b>Integrity:</b> Good
-----------------------	---------------------------	---------------------------

<b>Materials:</b>	<b>HISTORY:</b>  Placed at end of barn, viewing platform and ladder still attached
<b>Foundation:</b> Concrete	
<b>Walls:</b> Staved concrete	
<b>Roof:</b> None	
<b>Porch:</b> Front

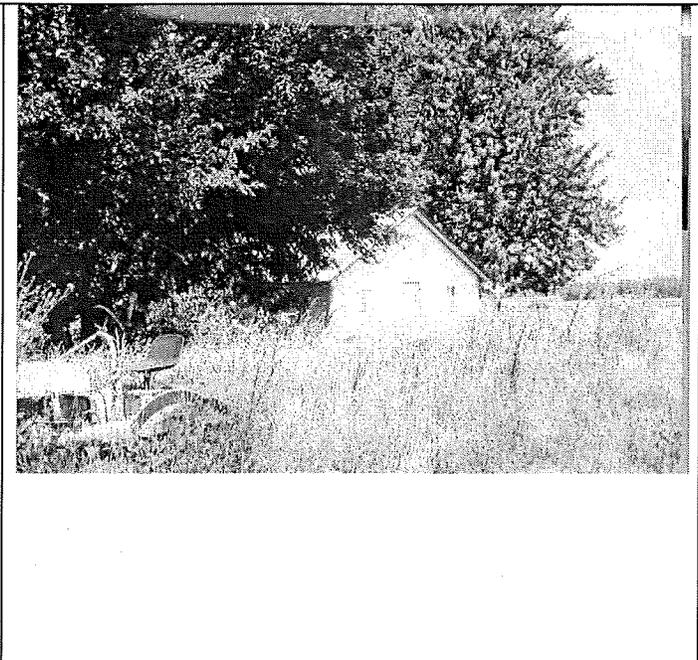
<b>Circa:</b> 1920	<b>Condition:</b> Good	<b>Integrity:</b> Good
-----------------------	---------------------------	---------------------------

<b>Materials:</b>	<b>HISTORY:</b>
<b>Foundation:</b> Concrete <b>Walls:</b> Clapboard <b>Roof:</b> Asphalt shingle <b>Porch:</b> Front	Looks unused

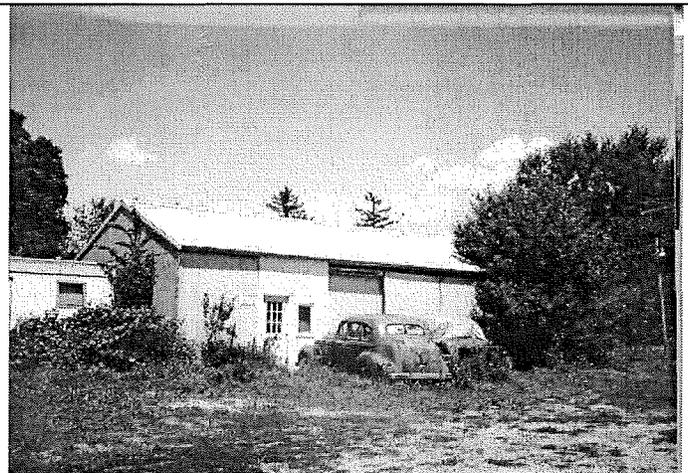
<b>Circa:</b> Post 1945	<b>Condition:</b> Good	<b>Integrity:</b> Fair
----------------------------	---------------------------	---------------------------

<b>Materials:</b>	<b>HISTORY:</b>  Metal pole building with sliding doors, used as office
<b>Foundation:</b> Concrete	
<b>Walls:</b> Gabled metal	
<b>Roof:</b> Corrugated metal	
<b>Porch:</b>

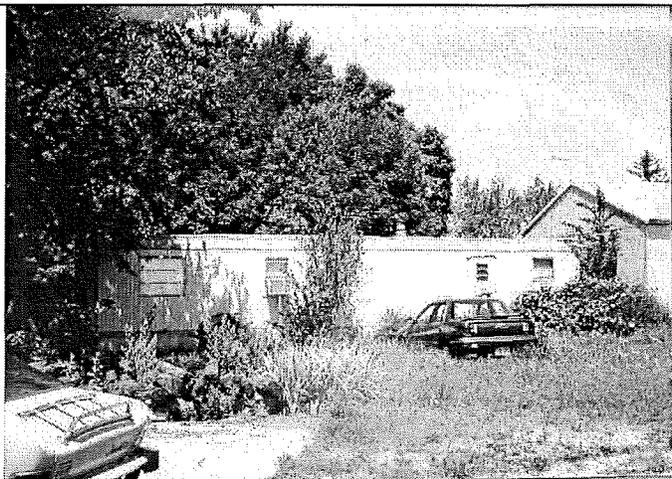
**Roll No./Neg.No.:** Y32

<b>Circa:</b> Post 1945	<b>Condition:</b> Good	<b>Integrity:</b> Poor
----------------------------	---------------------------	---------------------------

<b>Materials:</b>	<b>HISTORY:</b>
<b>Foundation:</b> Concrete	Modern trailer home
<b>Walls:</b> Metal	
<b>Roof:</b> Metal	
<b>Porch:</b>

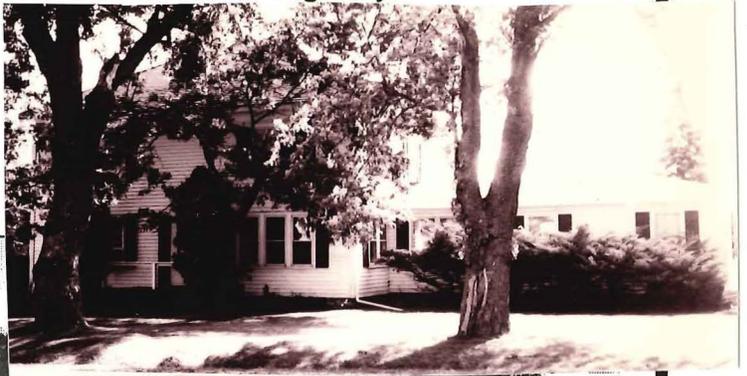
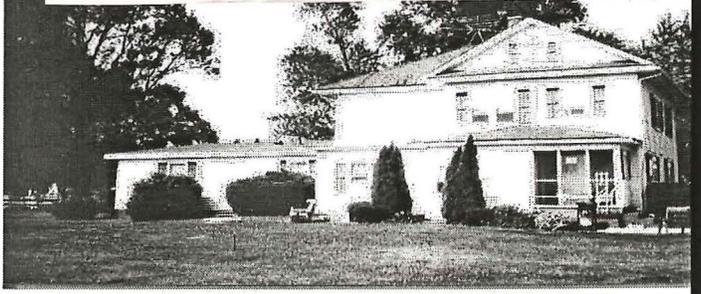
<b>Circa:</b> 1860-1880	<b>Condition:</b> Good	<b>Integrity:</b> Poor
----------------------------	---------------------------	---------------------------

<b>Materials:</b>	<b>HISTORY:</b>
<b>Foundation:</b> Concrete	Hipped roof, 2 story, extending side with single story addition. The front of the house could have been the rear originally.
<b>Walls:</b> Clapboard	
<b>Roof:</b> Asphalt shingle	Previous site = 2489
<b>Porch:</b> Rear, screened	extra 1998 view

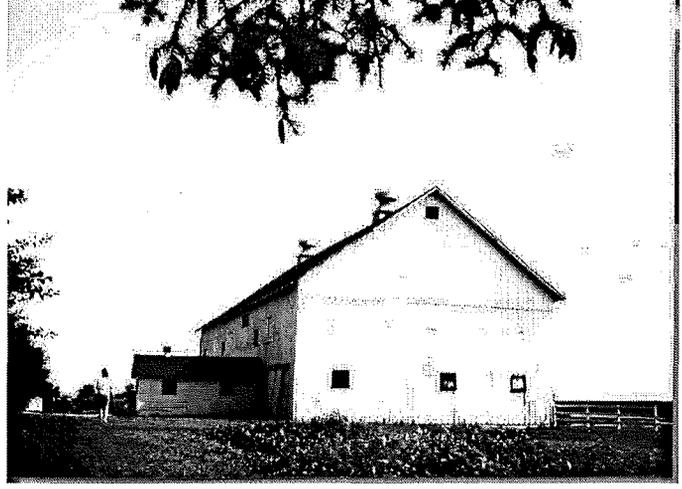
<b>Circa:</b> 1860-1880	<b>Condition:</b> Good	<b>Integrity:</b> Excellent
----------------------------	---------------------------	--------------------------------

<b>Materials:</b>	<b>HISTORY:</b>
<b>Foundation:</b> Stone	Double vented with milk house. Single vent, clapboard with side entry.
<b>Walls:</b> Vertical batten	Long single story additions.
<b>Roof:</b> Asphalt shingle	
<b>Porch:</b>

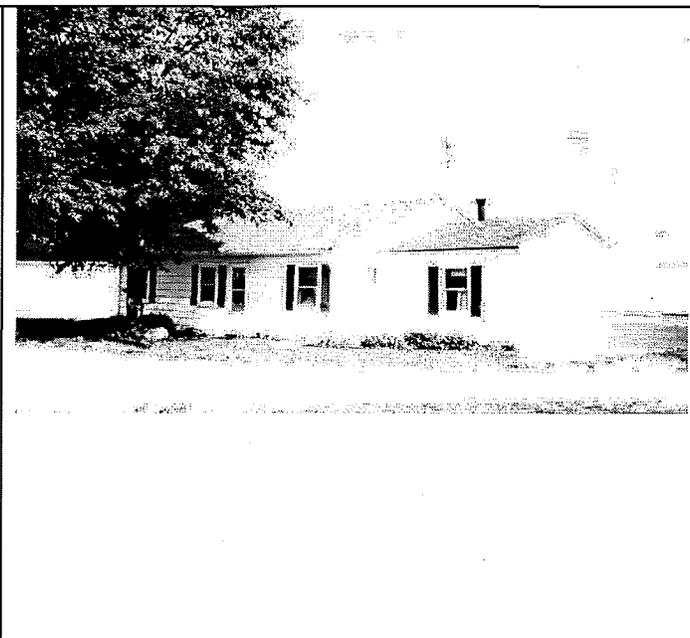
<b>Circa:</b> 1930 - 1940	<b>Condition:</b> Good	<b>Integrity:</b> Good
------------------------------	---------------------------	---------------------------

<b>Materials:</b>	<b>HISTORY:</b>
<b>Foundation:</b> Concrete	2 <sup>nd</sup> residence, single story with smaller single vented addition
<b>Walls:</b> Clapboard	
<b>Roof:</b> Asphalt shingle	
<b>Porch:</b>

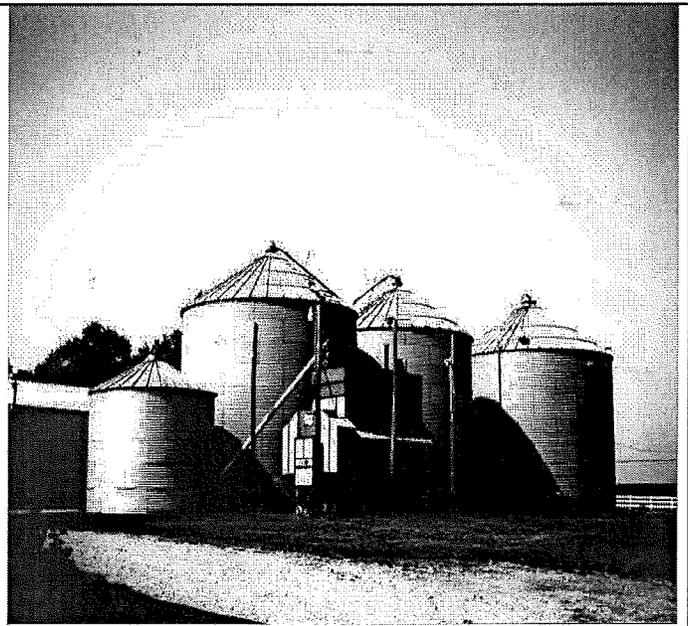
<b>Circa:</b> Post 1945	<b>Condition:</b> Excellent	<b>Integrity:</b> Good
----------------------------	--------------------------------	---------------------------

<b>Materials:</b>	<b>HISTORY:</b>  Round
<b>Foundation:</b> Concrete	
<b>Walls:</b> Metal	
<b>Roof:</b> Metal	
<b>Porch:</b>

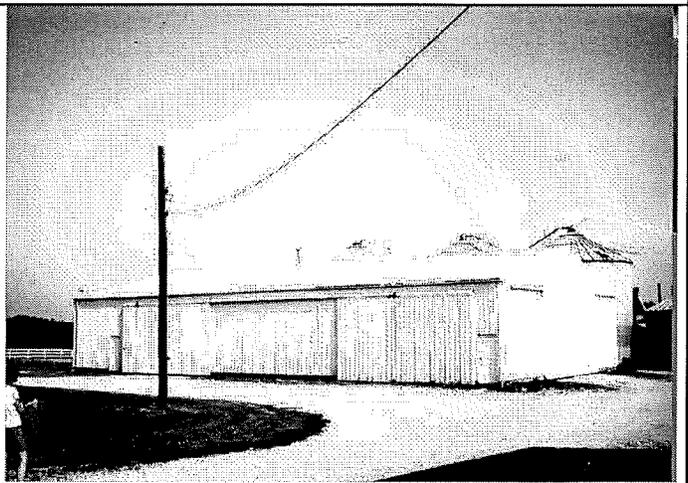
<b>Circa:</b> Post 1945	<b>Condition:</b> Good	<b>Integrity:</b> Good
----------------------------	---------------------------	---------------------------

<b>Materials:</b>	<b>HISTORY:</b>
<b>Foundation:</b> Concrete	Machine shed
<b>Walls:</b> Metal	
<b>Roof:</b> Metal	
<b>Porch:</b>

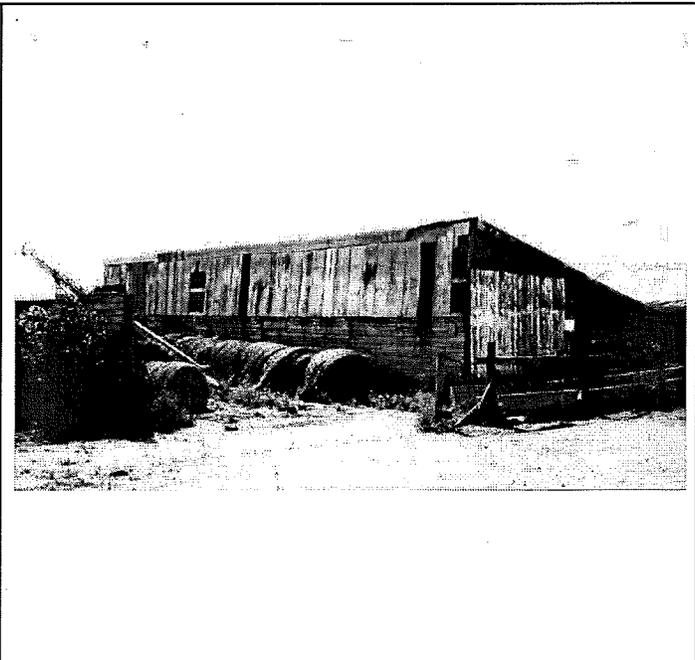
<b>Circa:</b> 1910	<b>Condition:</b> Poor	<b>Integrity:</b> Poor
-----------------------	---------------------------	---------------------------

<b>Materials:</b>	<b>HISTORY:</b>  5 structures of this sort on farm; basically a frame w/ open sides
<b>Foundation:</b> Could not determine	
<b>Walls:</b> Clapboard and metal	
<b>Roof:</b> Metal	
<b>Porch:</b>

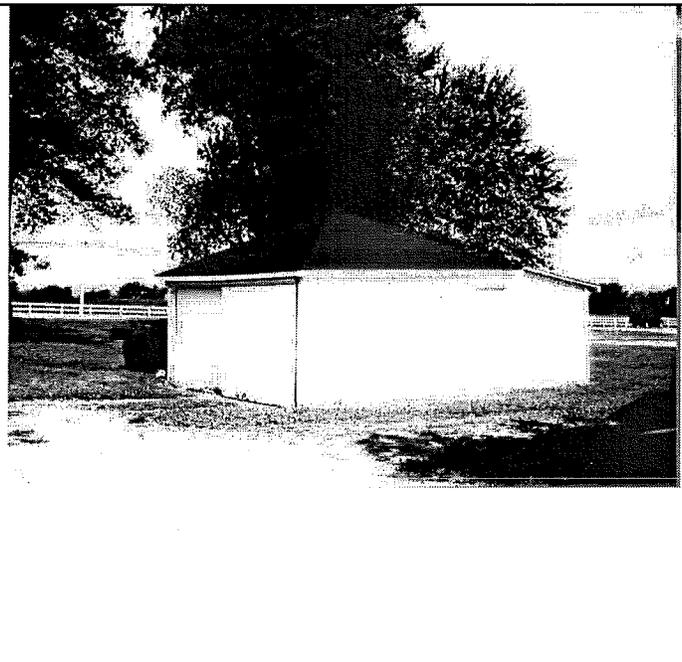
<b>Circa:</b> 1940	<b>Condition:</b> Good	<b>Integrity:</b> Good
-----------------------	---------------------------	---------------------------

<b>Materials:</b>	<b>HISTORY:</b>
<b>Foundation:</b> Concrete	Sliding doors
<b>Walls:</b> Vertical batten	Pyramidal roof
<b>Roof:</b> Sheet asphalt	
<b>Porch:</b>

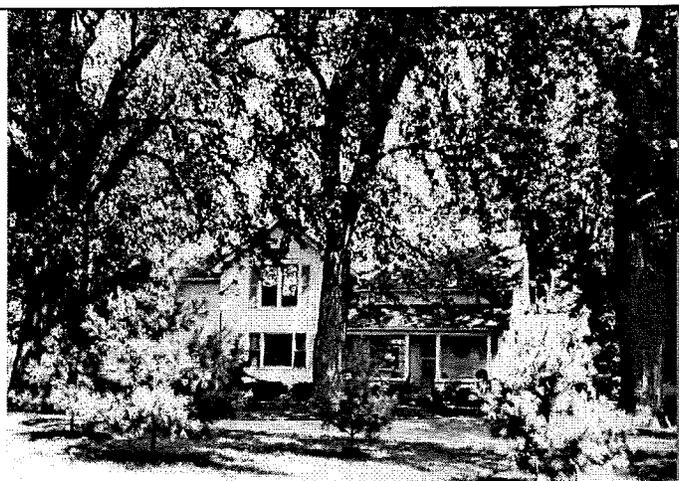
<b>Function:</b>	<b>Vernacular Type:</b>	<b>Arch. Style:</b>	<b>Alterations:</b>
Residence	Upright and wing		Major addition to side of upright Replacement windows

<b>Circa:</b> 1860-1890	<b>Condition:</b> Good	<b>Integrity:</b> Good
----------------------------	---------------------------	---------------------------

<b>Materials:</b>	<b>HISTORY:</b>
<b>Foundation:</b> Stone <b>Walls:</b> Metal Siding <b>Roof:</b> Asphalt shingle <b>Porch:</b>	2 story, porch in crook of longer arm, overhang on porch           Previous site = 2487

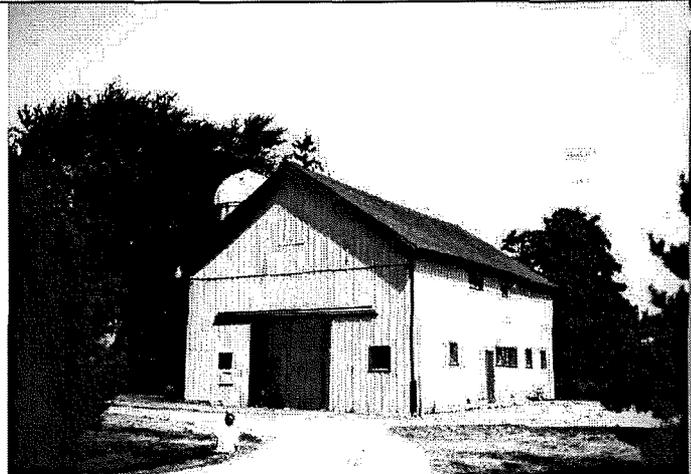
<b>Circa:</b> 1880-1920	<b>Condition:</b> Good	<b>Integrity:</b> Good
----------------------------	---------------------------	---------------------------

<b>Materials:</b>	<b>HISTORY:</b>  No vents, front gable, not ramped
<b>Foundation:</b> Poured concrete	
<b>Walls:</b> Vertical, batten	
<b>Roof:</b> Asphalt shingle	
<b>Porch:</b>

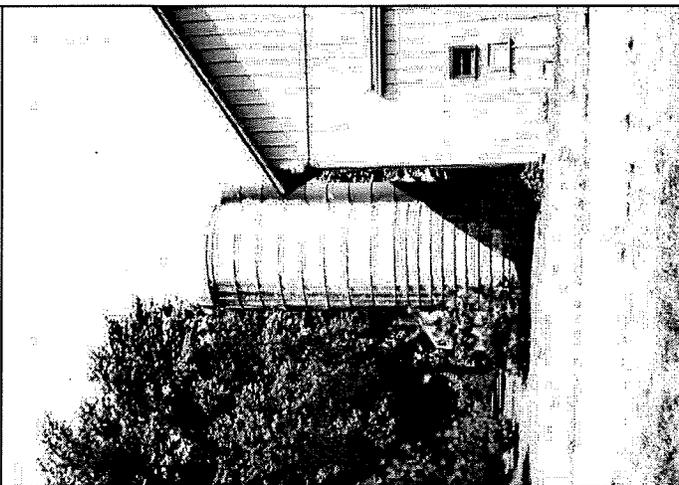
<b>Circa:</b> 1920	<b>Condition:</b> Good	<b>Integrity:</b> Good
-----------------------	---------------------------	---------------------------

<b>Materials:</b>	<b>HISTORY:</b>
<b>Foundation:</b> Concrete	
<b>Walls:</b> Staved concrete	
<b>Roof:</b> Metal dome	
<b>Porch:</b>

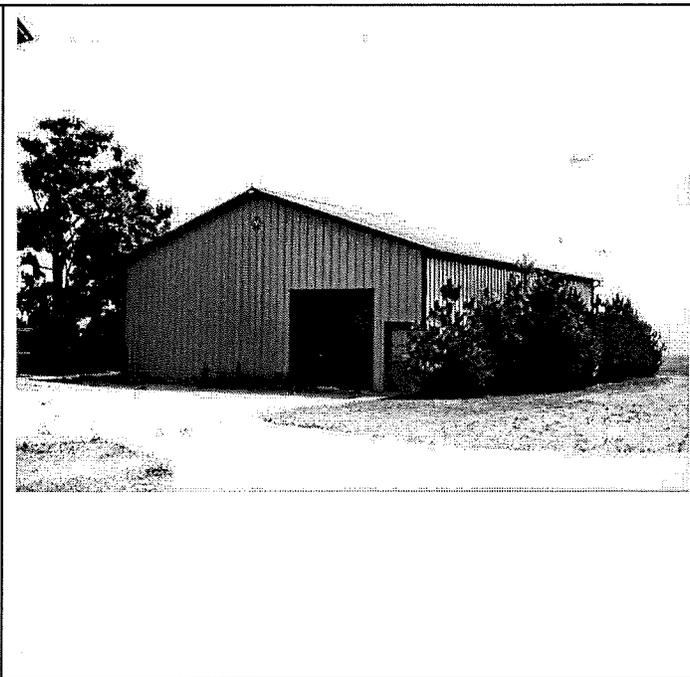
<b>Circa:</b> Post 1945	<b>Condition:</b> Excellent	<b>Integrity:</b> Good
----------------------------	--------------------------------	---------------------------

<b>Materials:</b>	<b>HISTORY:</b>  Up and over door
<b>Foundation:</b> Concrete	
<b>Walls:</b> Metal	
<b>Roof:</b> Metal	
<b>Porch:</b>

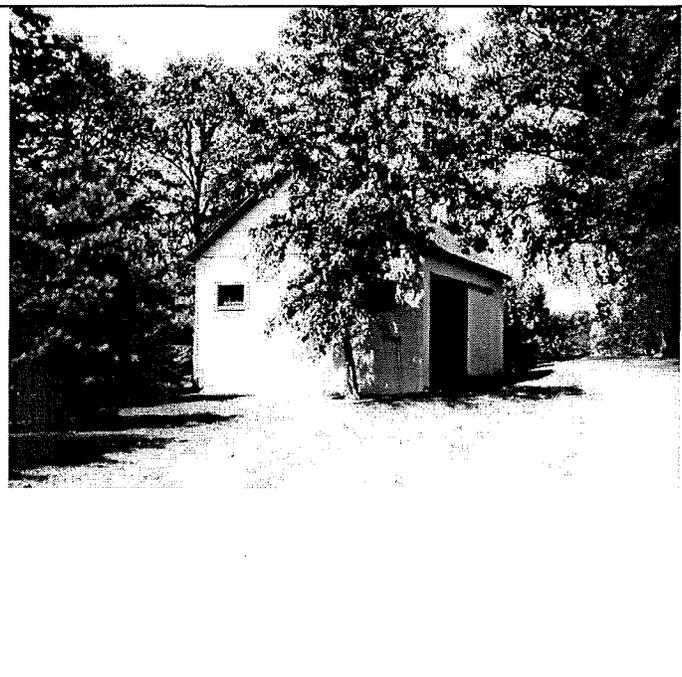
<b>Circa:</b> 1920	<b>Condition:</b> Good	<b>Integrity:</b> Good
-----------------------	---------------------------	---------------------------

<b>Materials:</b>	<b>HISTORY:</b>  Large sliding door
<b>Foundation:</b> Concrete	
<b>Walls:</b> Concrete block and clapboard	
<b>Roof:</b> Asphalt shingle	
<b>Porch:</b>

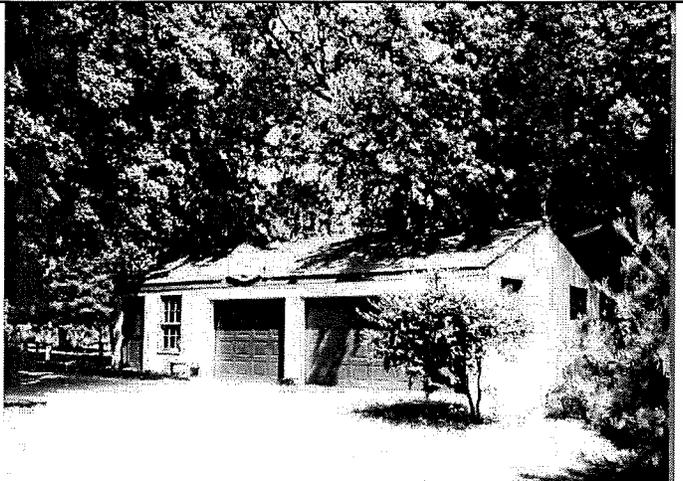
<b>Circa:</b> 1930	<b>Condition:</b> Good	<b>Integrity:</b> Good
-----------------------	---------------------------	---------------------------

<b>Materials:</b>	<b>HISTORY:</b>
<b>Foundation:</b> Concrete	
<b>Walls:</b> Concrete blocks	
<b>Roof:</b> Asphalt shingle	
<b>Porch:</b>

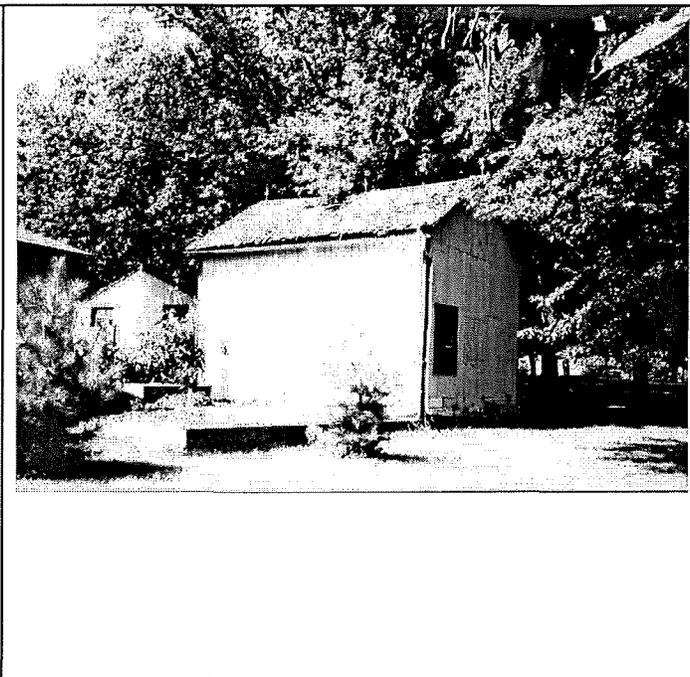
<b>Circa:</b> 1900 - 1920	<b>Condition:</b> Poor	<b>Integrity:</b> Good
------------------------------	---------------------------	---------------------------

<b>Materials:</b>	<b>HISTORY:</b>  Formerly a chicken coop
<b>Foundation:</b> Concrete	
<b>Walls:</b> Vertical plank	
<b>Roof:</b> Asphalt shingle	
<b>Porch:</b>

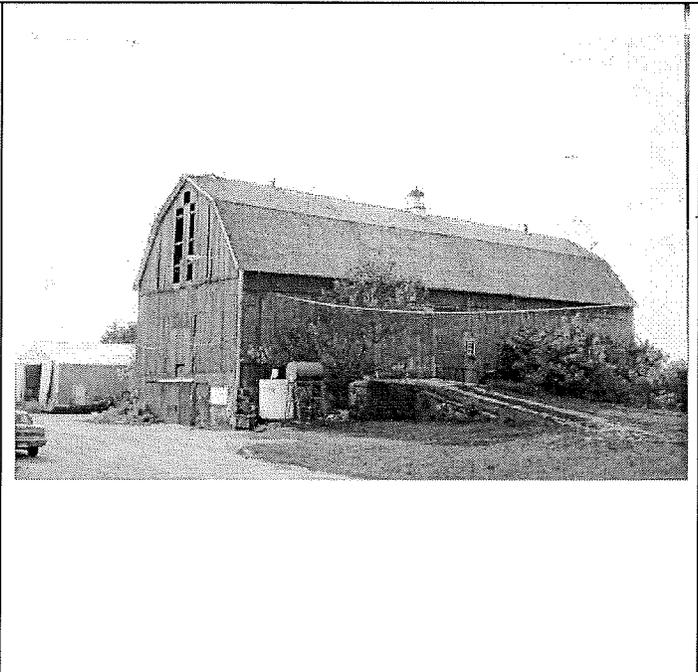
<b>Circa:</b> 1900 - 1930	<b>Condition:</b> Poor	<b>Integrity:</b> Good
------------------------------	---------------------------	---------------------------

<b>Materials:</b>	<b>HISTORY:</b>
<b>Foundation:</b> Stone <b>Walls:</b> Vertical plank <b>Roof:</b> Wood shingle <b>Porch:</b>	Habitat for humanity sign in front yard of property. Single vented, ramped with room underneath ramp, many slats missing.  Previous site = 4689

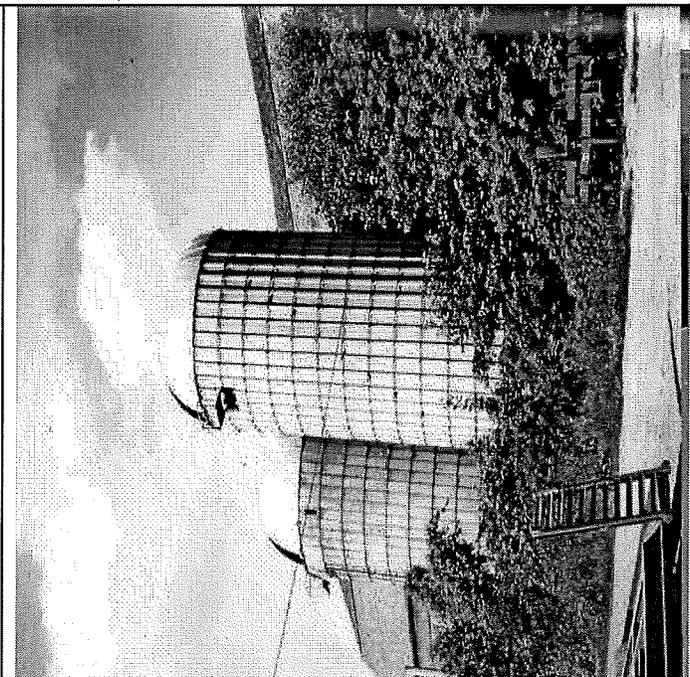
<b>Circa:</b> 1920	<b>Condition:</b> Good	<b>Integrity:</b> Excellent
-----------------------	---------------------------	--------------------------------

<b>Materials:</b>	<b>HISTORY:</b>
<b>Foundation:</b> Concrete  <b>Walls:</b> Staved concrete <b>Roof:</b> Metal dome  <b>Porch:</b>	Located along the long side of the barn, both have viewing platforms; one has ladder attached.          <div style="text-align: right;"><i>✓ Note: Photo elongated ✓</i></div>

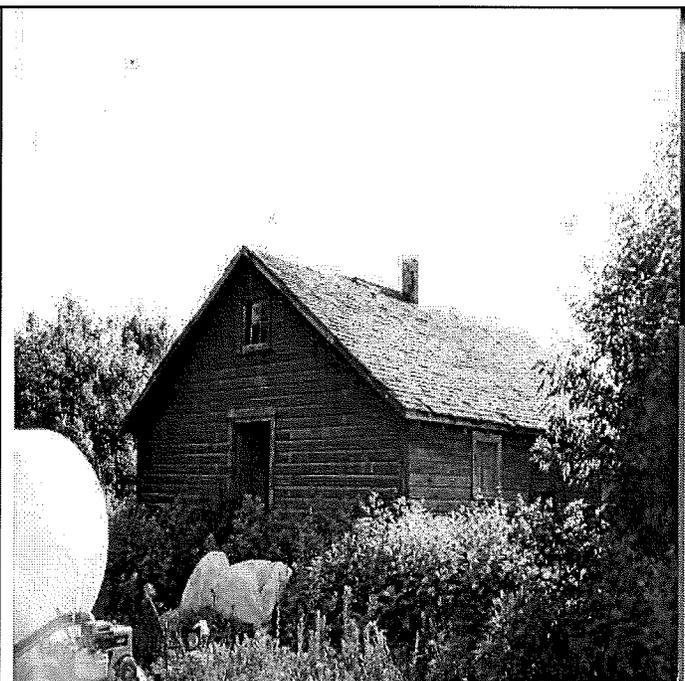
<b>Circa:</b> 1900-1930	<b>Condition:</b> Poor	<b>Integrity:</b> Good
----------------------------	---------------------------	---------------------------

<b>Materials:</b> <b>Foundation:</b> Concrete <b>Walls:</b> Beveled Clapboard <b>Roof:</b> Wood shingles <b>Porch:</b>	<b>HISTORY:</b>  Single vent
---	------------------------------------

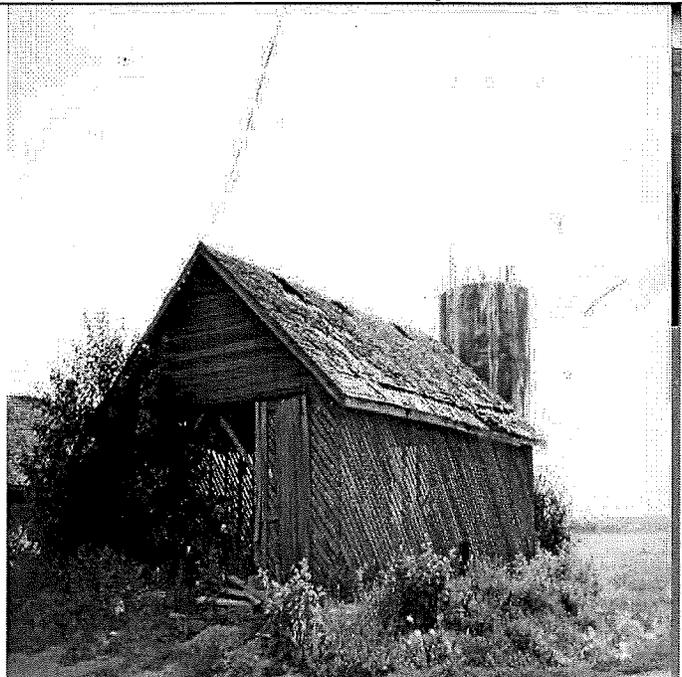
<b>Circa:</b> 1900-1940	<b>Condition:</b> Poor	<b>Integrity:</b> Poor
----------------------------	---------------------------	---------------------------

<b>Materials:</b>	<b>HISTORY:</b>
<b>Foundation:</b> Concrete	
<b>Walls:</b> Diagonal slats	
<b>Roof:</b> Wood shingles	
<b>Porch:</b>

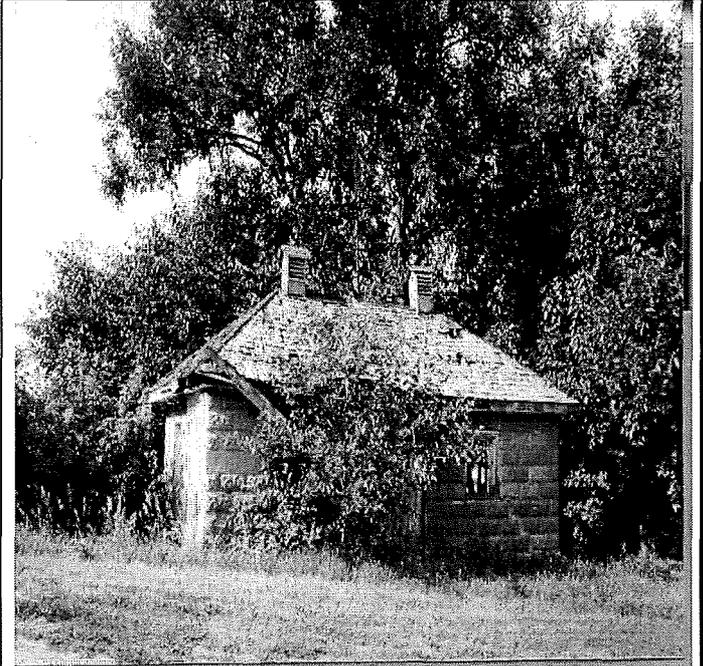
<b>Circa:</b> 1909	<b>Condition:</b> Poor	<b>Integrity:</b> Good
-----------------------	---------------------------	---------------------------

<b>Materials:</b>	<b>HISTORY:</b>
<b>Foundation:</b> Poured concrete <b>Walls:</b> <i>Molded</i> Concrete block <b>Roof:</b> Wood shingles <b>Porch:</b>	<p>“J.M. Phalin 1909” printed on one block, two vents, roof is near collapse;, hipped roof; very interesting construction.</p> <p style="text-align: right;"><i>↙ Note: Photo elongated ↘</i></p>

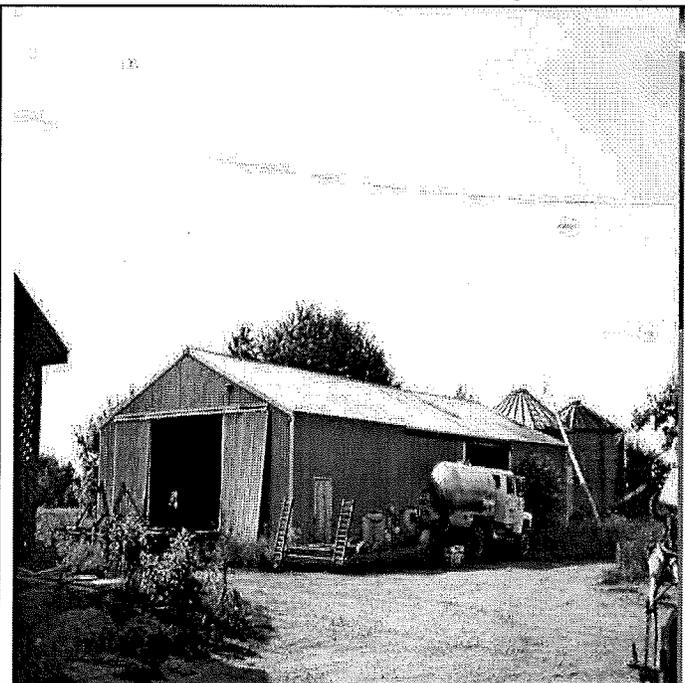
<b>Circa:</b> Post 1945	<b>Condition:</b> Good	<b>Integrity:</b> TBD
----------------------------	---------------------------	--------------------------

<b>Materials:</b> <b>Foundation:</b> Concrete <b>Walls:</b> Metal <b>Roof:</b> Metal <b>Porch:</b>	<b>HISTORY:</b>  No remarkable features
---	---

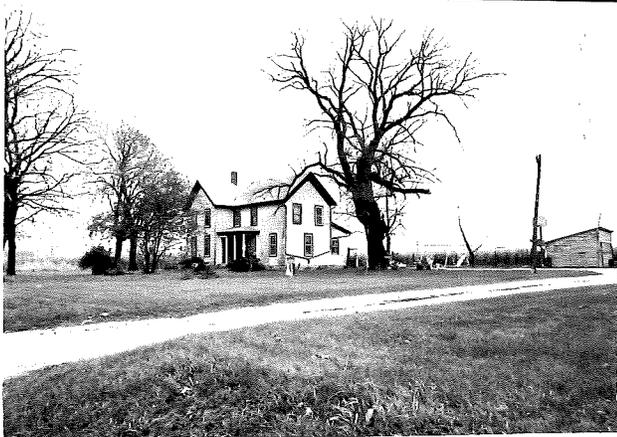
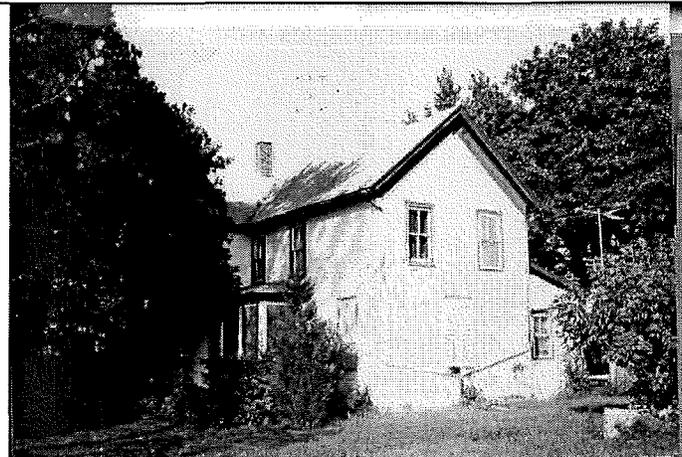
<b>Circa:</b> 1860-1880	<b>Condition:</b> Good	<b>Integrity:</b> Good
----------------------------	---------------------------	---------------------------

<b>Materials:</b>	<b>HISTORY:</b>
<b>Foundation:</b> Concrete	2 story , single brick chimney, has back extension <i>Has original two-over-two windows.</i>
<b>Walls:</b> Asbestos	
<b>Roof:</b> Wood shingle	
<b>Porch:</b> Enclosed in crook of "T"

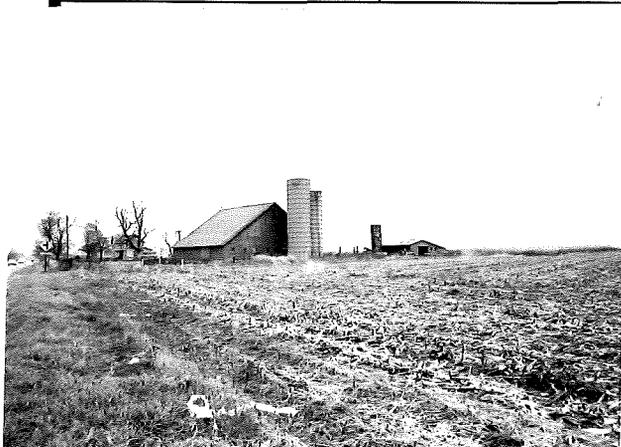
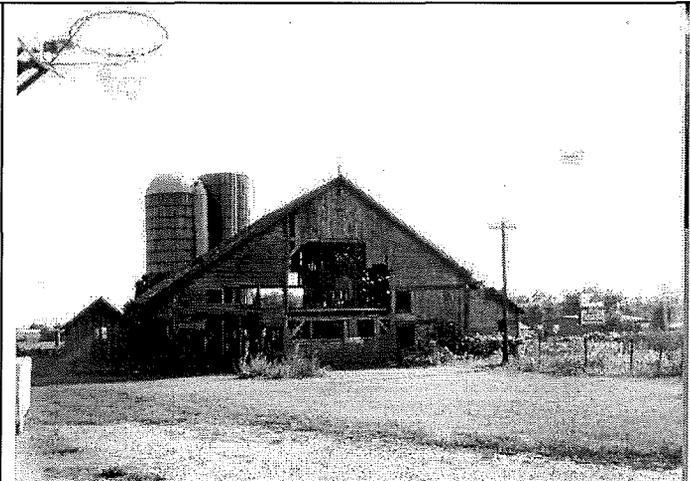
**Roll No./Neg.No.:** SS2

<b>Circa:</b> 1910-1930	<b>Condition:</b> Poor	<b>Integrity:</b> Good
----------------------------	---------------------------	---------------------------

<b>Materials:</b>	<b>HISTORY:</b>
<b>Foundation:</b> Concrete	Out of use
<b>Walls:</b> Vertical and clapboard	
<b>Roof:</b> Wood shingle	
<b>Porch:</b>

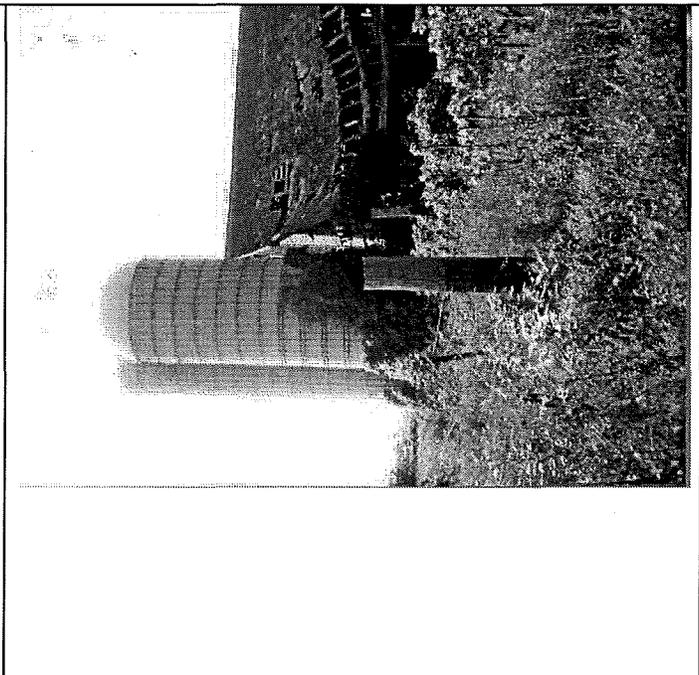
**Roll No./Neg.No.:** SS3

<b>Circa:</b> 1920	<b>Condition:</b> Good	<b>Integrity:</b> Good
-----------------------	---------------------------	---------------------------

<b>Materials:</b>	<b>HISTORY:</b>  Twin, one has viewing platform.
<b>Foundation:</b> Concrete	
<b>Walls:</b> Staved concrete	
<b>Roof:</b> Metal dome, 1 roof missing	
<b>Porch:</b>

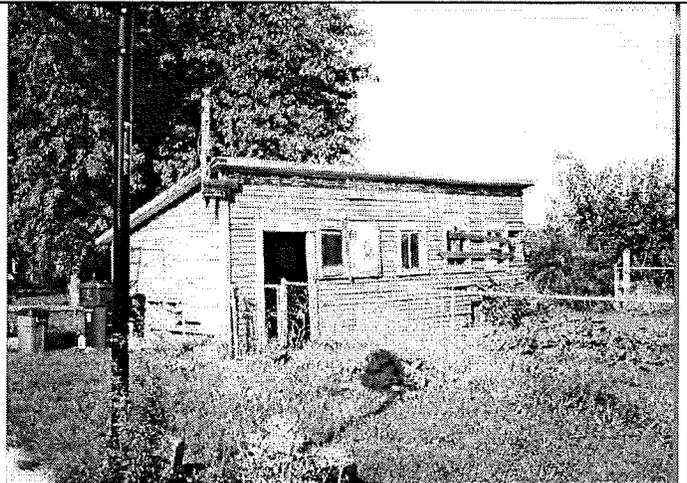
**Roll No./Neg.No.:** SS6

<b>Circa:</b> 1940	<b>Condition:</b> Poor	<b>Integrity:</b> Poor
-----------------------	---------------------------	---------------------------

<b>Materials:</b>	<b>HISTORY:</b>  In disrepair, door & windows missing.
<b>Foundation:</b> Concrete	
<b>Walls:</b> Clapboard	
<b>Roof:</b> Metal	
<b>Porch:</b>

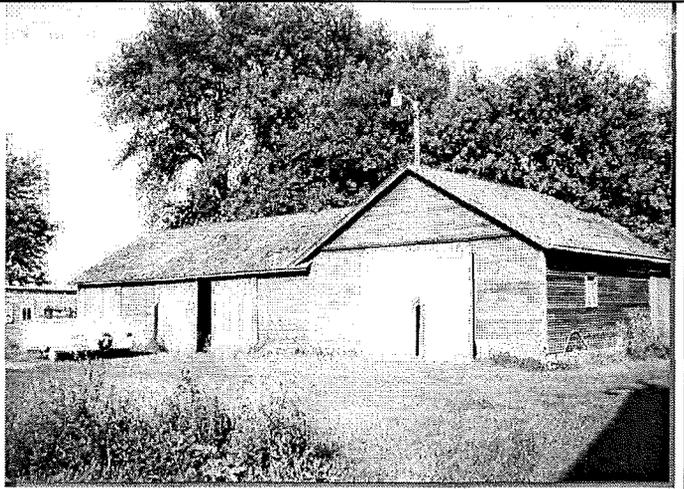
<b>Circa:</b> 1920	<b>Condition:</b> Good	<b>Integrity:</b> Good
-----------------------	---------------------------	---------------------------

<b>Materials:</b>	<b>HISTORY:</b>  Single story, sliding doors
<b>Foundation:</b> Concrete	
<b>Walls:</b> Clapboard	
<b>Roof:</b> Wood shingle	
<b>Porch:</b>

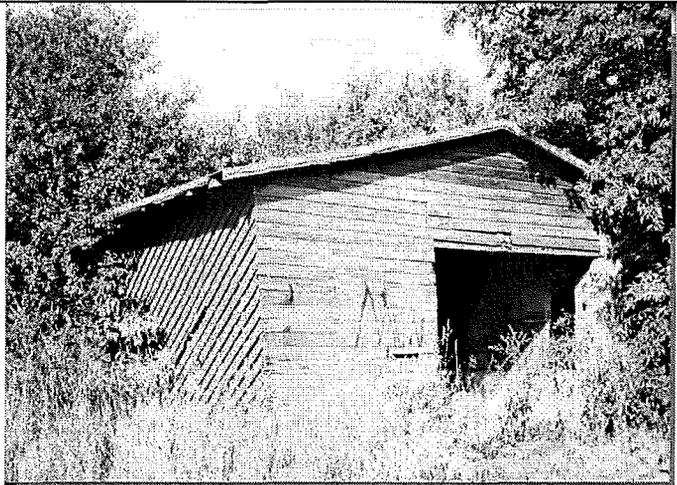
**Roll No./Neg.No.:** SS4

<b>Circa:</b> 1940	<b>Condition:</b> Poor	<b>Integrity:</b> Good
-----------------------	---------------------------	---------------------------

<b>Materials:</b>	<b>HISTORY:</b>
<b>Foundation:</b> Concrete	
<b>Walls:</b> Clapboard and open <i>diagonal</i> slats	
<b>Roof:</b> Asphalt shingle	
<b>Porch:</b>

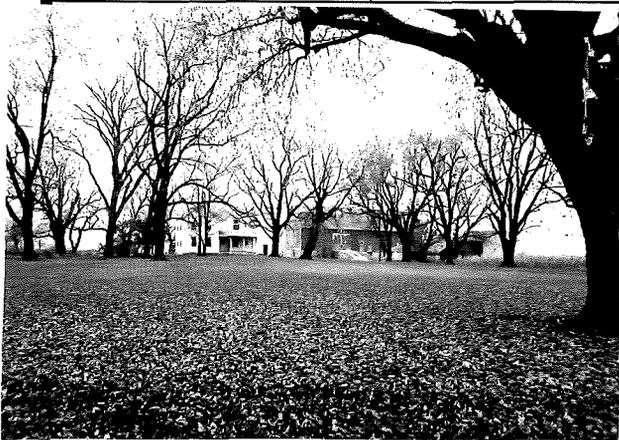
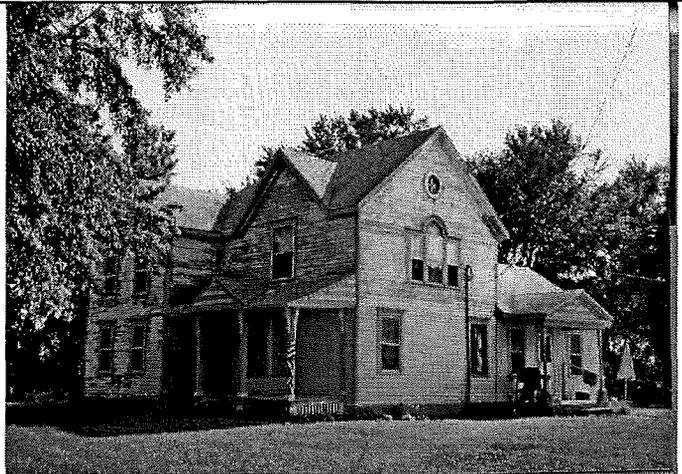
**Roll No./Neg.No.:** AA22

<b>Circa:</b> 1880 - 1910	<b>Condition:</b> Good	<b>Integrity:</b> Good
------------------------------	---------------------------	---------------------------

<b>Materials:</b>	<b>HISTORY:</b>
<b>Foundation:</b> Poured concrete	Linked with PIN: 14-10-300-002
<b>Walls:</b> Clapboard	Moldings around windows.
<b>Roof:</b> Asphalt shingle	Paladin window on end
<b>Porch:</b> Front with columns	<i>previous site = 4689</i>

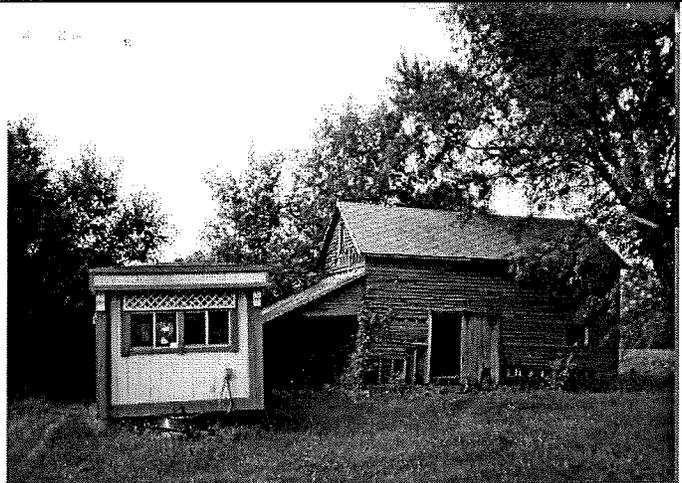
<b>Circa:</b> 1880 - 1920	<b>Condition:</b> Poor	<b>Integrity:</b> Poor
------------------------------	---------------------------	---------------------------

<b>Materials:</b>	<b>HISTORY:</b>  Falling apart
<b>Foundation:</b> Concrete	
<b>Walls:</b> Clapboard	
<b>Roof:</b> Asphalt shingle	
<b>Porch:</b>

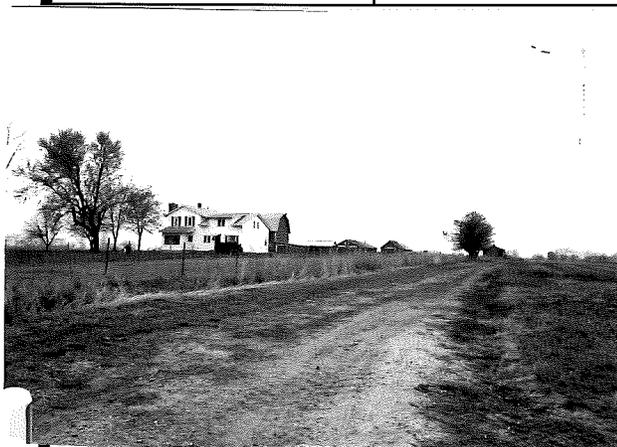
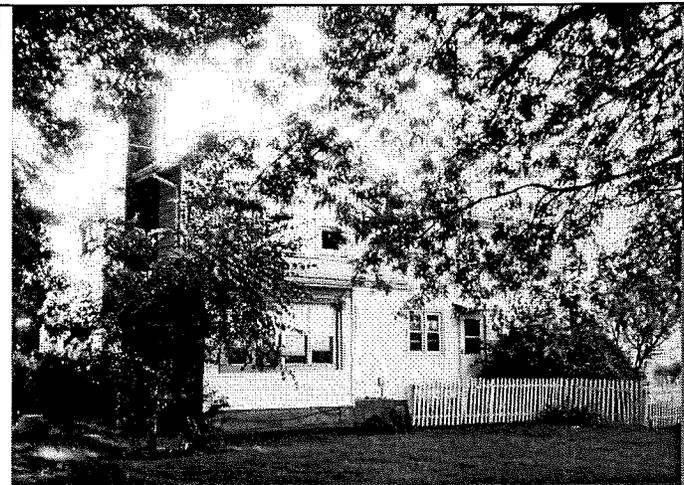
<b>Circa:</b> 1880 - 1920	<b>Condition:</b> Good	<b>Integrity:</b> Poor
------------------------------	---------------------------	---------------------------

<b>Materials:</b>  <b>Foundation:</b> Poured concrete <b>Walls:</b> Metal Siding <b>Roof:</b> Asphalt shingle <b>Porch:</b>	<b>HISTORY:</b>  "Morning Star Farm," main part is 2 story, side brick chimney.         Previous site = 4668
---	---

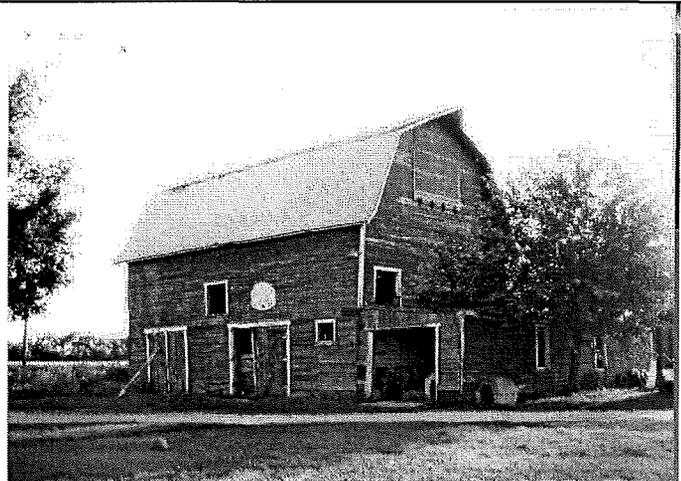
<b>Circa:</b> 1910-1930	<b>Condition:</b> Poor	<b>Integrity:</b> Good
----------------------------	---------------------------	---------------------------

<b>Materials:</b>	<b>HISTORY:</b>
<b>Foundation:</b> Concrete <b>Walls:</b> Clapboard <b>Roof:</b> Asphalt shingle <b>Porch:</b>	Grappling hook extension, double side entry

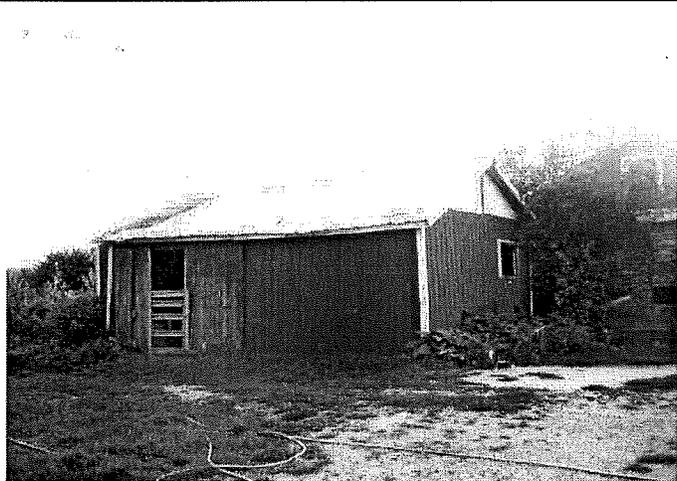
<b>Circa:</b> 1940	<b>Condition:</b> Poor	<b>Integrity:</b> Poor
-----------------------	---------------------------	---------------------------

<b>Materials:</b>	<b>HISTORY:</b>
<b>Foundation:</b> Unknown	
<b>Walls:</b> Metal	
<b>Roof:</b> Metal	
<b>Porch:</b>

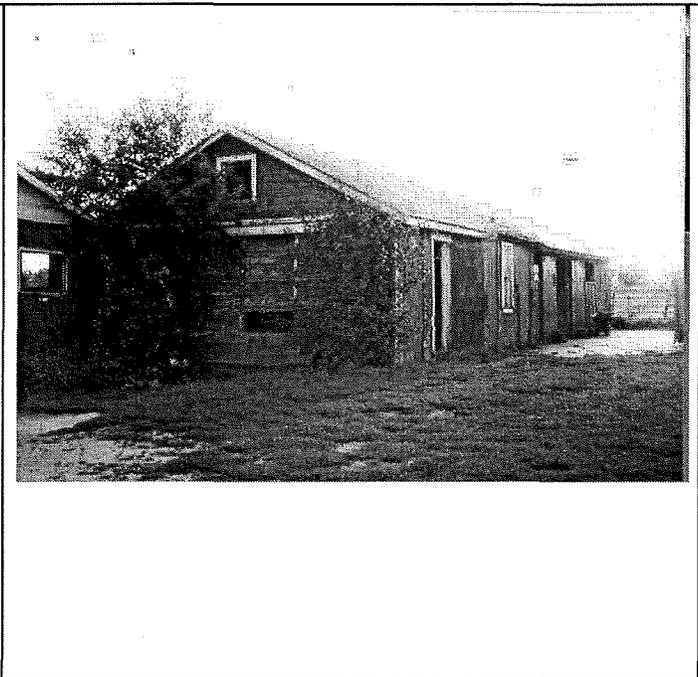
<b>Circa:</b> 1925	<b>Condition:</b> Poor	<b>Integrity:</b> Poor
-----------------------	---------------------------	---------------------------

<b>Materials:</b>	<b>HISTORY:</b>
<b>Foundation:</b> Concrete <b>Walls:</b> Vertical metal and clapboard <b>Roof:</b> Metal & asphalt shingle <b>Porch:</b>	Up and over door, single story, possibly once used as a horse stable.

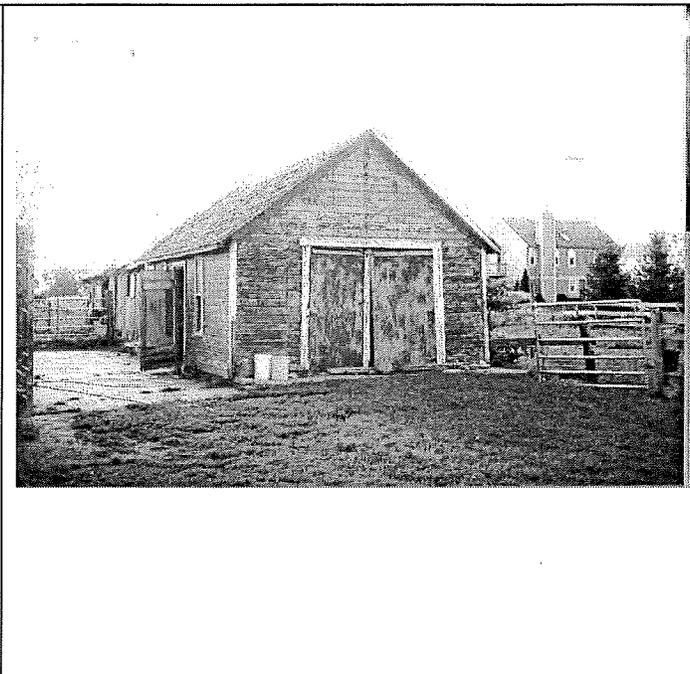
<b>Circa:</b> 1920	<b>Condition:</b> Good	<b>Integrity:</b> Good
-----------------------	---------------------------	---------------------------

<b>Materials:</b>	<b>HISTORY:</b>  Connected single story buildings, possibly used as stabling
<b>Foundation:</b> Concrete	
<b>Walls:</b> Beveled clapboard	
<b>Roof:</b> Wood shingle and metal	
<b>Porch:</b>
