McHenry County

Rural Survey

***Nunda Township***

***FIELD DATA SHEETS***

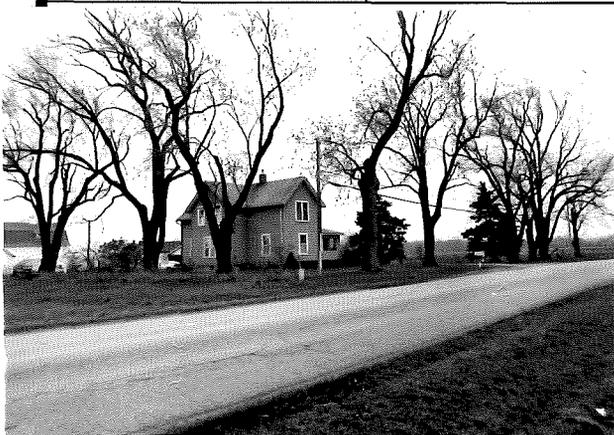
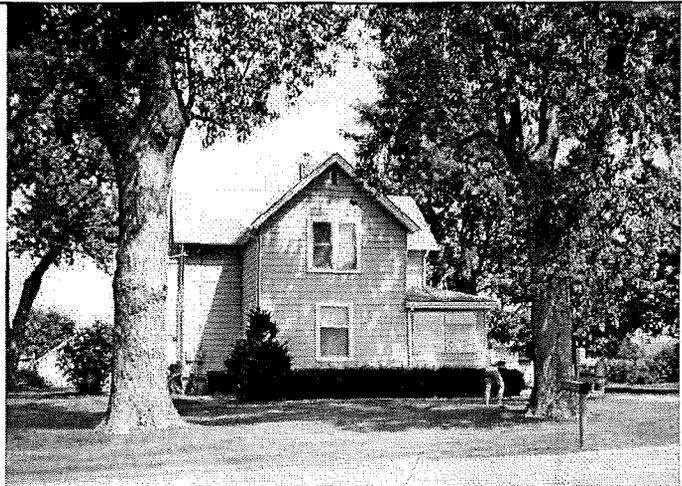
**Roll No./Neg.No.:** X23

Function:	Vernacular Type:	Arch. Style:	Alterations:
Residence	"T" - Plan		Added enclosed porches in corners; replacement windows

<b>Circa:</b> 1906	<b>Condition:</b> Good	<b>Integrity:</b> Fair
-----------------------	---------------------------	---------------------------

<b>Materials:</b>	<b>HISTORY:</b>
<b>Foundation:</b> Stone and concrete	Single chimney
<b>Walls:</b> Aluminum siding	Building date as per resident
<b>Roof:</b> Asphalt shingle	
<b>Porch:</b>	Previous site = 4669

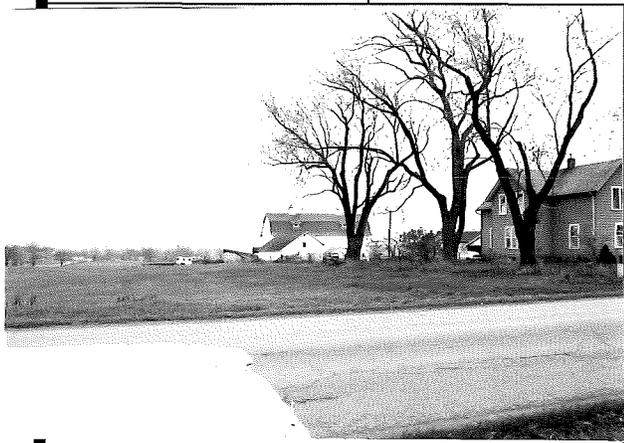
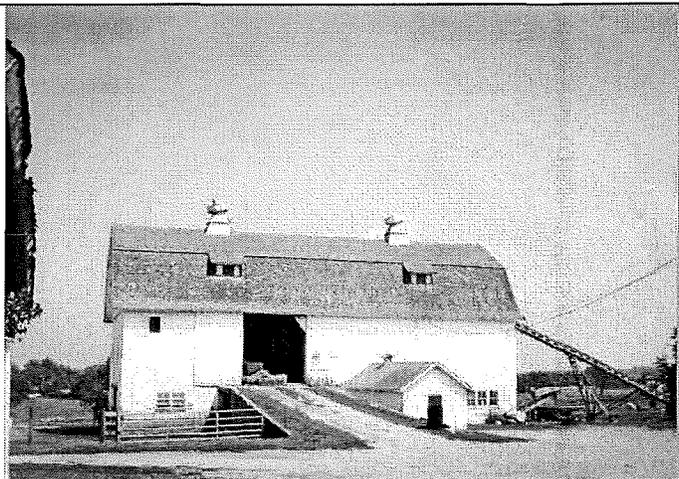
**Roll No./Neg.No.:** X18

<b>Circa:</b> 1910 - 1945	<b>Condition:</b> Good	<b>Integrity:</b> Good
------------------------------	---------------------------	---------------------------

<b>Materials:</b>	<b>HISTORY:</b>
<b>Foundation:</b> Concrete	2 vents (metal)
<b>Walls:</b> Vertical plank	Ramped
<b>Roof:</b> Wood shingle	Transverse aisle
<b>Porch:</b>	Vented milkhouse

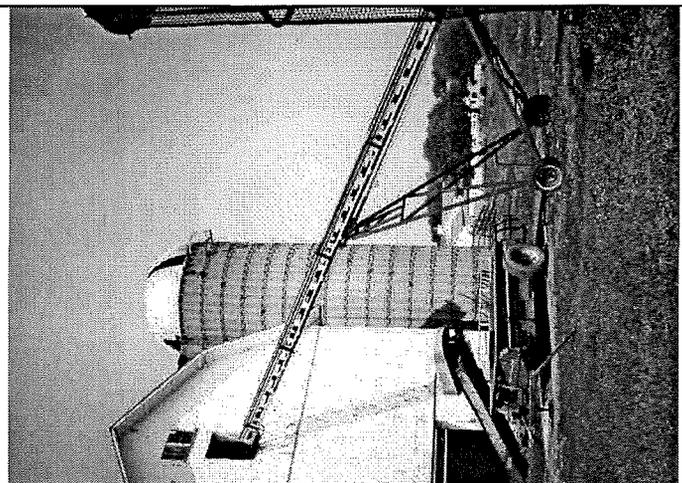
**Roll No./Neg.No.:** X21

<b>Circa:</b> 1920	<b>Condition:</b> Good	<b>Integrity:</b> Good
-----------------------	---------------------------	---------------------------

<b>Materials:</b>	<b>HISTORY:</b>
<b>Foundation:</b> Concrete <b>Walls:</b> Staved concrete <b>Roof:</b> Metal dome <b>Porch:</b>	Viewing platform in disrepair

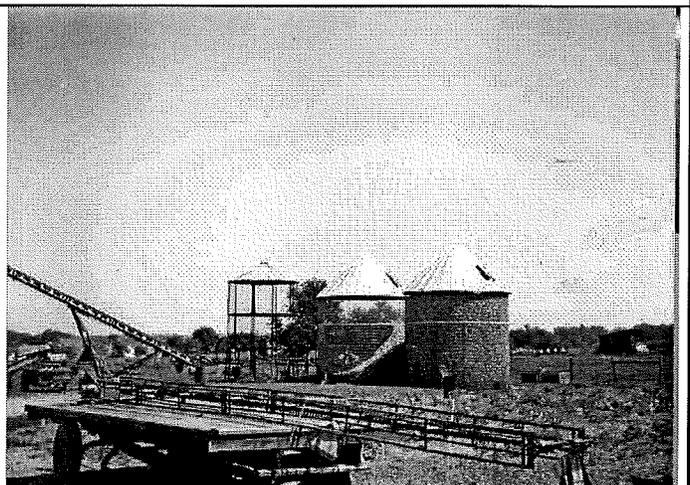
**Roll No./Neg.No.:** X20

<b>Circa:</b> 1940 - 1970	<b>Condition:</b> Excellent	<b>Integrity:</b> Excellent
------------------------------	--------------------------------	--------------------------------

<b>Materials:</b>	<b>HISTORY:</b>  <i>Round</i>
<b>Foundation:</b>	
<b>Walls:</b> Metal wire	
<b>Roof:</b> Metal	
<b>Porch:</b>

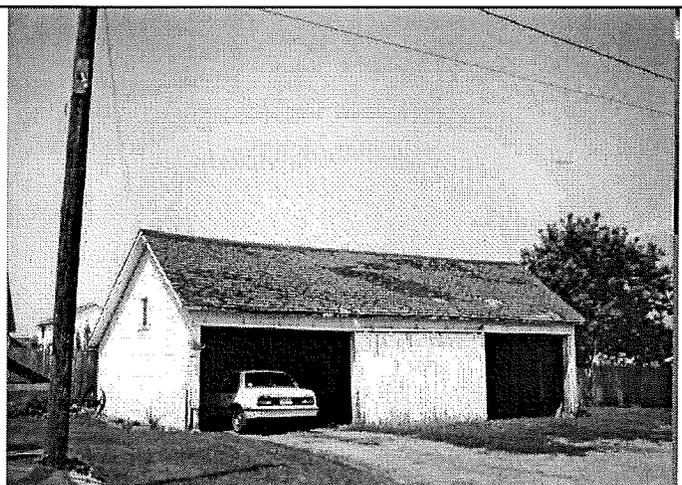
<b>Circa:</b> 1930	<b>Condition:</b> Fair	<b>Integrity:</b> Good
-----------------------	---------------------------	---------------------------

<b>Materials:</b>	<b>HISTORY:</b>  Now garage
<b>Foundation:</b> Concrete	
<b>Walls:</b> Clapboard	
<b>Roof:</b> Asphalt shingle	
<b>Porch:</b>

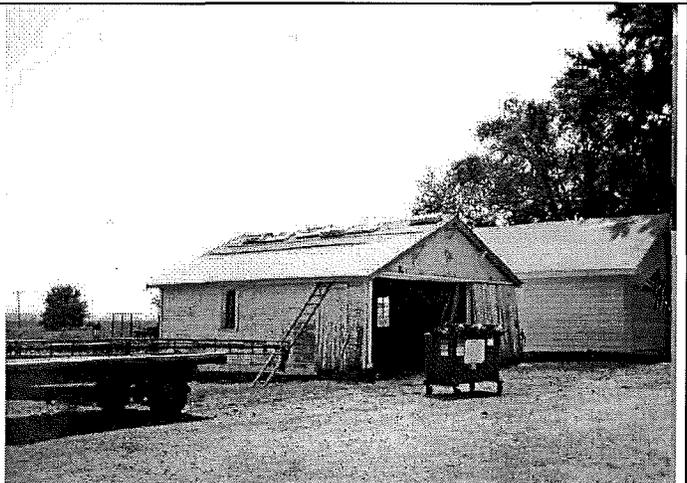
<b>Circa:</b> 1910	<b>Condition:</b> Poor	<b>Integrity:</b> Good
-----------------------	---------------------------	---------------------------

<b>Materials:</b>	<b>HISTORY:</b>
<b>Foundation:</b> Concrete	
<b>Walls:</b> Clapboard	
<b>Roof:</b> Asphalt shingle	
<b>Porch:</b>

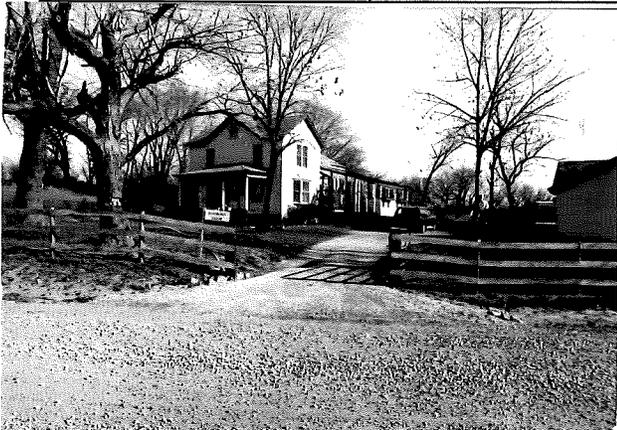
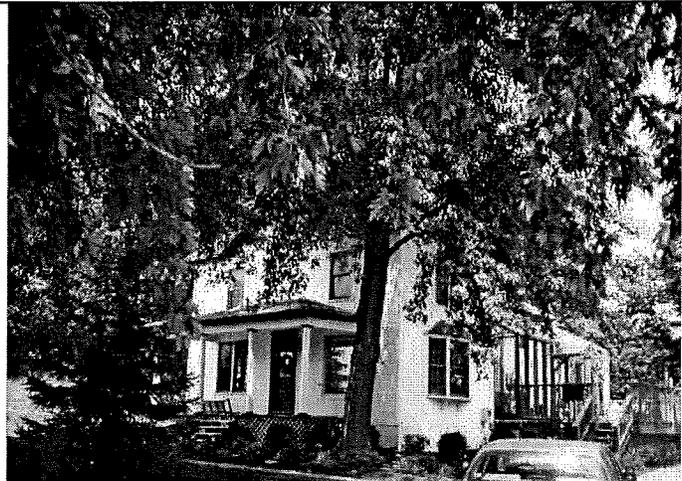
**Roll No./Neg.No.:** X8

<b>Circa:</b> 1860-1872	<b>Condition:</b> Excellent	<b>Integrity:</b> Poor
----------------------------	--------------------------------	---------------------------

<b>Materials:</b>	<b>HISTORY:</b>
<b>Foundation:</b> Poured concrete	Gabled dormer
<b>Walls:</b> Clapboard	2 story "Oakwood Farm"
<b>Roof:</b> Asphalt shingle	
<b>Porch:</b> With pillars	Previous site = 4720

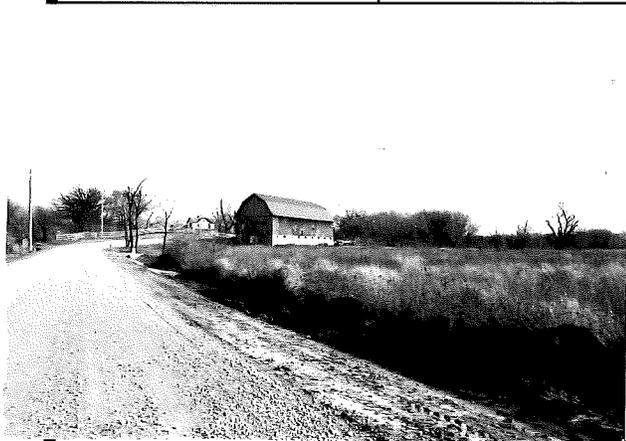
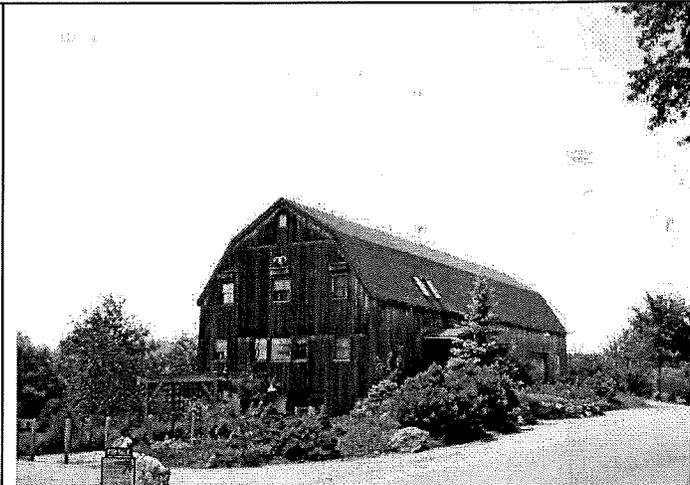
**Roll No./Neg.No.:** X9

<b>Circa:</b> 1910-1945	<b>Condition:</b> Excellent	<b>Integrity:</b> Poor
----------------------------	--------------------------------	---------------------------

<b>Materials:</b>	<b>HISTORY:</b>
<b>Foundation:</b> Poured concrete	Turned into a house
<b>Walls:</b> Vertical plank	This is actually on a different parcel of land, now (across the street)
<b>Roof:</b> Asphalt shingle	Banked
<b>Porch:</b>

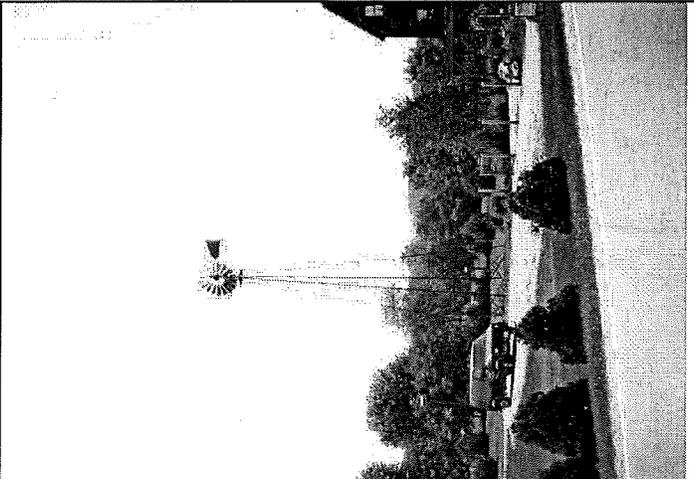
<b>Circa:</b> 1910	<b>Condition:</b> Excellent	<b>Integrity:</b> Excellent
-----------------------	--------------------------------	--------------------------------

<b>Materials:</b>	<b>HISTORY:</b>  Close to barn
<b>Foundation:</b>	
<b>Walls:</b>	
<b>Roof:</b>	
<b>Porch:</b>

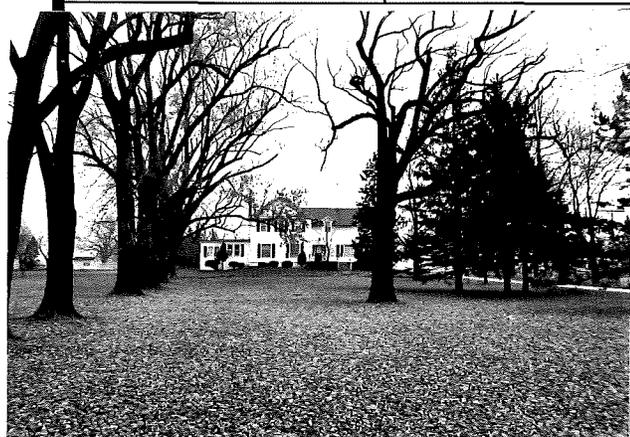
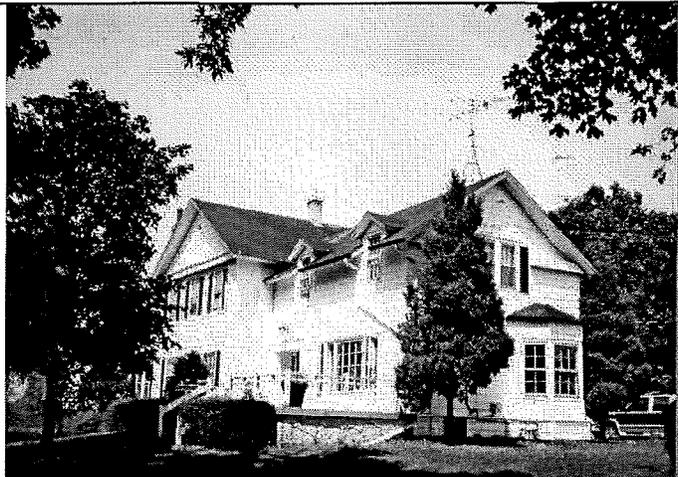
**Roll No./Neg.No.:** X11

<b>Function:</b>	<b>Vernacular Type:</b>	<b>Arch. Style:</b>	<b>Alterations:</b>
Residence	Upright and wing		Bayed windows; porch removed and replaced with patio

<b>Circa:</b> 1860 - 1910	<b>Condition:</b> Good	<b>Integrity:</b> Poor
------------------------------	---------------------------	---------------------------

<b>Materials:</b>	<b>HISTORY:</b>
<b>Foundation:</b> Concrete	2 story side wing
<b>Walls:</b> Aluminum siding	2 dormered windows on "wing" side
<b>Roof:</b> Asphalt shingle	Added enclosed porch on left
<b>Porch:</b>	"Charmar farms"
	Cidnet say parcel was deleted in 1997 to split into 14-14-200-014 and 14-14-200-015
	Previous survey = 4670

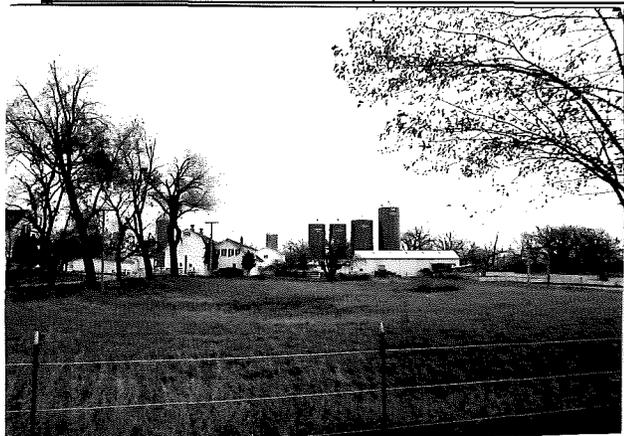
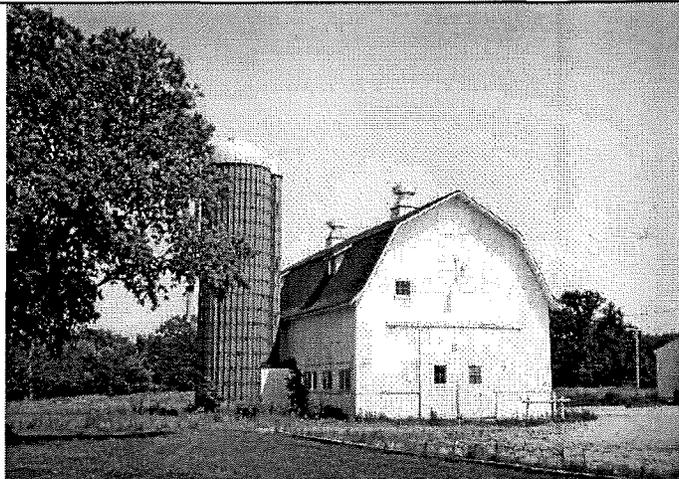
**Roll No./Neg.No.:** X13

<b>Circa:</b> 1910 - 1945	<b>Condition:</b> Good	<b>Integrity:</b> Excellent
------------------------------	---------------------------	--------------------------------

<b>Materials:</b>	<b>HISTORY:</b>
<b>Foundation:</b> Concrete	2 dormered windows
<b>Walls:</b> Vertical plank	2 vents
<b>Roof:</b> Asphalt shingle	Transverse aisle
<b>Porch:</b>

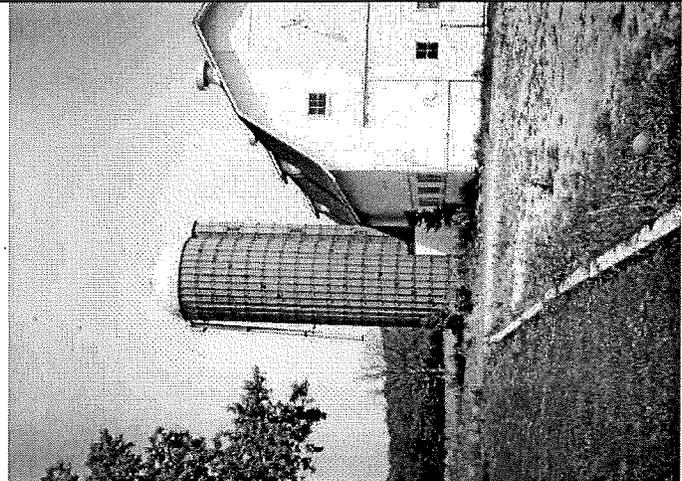
<b>Circa:</b> 1920	<b>Condition:</b> Excellent	<b>Integrity:</b> Excellent
-----------------------	--------------------------------	--------------------------------

<b>Materials:</b>	<b>HISTORY:</b>
<b>Foundation:</b> Concrete	
<b>Walls:</b> Staved concrete	
<b>Roof:</b> Metal dome	
<b>Porch:</b>

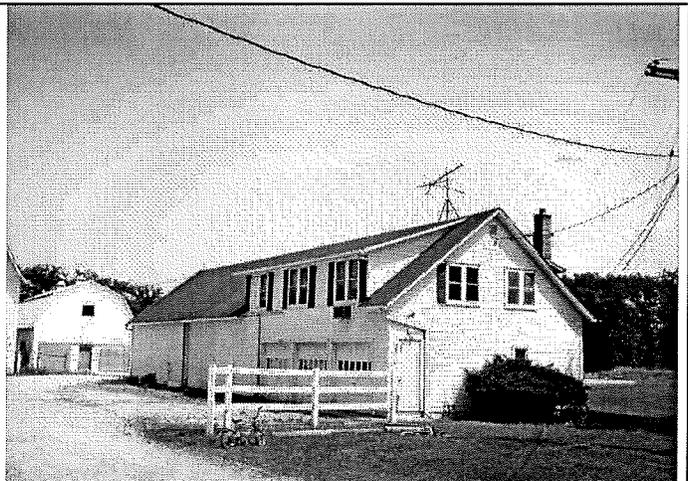
**Roll No./Neg.No.:** X12

<b>Circa:</b> 1910 - 1940	<b>Condition:</b> Good	<b>Integrity:</b> Poor
------------------------------	---------------------------	---------------------------

<b>Materials:</b>	<b>HISTORY:</b>
<b>Foundation:</b> Concrete	New garage doors and dormered attic
<b>Walls:</b> Clapboard	Converted from shed
<b>Roof:</b> Asphalt shingle	
<b>Porch:</b>

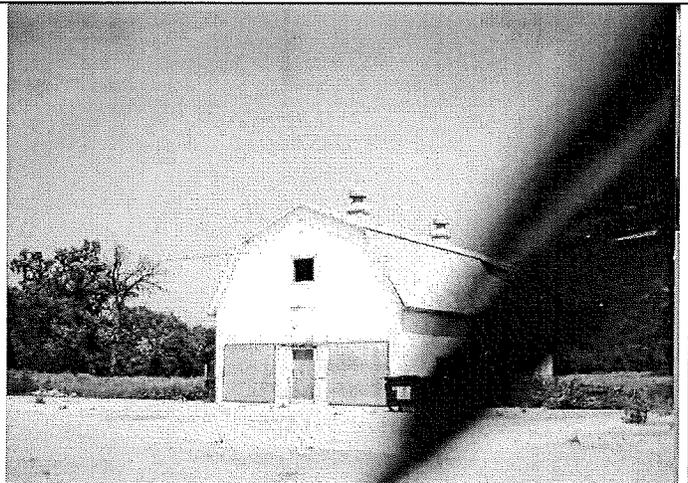
<b>Circa:</b> 1910 - 1940	<b>Condition:</b> Good	<b>Integrity:</b> Good
------------------------------	---------------------------	---------------------------

<b>Materials:</b>	<b>HISTORY:</b>
<b>Foundation:</b> Concrete	2 vents
<b>Walls:</b> Vertical plank	1 dormer
<b>Roof:</b> Batten metal	Transverse aisle
<b>Porch:</b>

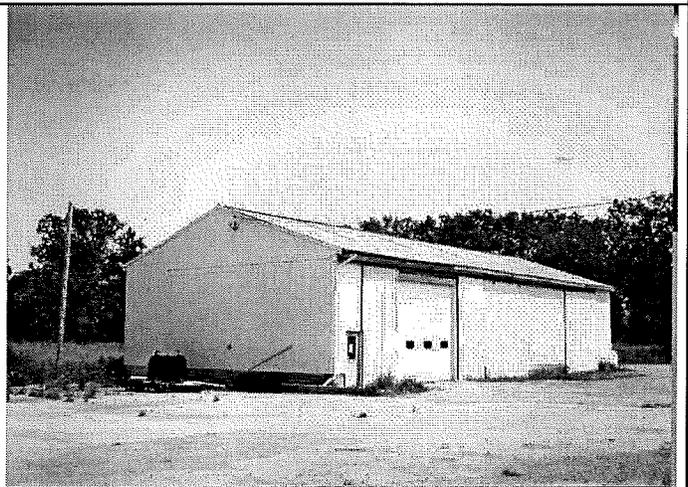
**Roll No./Neg.No.:** X15

<b>Circa:</b> Post 1945	<b>Condition:</b> Excellent	<b>Integrity:</b> Excellent
----------------------------	--------------------------------	--------------------------------

<b>Materials:</b>	<b>HISTORY:</b>
<b>Foundation:</b> Concrete	Up & over door
<b>Walls:</b> Vertical batten metal	
<b>Roof:</b> Metal	
<b>Porch:</b>

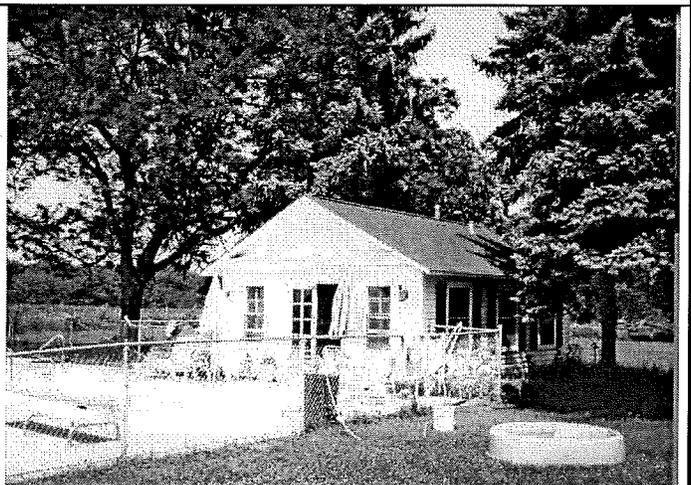
**Roll No./Neg.No.:** X17

<b>Circa:</b> 1920	<b>Condition:</b> Excellent	<b>Integrity:</b> Excellent
-----------------------	--------------------------------	--------------------------------

<b>Materials:</b>	<b>HISTORY:</b>  Now a pool house
<b>Foundation:</b> Concrete	
<b>Walls:</b> Clapboard	
<b>Roof:</b> Asphalt shingle	
<b>Porch:</b>

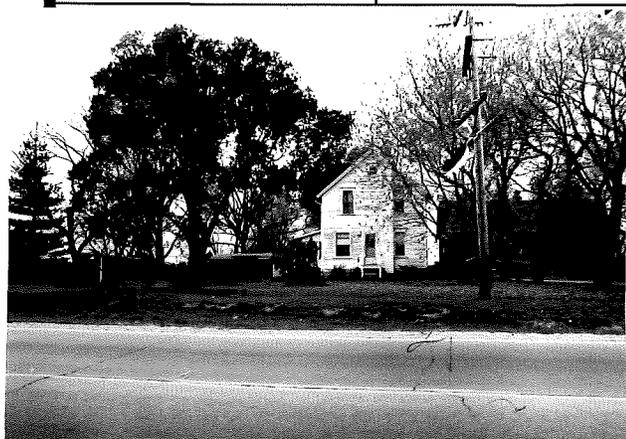
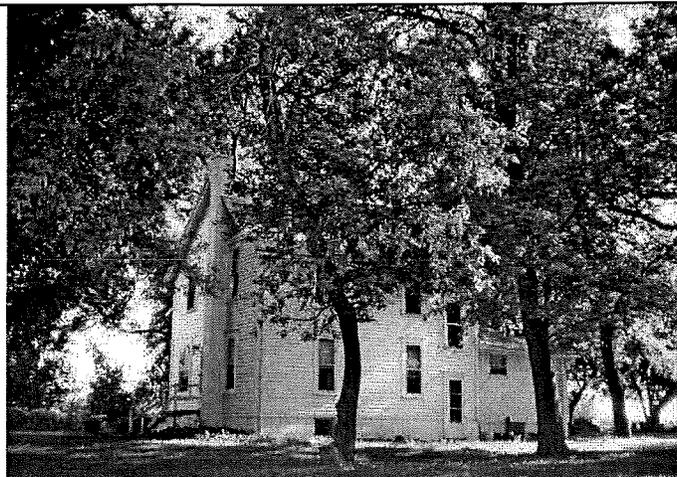
<b>Circa:</b> 1880-1900	<b>Condition:</b> Excellent	<b>Integrity:</b> Good
----------------------------	--------------------------------	---------------------------

<b>Materials:</b>	<b>HISTORY:</b>
<b>Foundation:</b> Concrete block	More than 100 years old
<b>Walls:</b> Clapboard	Original house on farmstead was across the drive, stones from that house in foundation of the addition to house pictured
<b>Roof:</b> Asphalt shingle	
<b>Porch:</b> <i>Removed</i>	Previous site = 4688

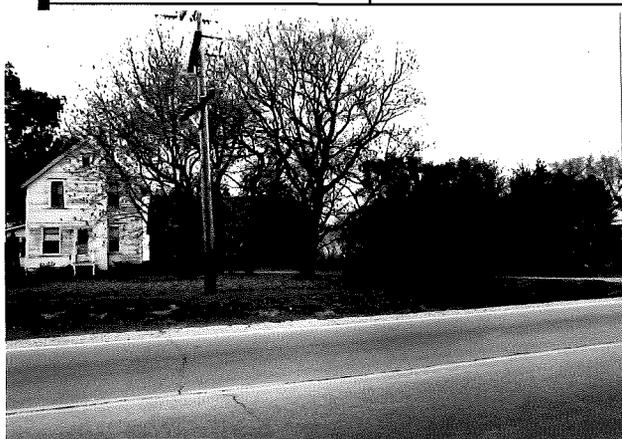
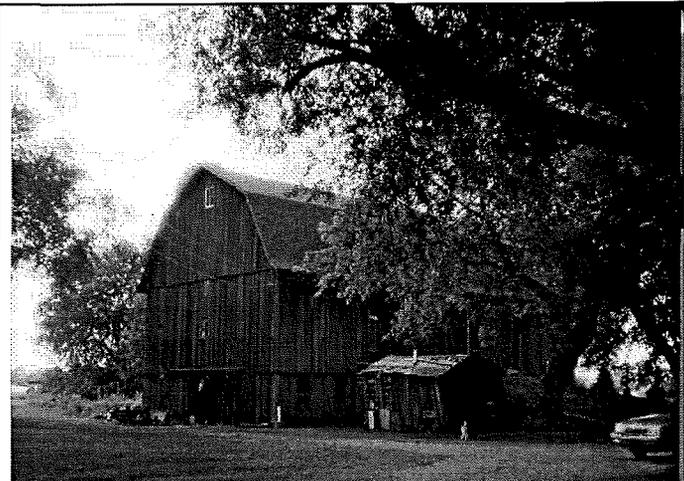
**Roll No./Neg.No.:** AA34

<b>Circa:</b> 1928	<b>Condition:</b> Poor	<b>Integrity:</b> Good
-----------------------	---------------------------	---------------------------

<b>Materials:</b>	<b>HISTORY:</b>
<b>Foundation:</b> Concrete	Built in 1928 according to resident
<b>Walls:</b> Vertical plank	Ramped with room underneath; transverse aisle
<b>Roof:</b> Asphalt shingle	Attached milk house is falling apart
<b>Porch:</b>

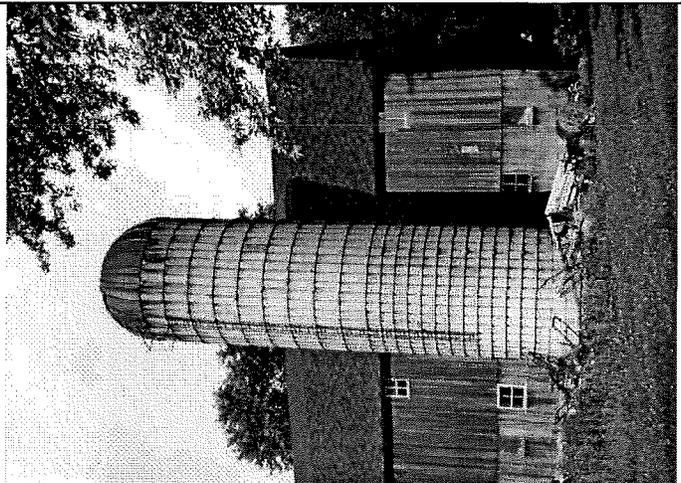
<b>Circa:</b> 1930	<b>Condition:</b> Good	<b>Integrity:</b> Good
-----------------------	---------------------------	---------------------------

<b>Materials:</b>	<b>HISTORY:</b>
<b>Foundation:</b> Concrete <b>Walls:</b> Staved concrete <b>Roof:</b> Metal dome <b>Porch:</b>	Ladder still attached  Viewing platform is in despair

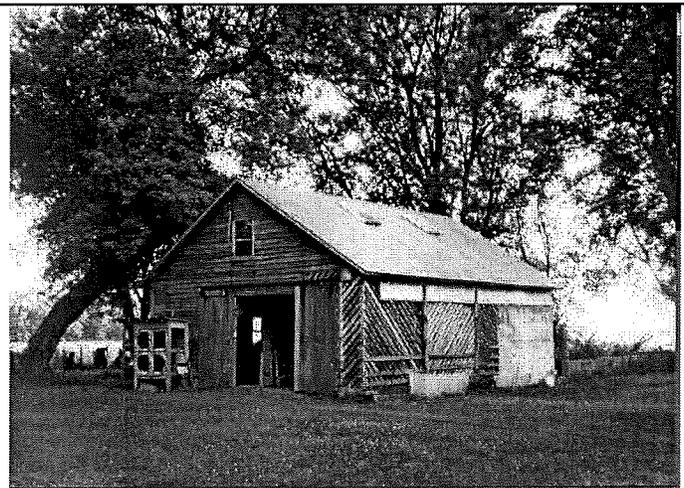
**Roll No./Neg.No.:** AA31

<b>Circa:</b> 1920	<b>Condition:</b> Poor	<b>Integrity:</b> Poor
-----------------------	---------------------------	---------------------------

<b>Materials:</b>	<b>HISTORY:</b>
<b>Foundation:</b> Concrete	
<b>Walls:</b> Clapboard and diagonal slat	
<b>Roof:</b> Asphalt shingle	
<b>Porch:</b>

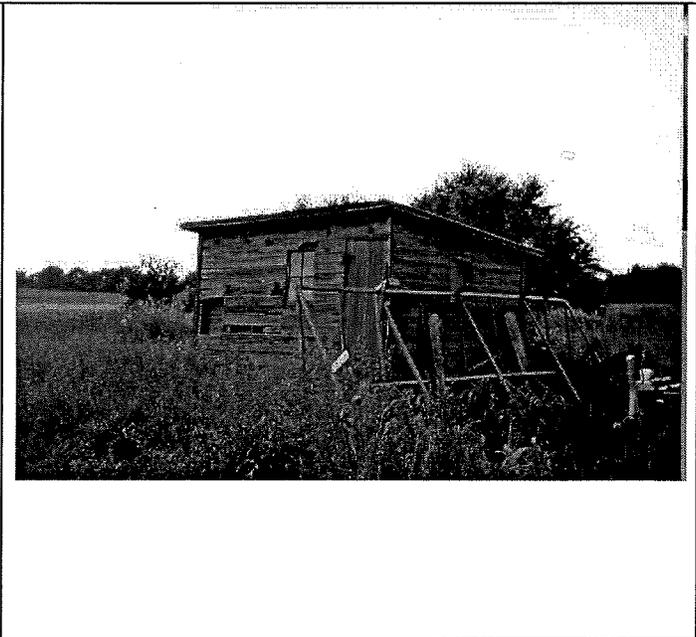
<b>Circa:</b> 1920	<b>Condition:</b> Poor	<b>Integrity:</b> Poor
-----------------------	---------------------------	---------------------------

<b>Materials:</b>	<b>HISTORY:</b>  <i>Slant roof</i>
<b>Foundation:</b> Concrete	
<b>Walls:</b> <i>Clapboard</i>	
<b>Roof:</b> Corrugated metal	
<b>Porch:</b>

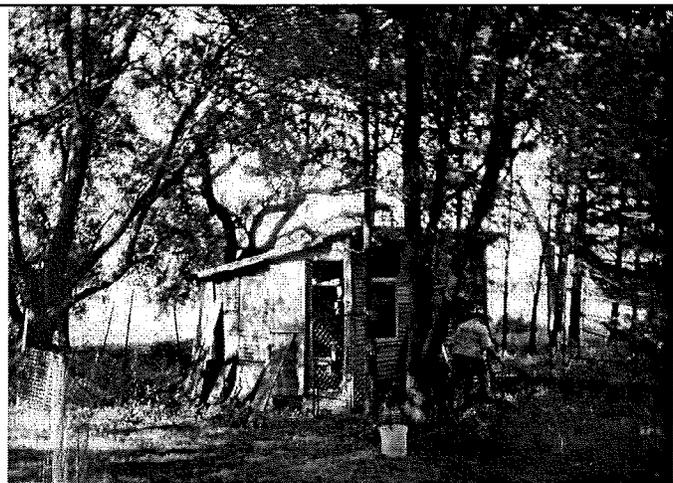
**Roll No./Neg.No.:** AA35

<b>Circa:</b> 1925	<b>Condition:</b> Poor	<b>Integrity:</b> Poor
-----------------------	---------------------------	---------------------------

<b>Materials:</b>	<b>HISTORY:</b>  Chicken coop
<b>Foundation:</b> Concrete	
<b>Walls:</b> Clapboard	
<b>Roof:</b> Asphalt shingle	
<b>Porch:</b>

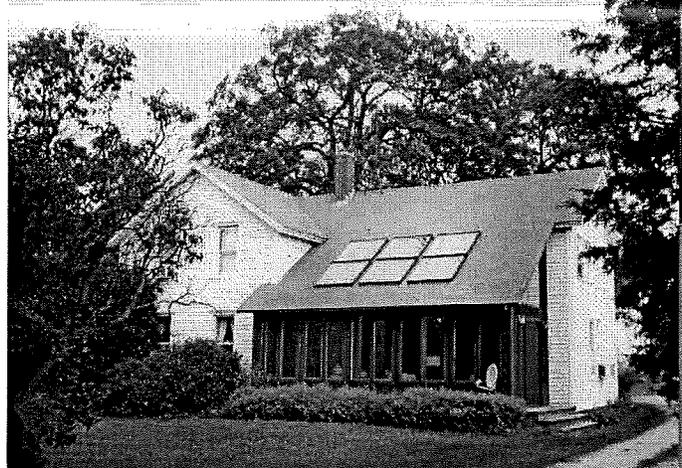
**Roll No./Neg.No.:** Z36

<b>Circa:</b> 1880 - 1910	<b>Condition:</b> Good	<b>Integrity:</b> Poor
------------------------------	---------------------------	---------------------------

<b>Materials:</b>	<b>HISTORY:</b>
<b>Foundation:</b> Stone <b>Walls:</b> Synthetic siding <b>Roof:</b> Asphalt shingle <b>Porch:</b>	Major addition: Front porch and rear hipped roof structure ( kitchen)          Previous site = 2576

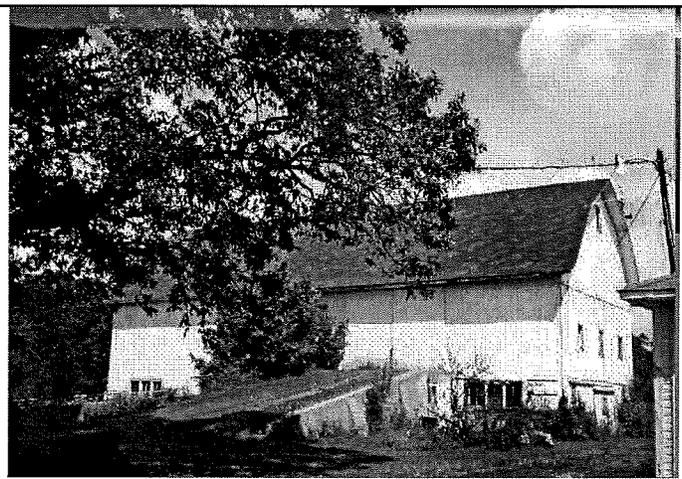
**Roll No./Neg.No.: Z29**

<b>Circa:</b> 1910-1930	<b>Condition:</b> Good	<b>Integrity:</b> Good
----------------------------	---------------------------	---------------------------

<b>Materials:</b>	<b>HISTORY:</b>  Ramped with a room below the ramp, sliding doors, transverse aisle, milkhouse in rear
<b>Foundation:</b> Poured	
<b>Walls:</b> Vertical	
<b>Roof:</b> Asphalt shingle	
<b>Porch:</b>

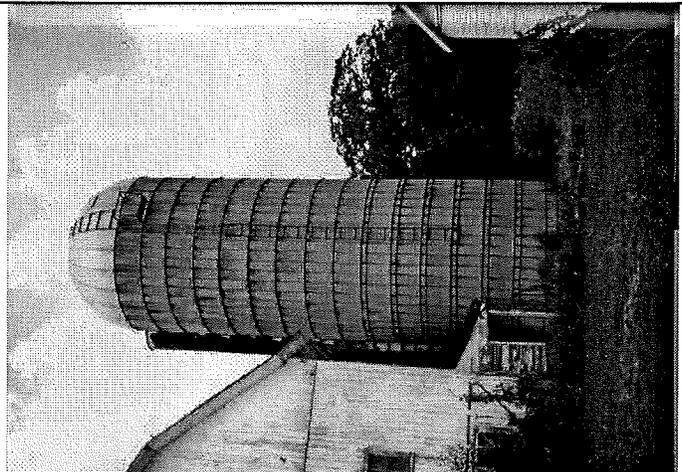
**Roll No./Neg.No.: Z30**

<b>Circa:</b> 1920 - 1930	<b>Condition:</b> Excellent	<b>Integrity:</b> Excellent
------------------------------	--------------------------------	--------------------------------

<b>Materials:</b>	<b>HISTORY:</b>  Ladder and viewing platform still attached.
<b>Foundation:</b> Concrete	
<b>Walls:</b> Staved concrete	
<b>Roof:</b> Metal dome	
<b>Porch:</b>

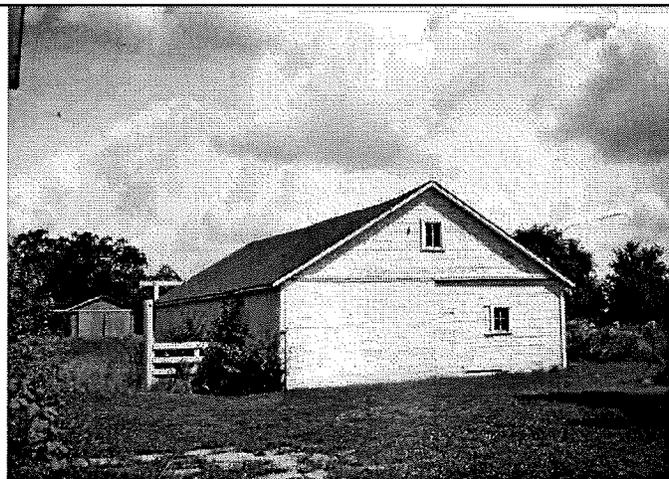
<b>Circa:</b> 1940	<b>Condition:</b> Good	<b>Integrity:</b> Good
-----------------------	---------------------------	---------------------------

<b>Materials:</b>	<b>HISTORY:</b>  Metal patch where sliding door used to be
<b>Foundation:</b> Concrete <b>Walls:</b> Clapboard <b>Roof:</b> Asphalt shingle <b>Porch:</b>

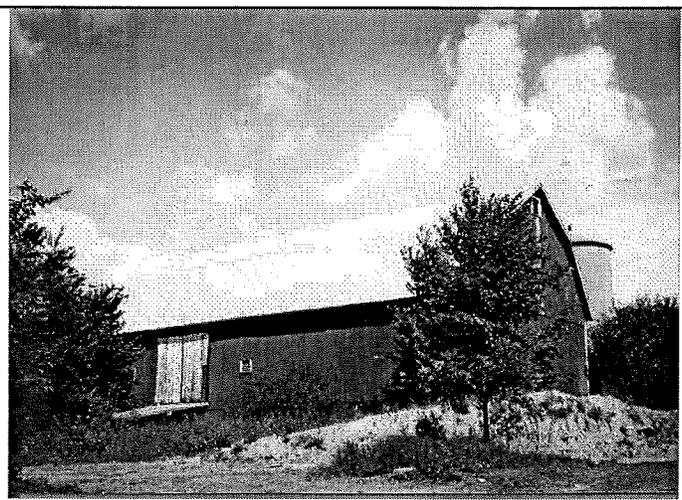
<b>Circa:</b> 1890-1910	<b>Condition:</b> Poor	<b>Integrity:</b> Good
----------------------------	---------------------------	---------------------------

<b>Materials:</b>	<b>HISTORY:</b>
<b>Foundation:</b> Stone <b>Walls:</b> Vertical plank <b>Roof:</b> Asphalt shingle <b>Porch:</b>	Ramped, concrete-not built up with land or a room underneath, but supported with concrete braces not used anymore and lower level is deteriorating

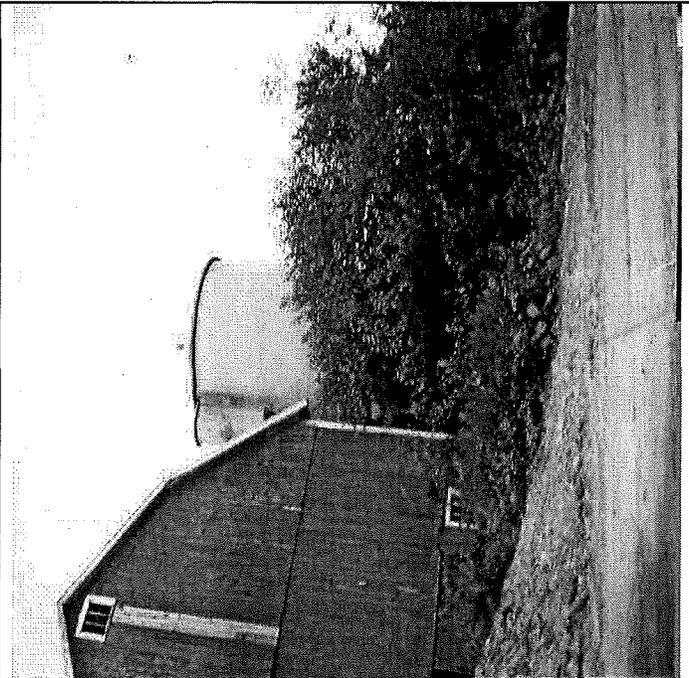
**Roll No./Neg.No.:** Z28

<b>Circa:</b> 1920	<b>Condition:</b> Good	<b>Integrity:</b> Excellent
-----------------------	---------------------------	--------------------------------

<b>Materials:</b>	<b>HISTORY:</b>
<b>Foundation:</b> Concrete <b>Walls:</b> <i>Poured</i> Concrete <b>Roof:</b> Concrete cone <b>Porch:</b>	Entire structure built of concrete with conical top

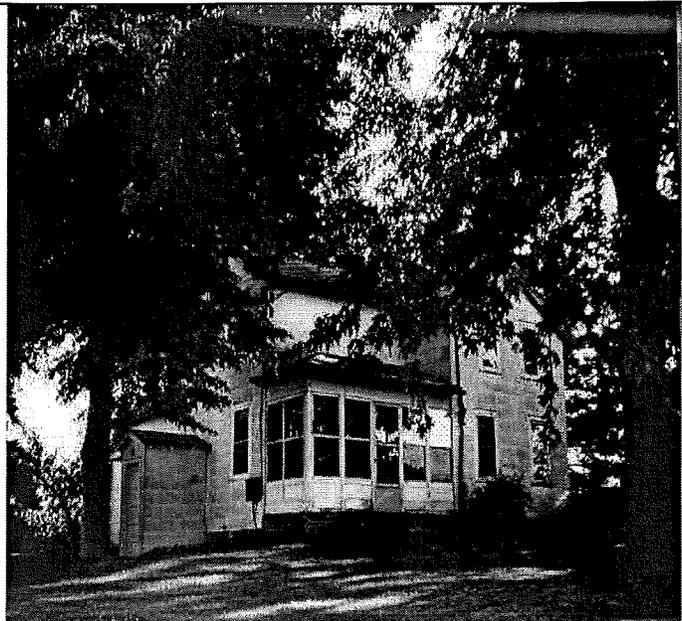
**Roll No./Neg.No.:** BB5

<b>Circa:</b> 1860-1880	<b>Condition:</b> Good	<b>Integrity:</b> Poor
----------------------------	---------------------------	---------------------------

<b>Materials:</b> <b>Foundation:</b> Stone Concrete (additions) <b>Walls:</b> Asbestos <b>Roof:</b> Asphalt shingle <b>Porch:</b> Front, screened	<b>HISTORY:</b>  Many alterations, rear gable addition  Previous site = 4711		
--	--	--	--

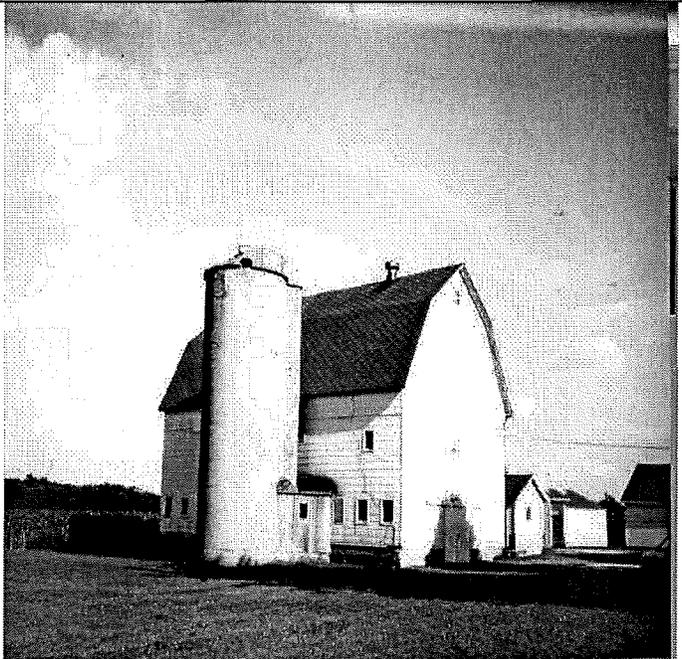
**Roll No./Neg.No.:** BB4      **Surveyed by:** KD      **Date:** 7-16-98

<b>Circa:</b> 1910-1945	<b>Condition:</b> Good	<b>Integrity:</b> Excellent
----------------------------	---------------------------	--------------------------------

<b>Materials:</b> <b>Foundation:</b> Concrete <b>Walls:</b> Asbestos <b>Roof:</b> Asphalt shingle <b>Porch:</b>	<b>HISTORY:</b>  Ramped, transverse aisle, double vented; according to resident built in 1926 or 1927
---	---

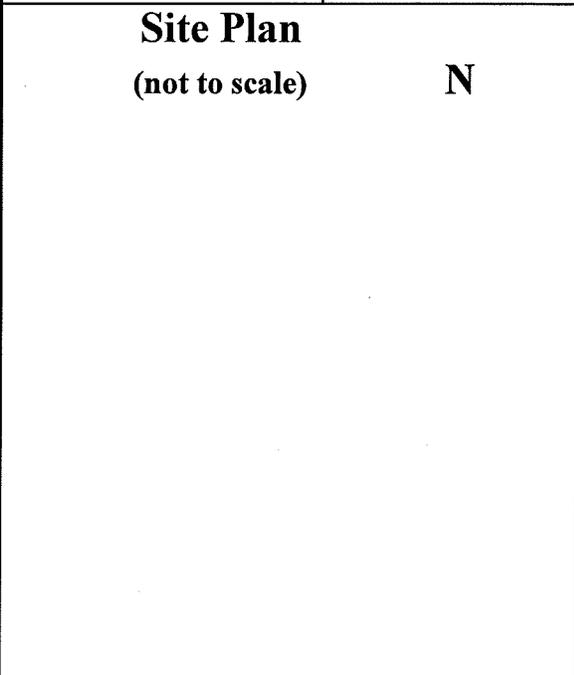
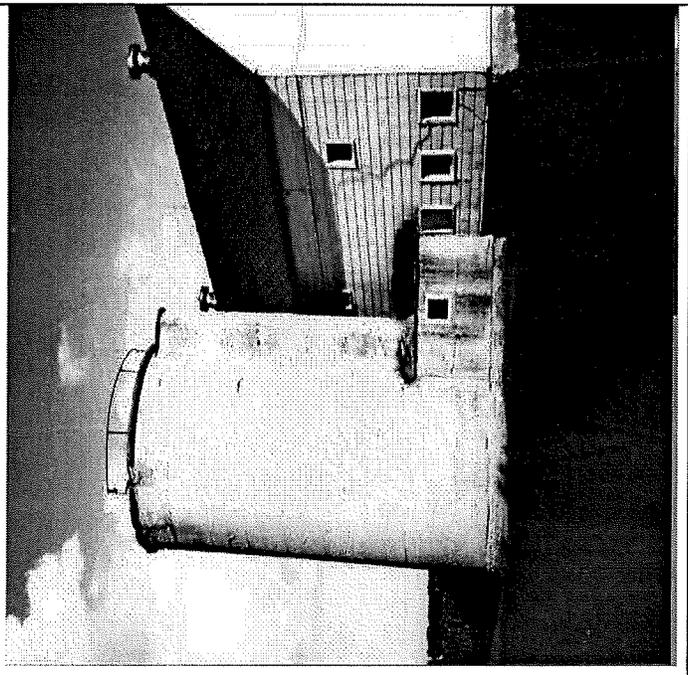
<b>Circa:</b> 1920	<b>Condition:</b> Poor	<b>Integrity:</b> Good
-----------------------	---------------------------	---------------------------

<b>Materials:</b> <b>Foundation:</b> Concrete <b>Walls:</b> Concrete, poured <b>Roof:</b> Concrete cone <b>Porch:</b>	<b>HISTORY:</b>  Located at side of barn, connection to barn has a window.
--	--

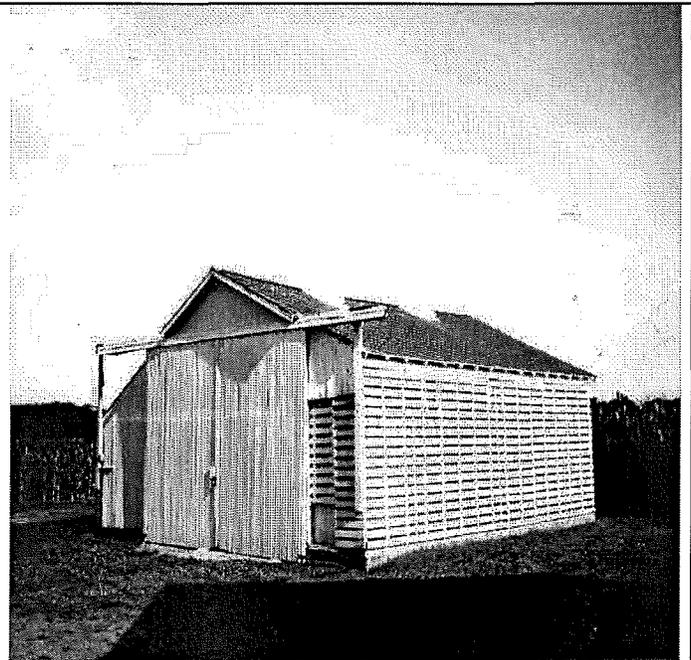
<b>Circa:</b> 1940	<b>Condition:</b> Good	<b>Integrity:</b> Poor
-----------------------	---------------------------	---------------------------

<b>Materials:</b> <b>Foundation:</b> Concrete <b>Walls:</b> Vertical plank <b>Roof:</b> Asphalt shingle <b>Porch:</b>	<b>HISTORY:</b>  Frame added to hold sliding doors; 2 vents
--	---

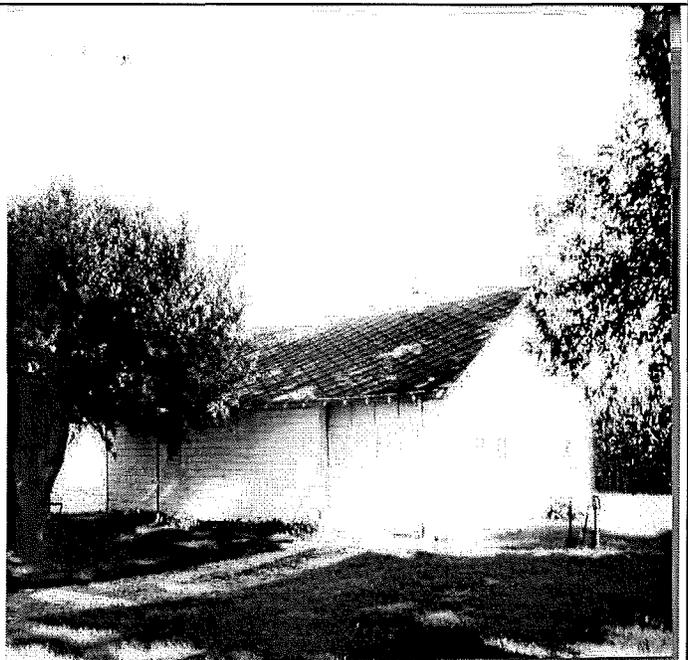
<b>Circa:</b> 1940	<b>Condition:</b> Good	<b>Integrity:</b> Good
-----------------------	---------------------------	---------------------------

<b>Materials:</b> <b>Foundation:</b> Concrete <b>Walls:</b> Clapboard <b>Roof:</b> Asphalt shingle <b>Porch:</b>	<b>HISTORY:</b>  Outbuilding converted to a garage. Up and over door, double vented
---	---

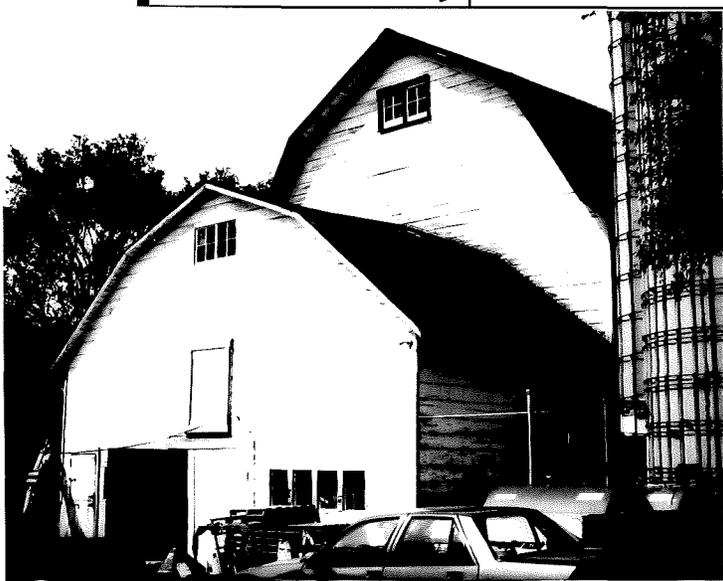
**Roll No./Neg.No.:** CC6 & CC10

<b>Materials:</b>	<b>HISTORY:</b>
<b>Foundation:</b> Stone <b>Walls:</b> Vertical plank <b>Roof:</b> Metal <b>Porch:</b>	Ramped with transverse aisle, smaller gambrel, addition in rear with clapboard          <i>← extra 1998 view →</i>

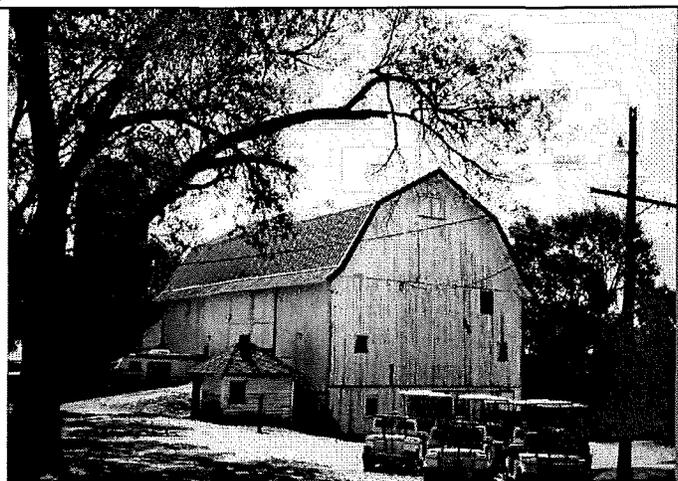
<b>Circa:</b> 1910-1945	<b>Condition:</b> Good	<b>Integrity:</b> Good
----------------------------	---------------------------	---------------------------

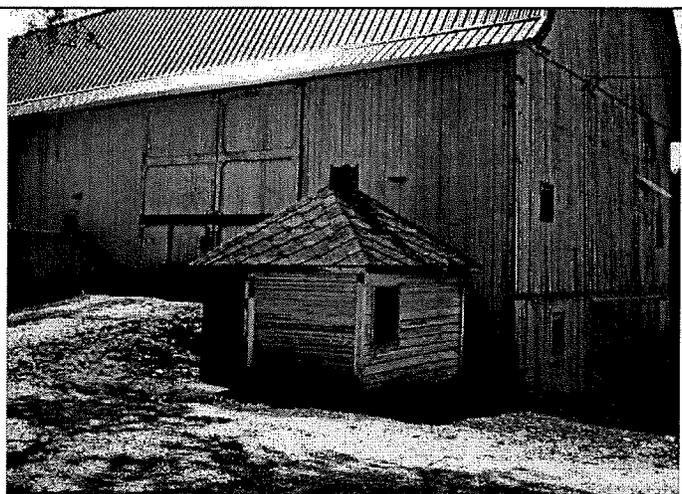
**Roll No./Neg.No.:** CC8

<b>Circa:</b> 1910 - 1930	<b>Condition:</b> Poor	<b>Integrity:</b> Poor
------------------------------	---------------------------	---------------------------

<b>Materials:</b>	<b>HISTORY:</b>
<b>Foundation:</b> Concrete <b>Walls:</b> Clapboard <b>Roof:</b> Asphalt shingle <b>Porch:</b>	Single vent, single pen, siding boards do not match <i>detached</i>

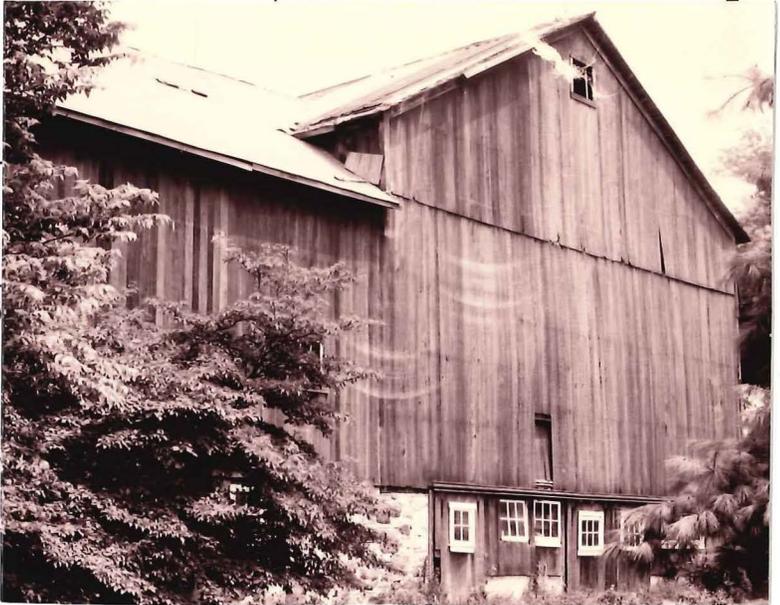
<b>Materials:</b>	<b>HISTORY:</b>
<b>Foundation:</b> Stone	Has zip zag cut pattern on siding where vertical plank overlaps Ramped plank overlaps Interesting wood designs on sliding doors has a porch on the side "Dutch Uncle" to protect grappling area Previous site = 2169
<b>Walls:</b> Vertical plank	
<b>Roof:</b> Wood shingles and batten metal	
<b>Porch:</b>

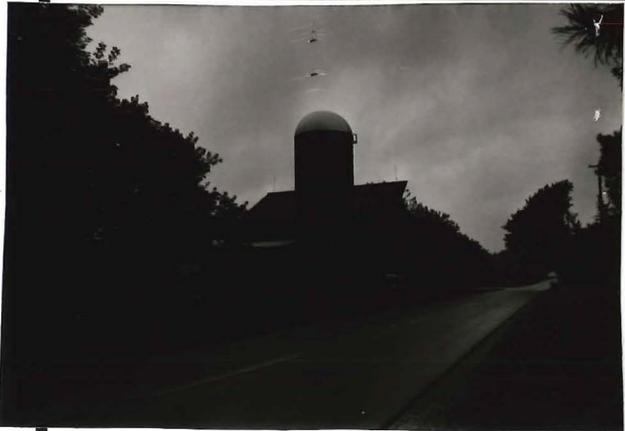
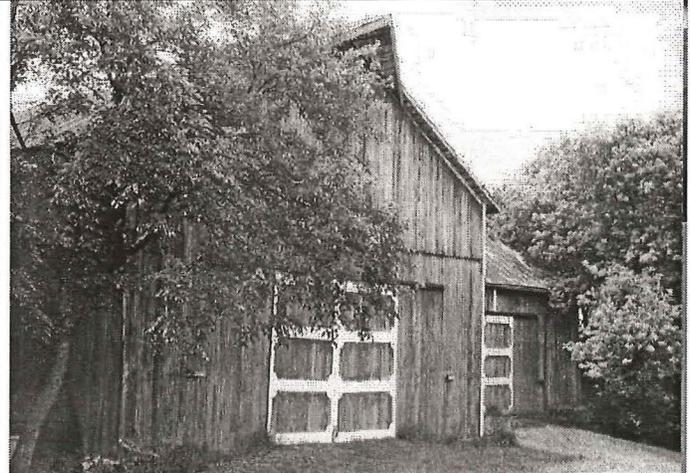
**Roll No./Neg.No.:** U6&U8

<b>Circa:</b> 1880-1920	<b>Condition:</b> Good
----------------------------	---------------------------

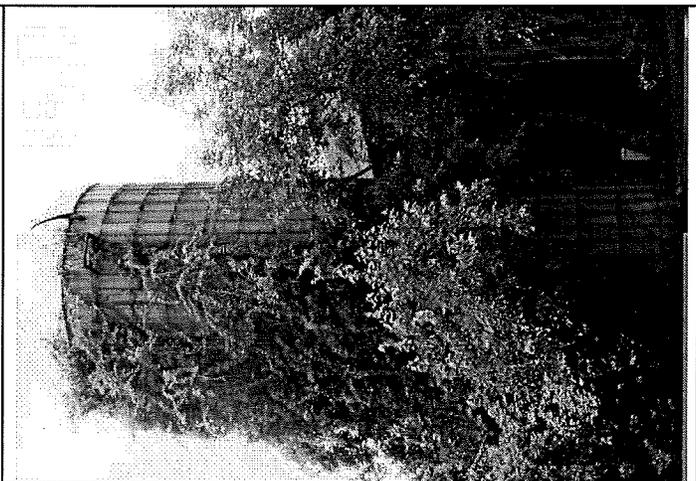
**Roll No./Neg.No.:** U5

<b>Circa:</b> 1920	<b>Condition:</b> Good	<b>Integrity:</b> Good
-----------------------	---------------------------	---------------------------

<b>Materials:</b>	<b>HISTORY:</b>  Obscured by trees
<b>Foundation:</b> Concrete	
<b>Walls:</b> Staved concrete	
<b>Roof:</b> Metal dome	
<b>Porch:</b>

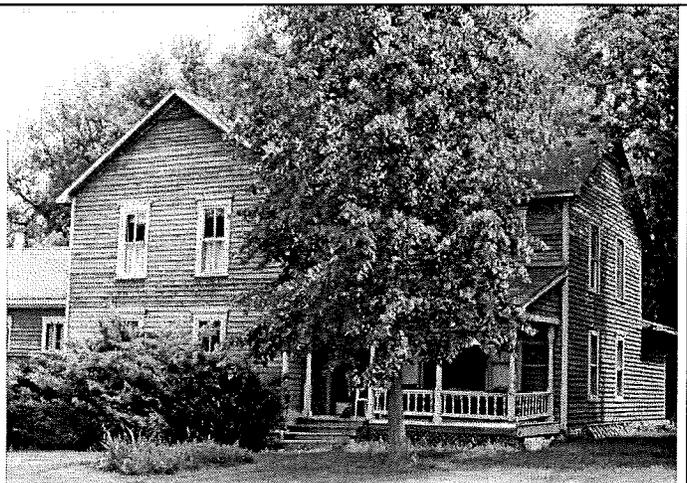
**Roll No./Neg.No.:** U7

<b>Circa:</b> 1870 - 1890	<b>Condition:</b> Poor	<b>Integrity:</b> Good
------------------------------	---------------------------	---------------------------

<b>Materials:</b>	<b>HISTORY:</b>  Residence is on some parcel, but driveway is off of Springbrook Rd  House has been moved from Barrington and reassembled in this location
<b>Foundation:</b> Concrete	
<b>Walls:</b> Clapboard	
<b>Roof:</b> Asphalt shingle	
<b>Porch:</b> Front covered

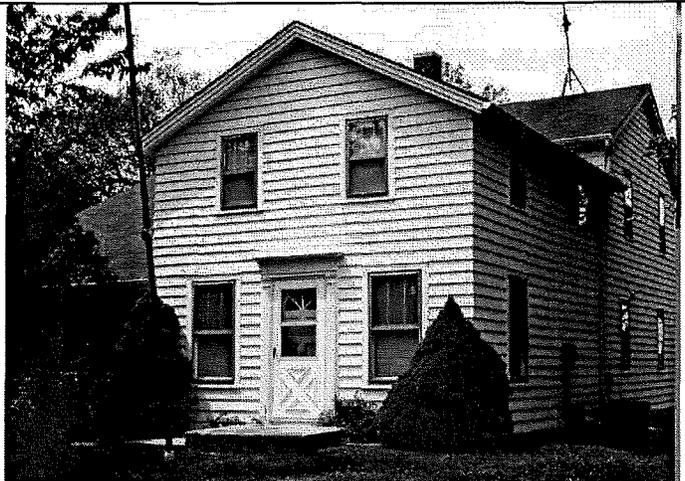
**Roll No./Neg.No.:** T34

<b>Circa:</b> 1910 - 1930	<b>Condition:</b> Excellent	<b>Integrity:</b> Poor
------------------------------	--------------------------------	---------------------------

<b>Materials:</b>	<b>HISTORY:</b>
<b>Foundation:</b> Stone and poured addition	Decorative columns on door
<b>Walls:</b> <i>Alum. siding</i>	2 chimneys one in center and one on end is made of stone
<b>Roof:</b> Asphalt shingle	
<b>Porch:</b> Enclosed side porch	Previous survey-2172

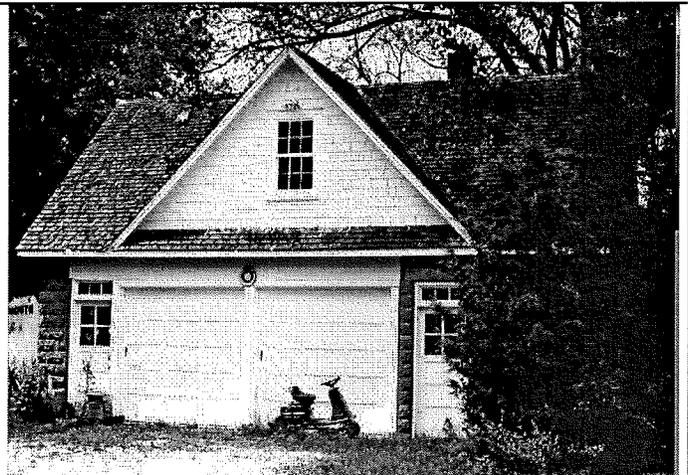
**Roll No./Neg.No.:** T34

<b>Circa:</b> 1910 - 1930	<b>Condition:</b> Good	<b>Integrity:</b> Good
------------------------------	---------------------------	---------------------------

<b>Materials:</b>	<b>HISTORY:</b>
<b>Foundation:</b> Stone and poured concrete	Lintel says "1929 Kleinrath"
<b>Walls:</b> Molded Block and wood shingles	Brick chimney 2 car garage
<b>Roof:</b> Wood shingle	Previous survey-2172
<b>Porch:</b>

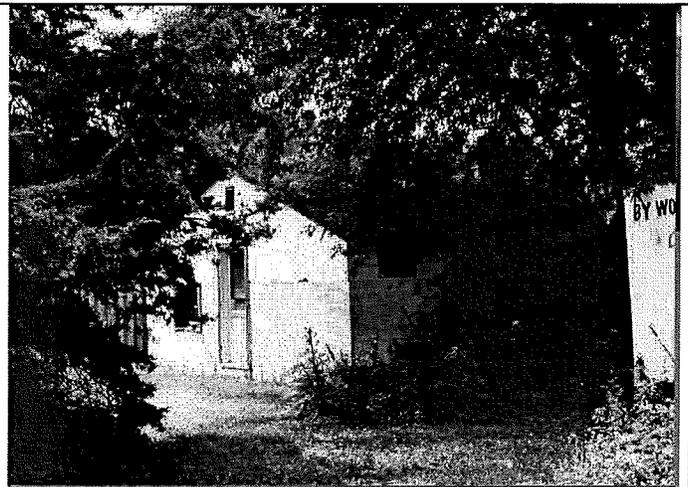
**Roll No./Neg.No.:** T36

<b>Circa:</b> 1920	<b>Condition:</b> Poor	<b>Integrity:</b> Good
-----------------------	---------------------------	---------------------------

<b>Materials:</b>	<b>HISTORY:</b>  Small rectangular windows along the length of building
<b>Foundation:</b> Concrete	
<b>Walls:</b> Concrete block and asbestos siding	
<b>Roof:</b> Asphalt shingle	
<b>Porch:</b> Enclosed side porch
