McHenry County

Rural Survey

***Nunda Township***

***FIELD DATA SHEETS***

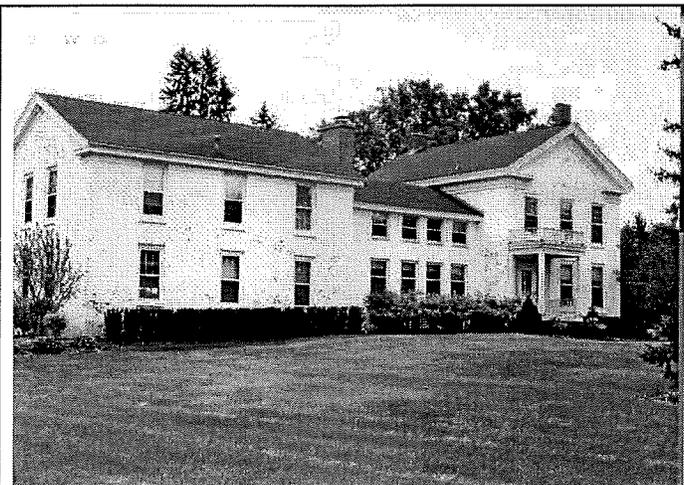
**Roll No./Neg.No.:** U1

<b>Circa:</b> 1837	<b>Condition:</b> Good	<b>Integrity:</b> Excellent
-----------------------	---------------------------	--------------------------------

<b>Materials:</b>	<b>HISTORY:</b>
<b>Foundation:</b> Stone	Previous survey says house dates from 1837
<b>Walls:</b> Brick	Owner of residence is the developer for surrounding subdivision
<b>Roof:</b> Asphalt shingle	In very good condition
<b>Porch:</b> Rear enclosed	Some alterations to middle section (new windows)
	Used to belong to the Holcomb family buried in close cemetery
	Previous site = 2170

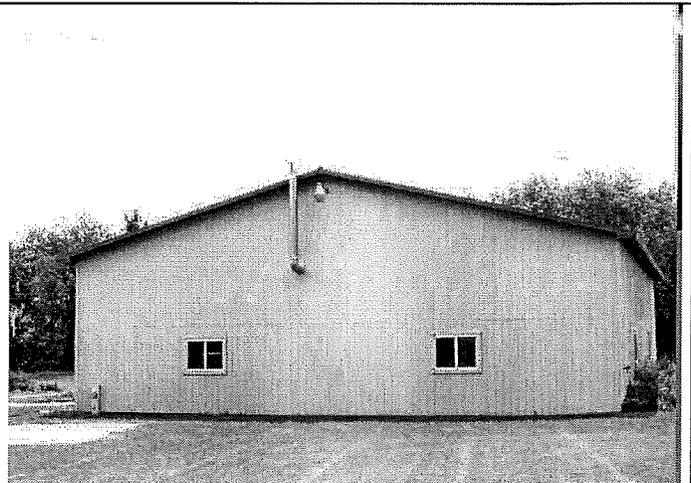
**Roll No./Neg.No.:** U2

<b>Circa:</b> Post 1945	<b>Condition:</b> Excellent	<b>Integrity:</b> Excellent
----------------------------	--------------------------------	--------------------------------

<b>Materials:</b>	<b>HISTORY:</b>  Machine Shed
<b>Foundation:</b> Concrete	
<b>Walls:</b> Vertical press board	
<b>Roof:</b> Metal	
<b>Porch:</b>

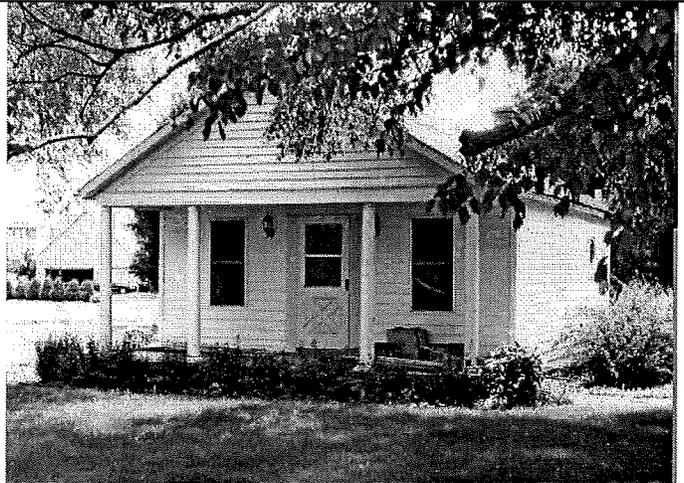
**Roll No./Neg.No.:** U3

<b>Circa:</b> 1930	<b>Condition:</b> Good	<b>Integrity:</b> Good
-----------------------	---------------------------	---------------------------

<b>Materials:</b>	<b>HISTORY:</b>
<b>Foundation:</b> Concrete block	Columns on front porch
<b>Walls:</b> Clapboard	Maybe originally servants quarters, single room
<b>Roof:</b>	
<b>Porch:</b> Front recessed

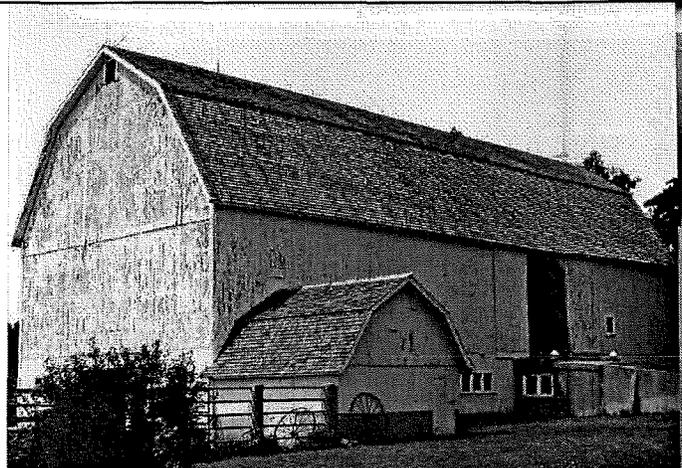
**Roll No./Neg.No.:** T20

<b>Circa:</b> 1910-1940	<b>Condition:</b> Good	<b>Integrity:</b> Good
----------------------------	---------------------------	---------------------------

<b>Materials:</b>	<b>HISTORY:</b>
<b>Foundation:</b> Stone	Ramped with room underneath ramp (2 vents on the ramp for this room)
<b>Walls:</b> Vertical plank	Transverse aisle
<b>Roof:</b> Wood shingles	Milk house w/gambrel roof, not as common
<b>Porch:</b>	
	Previous site = 2174

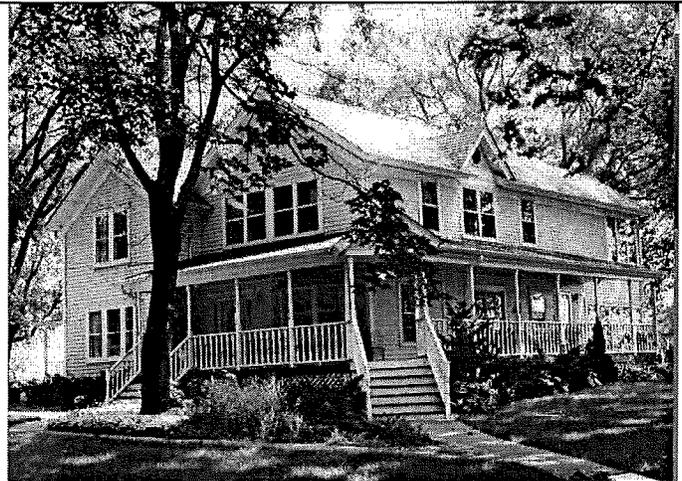
<b>Circa:</b> 1870-1900	<b>Condition:</b> Excellent	<b>Integrity:</b> Poor
----------------------------	--------------------------------	---------------------------

<b>Materials:</b>	<b>HISTORY:</b>
<b>Foundation:</b> Poured	Very large, unclear which are additions
<b>Walls:</b> Clapboard	New decorative columns at corners
<b>Roof:</b> Asphalt shingle	Moldings (stripe) along roof line
<b>Porch:</b> Wrap-around

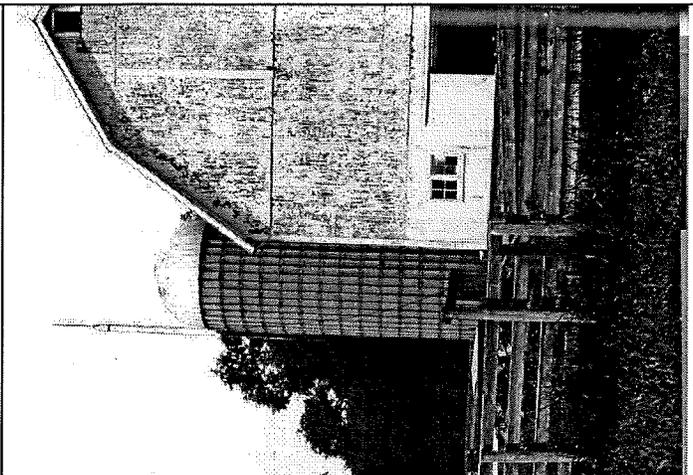
**Roll No./Neg.No.:** T23

<b>Circa:</b> 1920	<b>Condition:</b> Good	<b>Integrity:</b> Good
-----------------------	---------------------------	---------------------------

<b>Materials:</b>	<b>HISTORY:</b>
<b>Foundation:</b> Concrete	
<b>Walls:</b> Staved concrete	
<b>Roof:</b> Metal dome	
<b>Porch:</b>

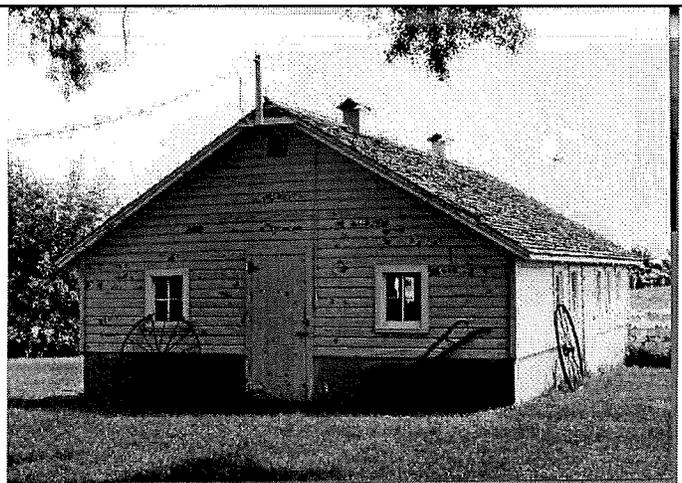
**Roll No./Neg.No.:** T21

<b>Circa:</b> 1940	<b>Condition:</b> Good	<b>Integrity:</b> Excellent
-----------------------	---------------------------	--------------------------------

<b>Materials:</b>	<b>HISTORY:</b>
<b>Foundation:</b> Concrete	
<b>Walls:</b> Clapboard	
<b>Roof:</b> Wood shingle	
<b>Porch:</b>

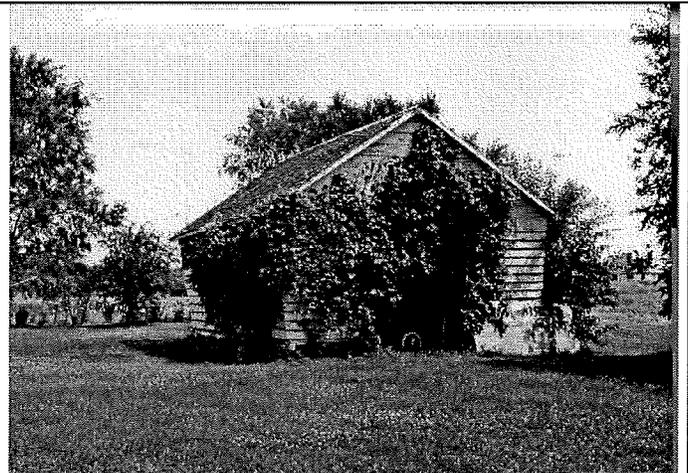
<b>Circa:</b> 1920	<b>Condition:</b> Good	<b>Integrity:</b> Good
-----------------------	---------------------------	---------------------------

<b>Materials:</b>	<b>HISTORY:</b>
<b>Foundation:</b> Concrete blocks	Covered in ivy
<b>Walls:</b> Open slats	Large central aisle
<b>Roof:</b> Wood shingle	
<b>Porch:</b>

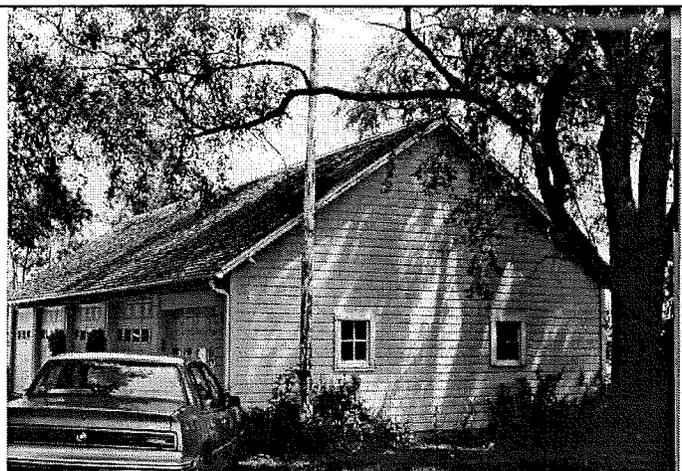
**Roll No./Neg.No.:** T24

<b>Circa:</b> Post 1945	<b>Condition:</b> Good	<b>Integrity:</b> Good
----------------------------	---------------------------	---------------------------

<b>Materials:</b>	<b>HISTORY:</b>
<b>Foundation:</b> Concrete	
<b>Walls:</b> Clapboard	
<b>Roof:</b> Wood shingle	
<b>Porch:</b>

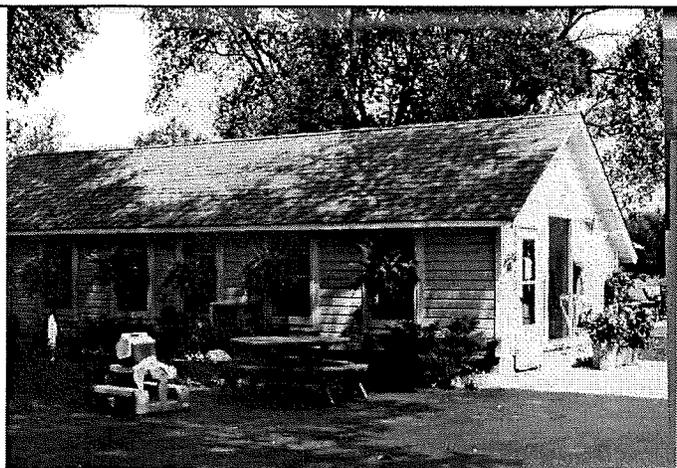
**Roll No./Neg.No.:** T25

<b>Circa:</b> Post 1945	<b>Condition:</b> Excellent	<b>Integrity:</b> Excellent
----------------------------	--------------------------------	--------------------------------

<b>Materials:</b>	<b>HISTORY:</b>  Used as a pool house  New windows, has been converted quite a bit
<b>Foundation:</b> Concrete	
<b>Walls:</b> Clapboard	
<b>Roof:</b> Asphalt shingle	
<b>Porch:</b>

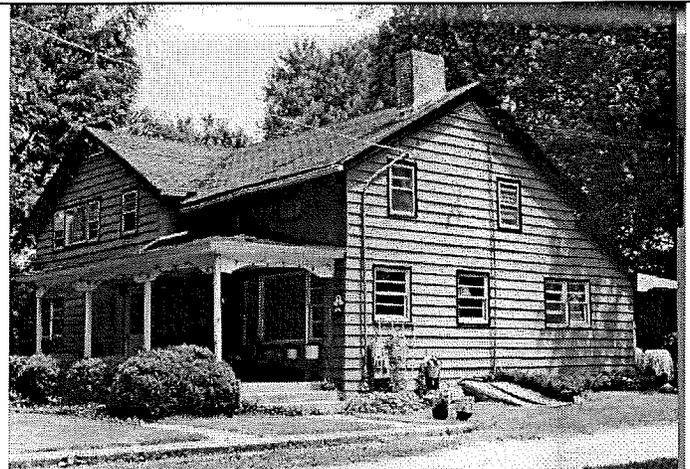
**Roll No./Neg.No.:** T27

<b>Circa:</b> 1870 - 1890	<b>Condition:</b> Good	<b>Integrity:</b> Poor
------------------------------	---------------------------	---------------------------

<b>Materials:</b>	<b>HISTORY:</b>
<b>Foundation:</b> Stone	Cellar outside entrance
<b>Walls:</b> Clapboard	Addition in rear has concrete foundation
<b>Roof:</b> Asphalt shingle	Contains two residences in same building
<b>Porch:</b> Front, covered	Previous site = 2176

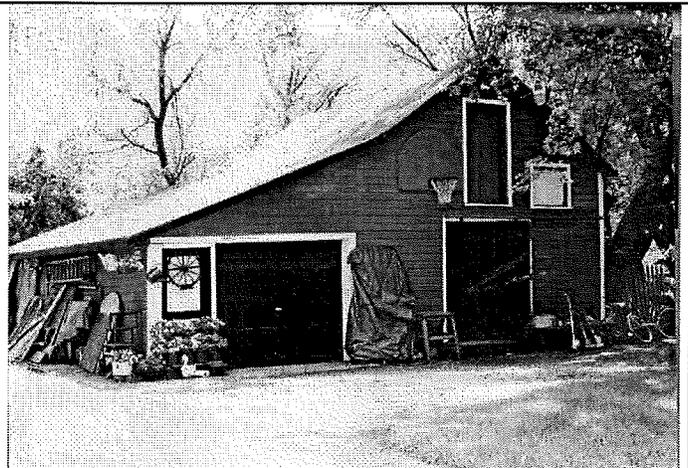
**Roll No./Neg.No.:** T28

<b>Circa:</b> 1900-1930	<b>Condition:</b> Good	<b>Integrity:</b> Good
----------------------------	---------------------------	---------------------------

<b>Materials:</b>	<b>HISTORY:</b>  Used as garage
<b>Foundation:</b> Concrete	
<b>Walls:</b> Beveled clapboard	
<b>Roof:</b> Asphalt shingle	
<b>Porch:</b>

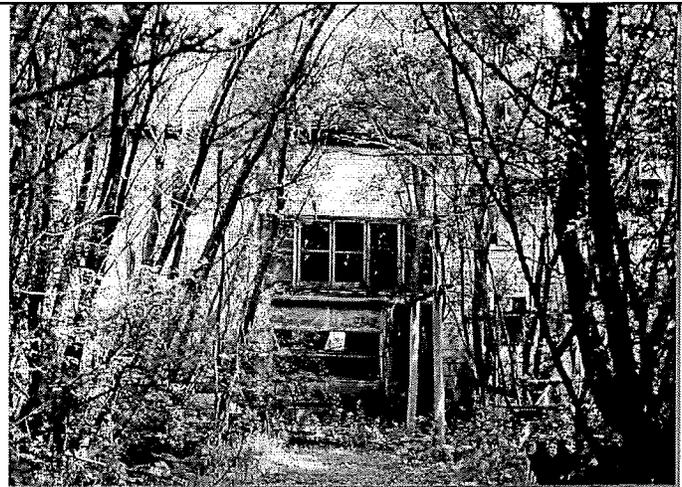
**Roll No./Neg.No.:** T29      **Surveyed by:** LM&KD      **Date:** 7-7-98

<b>Circa:</b> 1910 -1920	<b>Condition:</b> Poor	<b>Integrity:</b> Poor
-----------------------------	---------------------------	---------------------------

<b>Materials:</b>	<b>HISTORY:</b>
<b>Foundation:</b> Stone	Heavy over growth, abandoned, in very bad shape
<b>Walls:</b> Asbestos and batten vertical plank	
<b>Roof:</b>	
<b>Porch:</b>

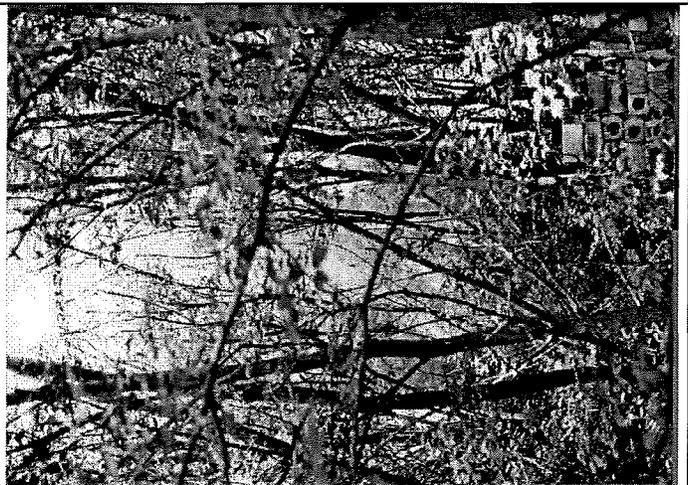
**Roll No./Neg.No.:** T30      **Surveyed by:** LM&KD      **Date:** 7-2-98

<b>Circa:</b> 1920	<b>Condition:</b> Poor	<b>Integrity:</b> Poor
-----------------------	---------------------------	---------------------------

<b>Materials:</b>	<b>HISTORY:</b>
<b>Foundation:</b> Concrete <b>Walls:</b> <i>Poured</i> Concrete <b>Roof:</b> Concrete cone <b>Porch:</b>	Too much overgrowth to see structure

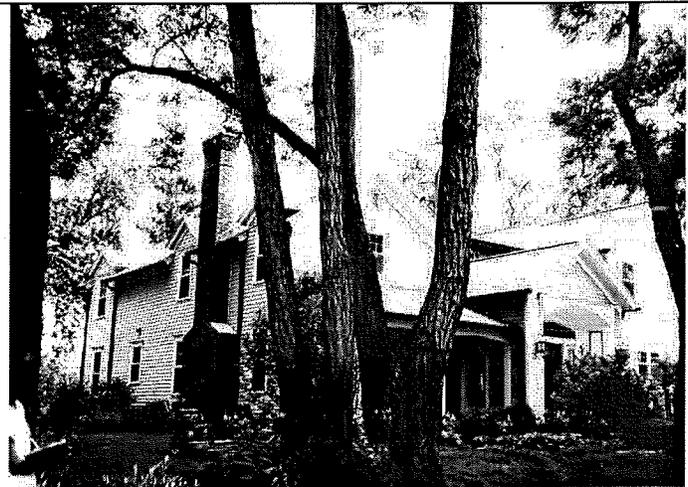
<b>Circa:</b> 1860-1910	<b>Condition:</b> Excellent	<b>Integrity:</b> Poor
----------------------------	--------------------------------	---------------------------

<b>Materials:</b>	<b>HISTORY:</b>
<b>Foundation:</b> Stone	Impossible to tell which part is original
<b>Walls:</b> Clap board	Major additions connect main part of house
<b>Roof:</b> Asphalt shingle	Greek revival brick building.
<b>Porch:</b>	
	Previous site = 2164

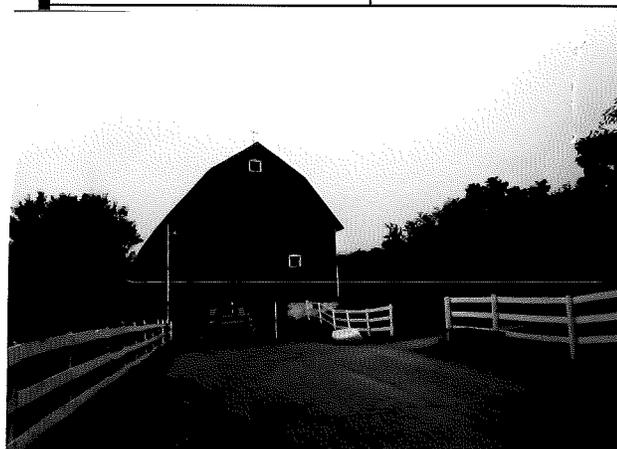
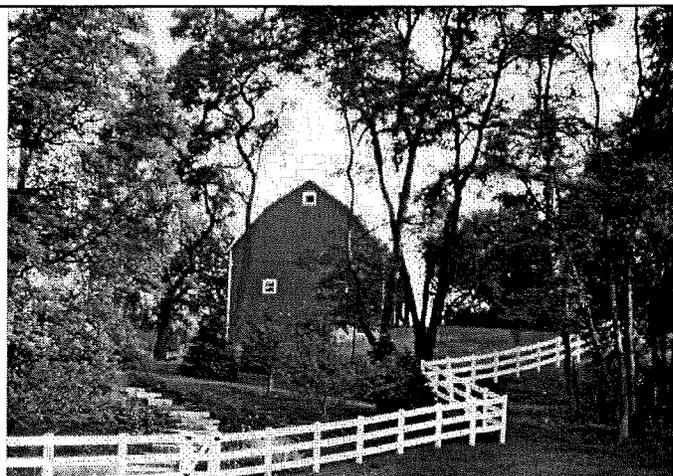
**Roll No./Neg.No.:** SS19

<b>Circa:</b> 1890-1910	<b>Condition:</b> Excellent	<b>Integrity:</b> Excellent
----------------------------	--------------------------------	--------------------------------

<b>Materials:</b>	<b>HISTORY:</b>
<b>Foundation:</b> Stone <b>Walls:</b> Vertical plank <b>Roof:</b> Asphalt shingle <b>Porch:</b>	Square nails used, ramped with transverse aisle, 2 silos have been knocked down, banked

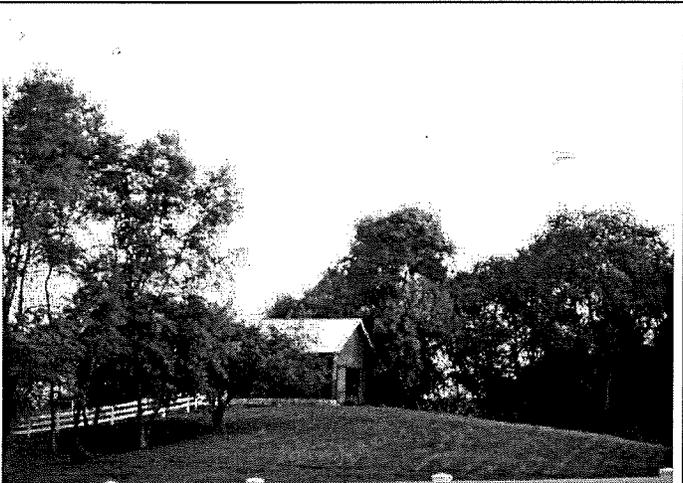
<b>Circa:</b> 1900	<b>Condition:</b> Good	<b>Integrity:</b> Excellent
-----------------------	---------------------------	--------------------------------

<b>Materials:</b>	<b>HISTORY:</b>
<b>Foundation:</b> Stone	
<b>Walls:</b> Vertical plank	
<b>Roof:</b> Metal	
<b>Porch:</b>

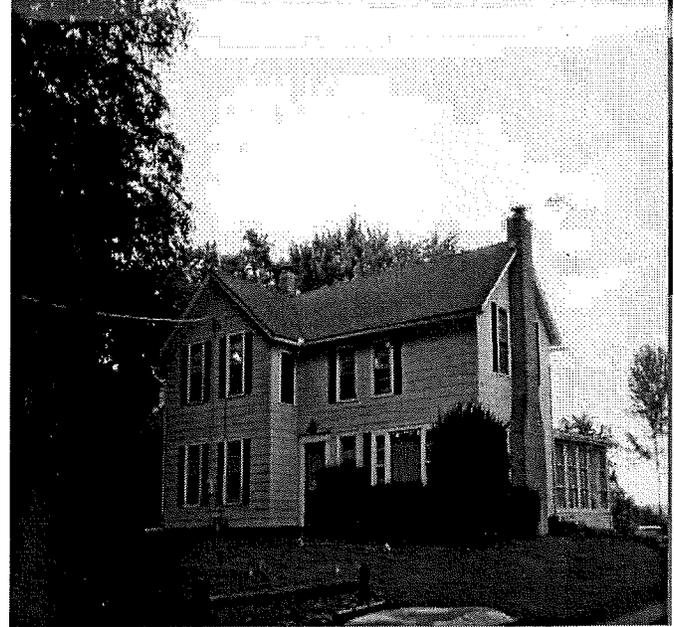
**Roll No./Neg.No.:** Z13

<b>Circa:</b> 1860 - 1880	<b>Condition:</b> Excellent	<b>Integrity:</b> Poor
------------------------------	--------------------------------	---------------------------

<b>Materials:</b>	<b>HISTORY:</b>
<b>Foundation:</b> Stone <b>Walls:</b> Asbestos <b>Roof:</b> Asphalt shingle <b>Porch:</b> Removed	2 brick chimneys, additions on side and rear, single story,          Previous site = 2165

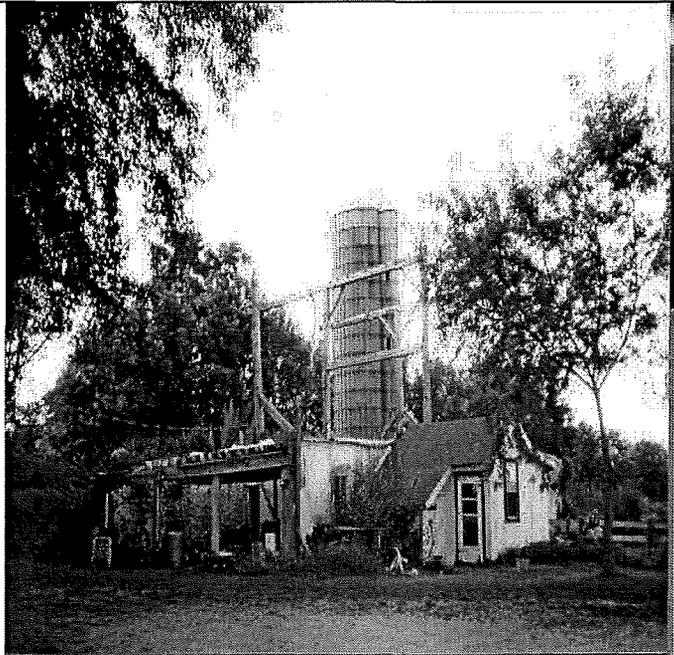
<b>Circa:</b> 1910-1945	<b>Condition:</b> Poor	<b>Integrity:</b> Poor
----------------------------	---------------------------	---------------------------

<b>Materials:</b>	<b>HISTORY:</b>  Only foundation, milk house, and some support beams remain
<b>Foundation:</b> Stone	
<b>Walls:</b> Vertical plank	
<b>Roof:</b> Asphalt shingle	
<b>Porch:</b>

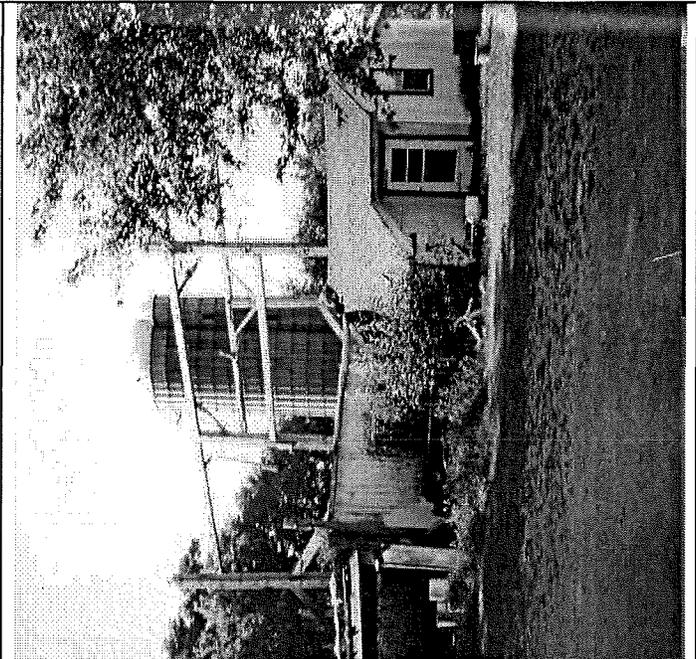
<b>Circa:</b> 1920	<b>Condition:</b> Good	<b>Integrity:</b> Good
-----------------------	---------------------------	---------------------------

<b>Materials:</b>	<b>HISTORY:</b>
<b>Foundation:</b> Concrete  <b>Walls:</b> Staved concrete <b>Roof:</b> Metal dome  <b>Porch:</b>	No remarkable features; probably next to be torn down.          <div style="text-align: right; font-style: italic;">↙ Note: Photo elongated ↘</div>

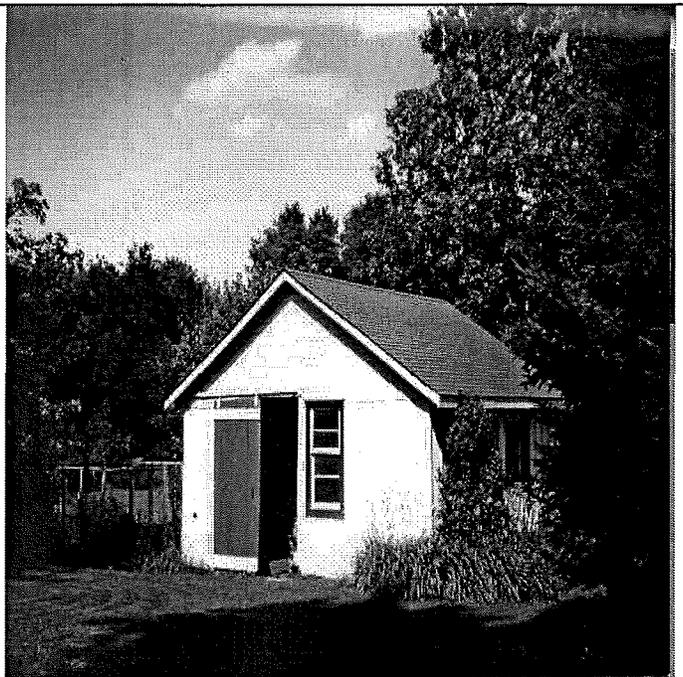
<b>Circa:</b> 1920	<b>Condition:</b> Good	<b>Integrity:</b> Good
-----------------------	---------------------------	---------------------------

<b>Materials:</b>  <b>Foundation:</b> Concrete  <b>Walls:</b> Batten vertical plank <b>Roof:</b> Asphalt shingle  <b>Porch:</b>	<b>HISTORY:</b> Sliding door on front, 2 side windows
---	--

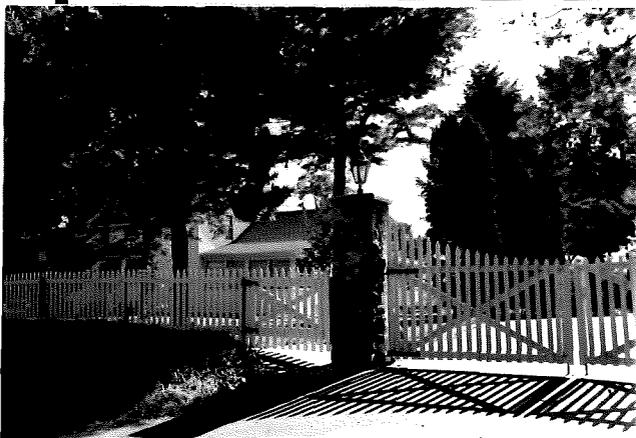
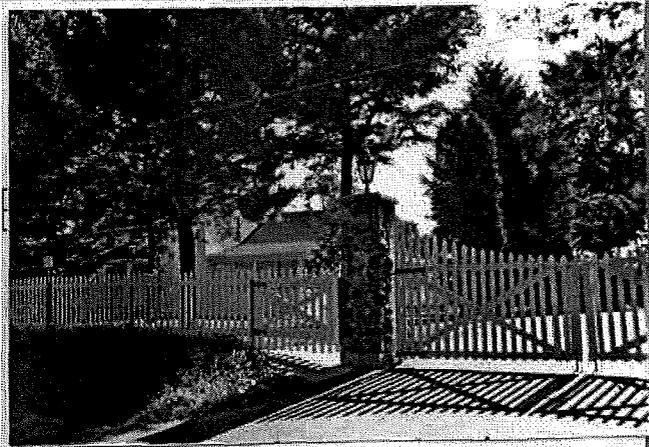
<b>Circa:</b> 1860	<b>Condition:</b> Good	<b>Integrity:</b> Good
-----------------------	---------------------------	---------------------------

<b>Materials:</b>	<b>HISTORY:</b>
<b>Foundation:</b> Stone and concrete	Resident claims house is at least 130 years old, house was moved from original site on same parcel, original part was 2 story (4 rooms), side gable
<b>Walls:</b> Metal siding	
<b>Roof:</b> Asphalt shingle	
<b>Porch:</b>	
	Previous site = 1391

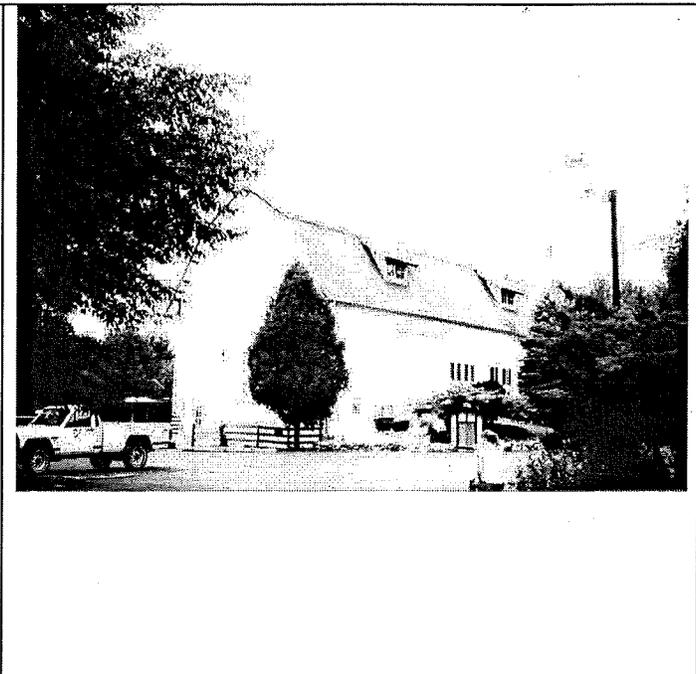
<b>Circa:</b> 1930	<b>Condition:</b> Excellent	<b>Integrity:</b> Good
-----------------------	--------------------------------	---------------------------

<b>Materials:</b>	<b>HISTORY:</b>
<b>Foundation:</b> Concrete <b>Walls:</b> Metal <b>Roof:</b> Asphalt shingle <b>Porch:</b>	2 dormer windows, ramped, transverse aisle, major alterations, has an apartment on the inside

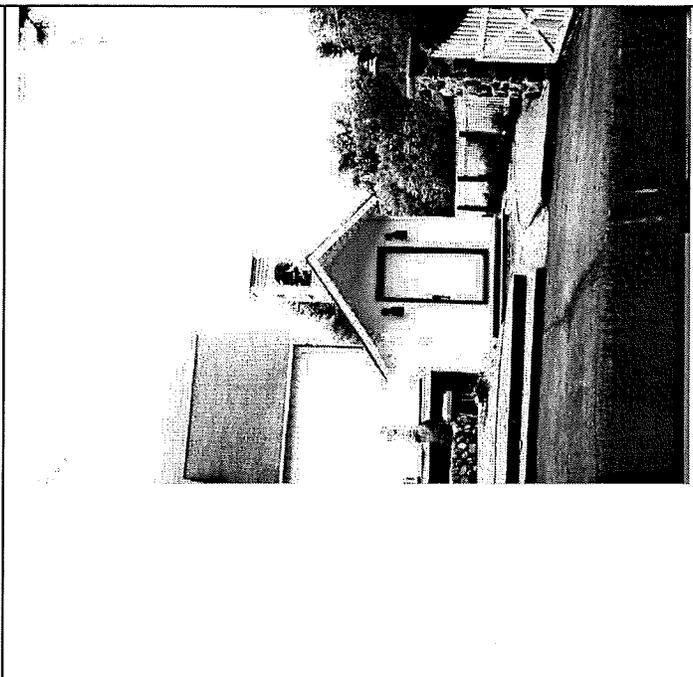
**Roll No./Neg.No.:** CC31

<b>Circa:</b> 1930	<b>Condition:</b> Excellent	<b>Integrity:</b> Poor
-----------------------	--------------------------------	---------------------------

<b>Materials:</b>	<b>HISTORY:</b>  Turned into a chapel with cupola and bell, has an extended peak roof
<b>Foundation:</b> Concrete	
<b>Walls:</b> Metal	
<b>Roof:</b> Asphalt shingle	
<b>Porch:</b>

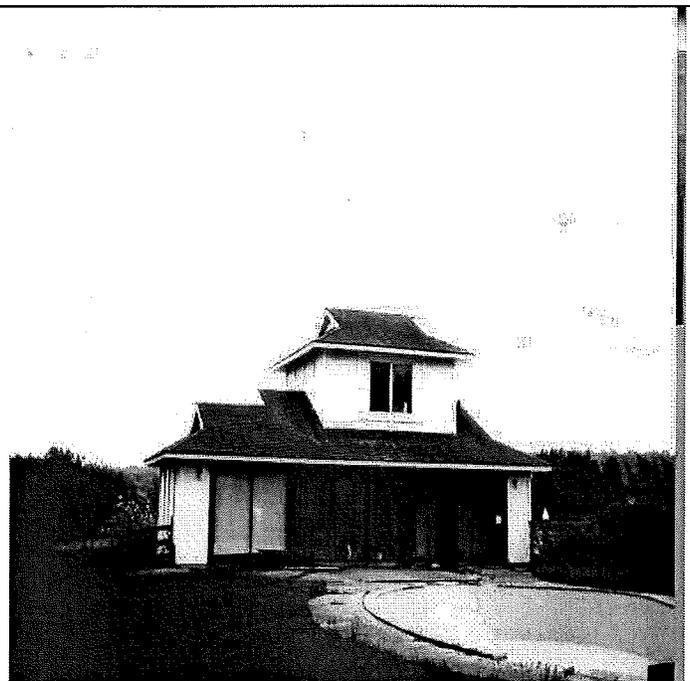
<b>Circa:</b> Post 1945	<b>Condition:</b> Good	<b>Integrity:</b> Poor
----------------------------	---------------------------	---------------------------

<b>Materials:</b>	<b>HISTORY:</b>  In front of kidney-bean shaped pool, gabled and hipped roofs
<b>Foundation:</b> Concrete	
<b>Walls:</b> Plywood	
<b>Roof:</b> Asphalt shingle	
<b>Porch:</b>

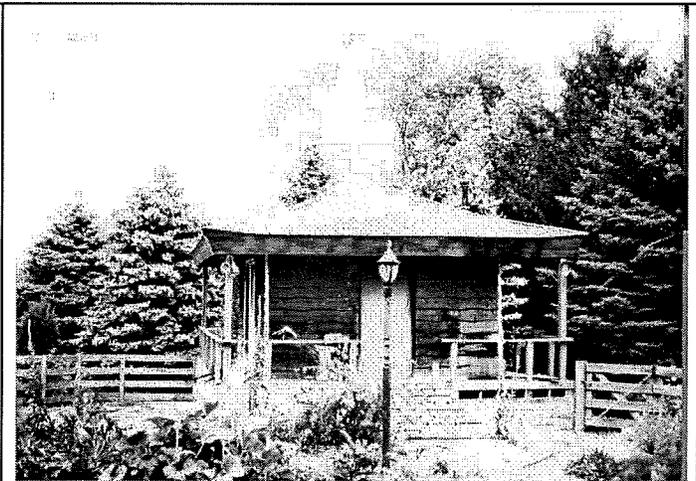
<b>Circa:</b> Post 1945	<b>Condition:</b> Good	<b>Integrity:</b> <i>Good</i>
----------------------------	---------------------------	----------------------------------

<b>Materials:</b>	<b>HISTORY:</b>  Pagoda- style roof, in garden setting.
<b>Foundation:</b> On stilts	
<b>Walls:</b> Split boards	
<b>Roof:</b> Asphalt shingle	
<b>Porch:</b>

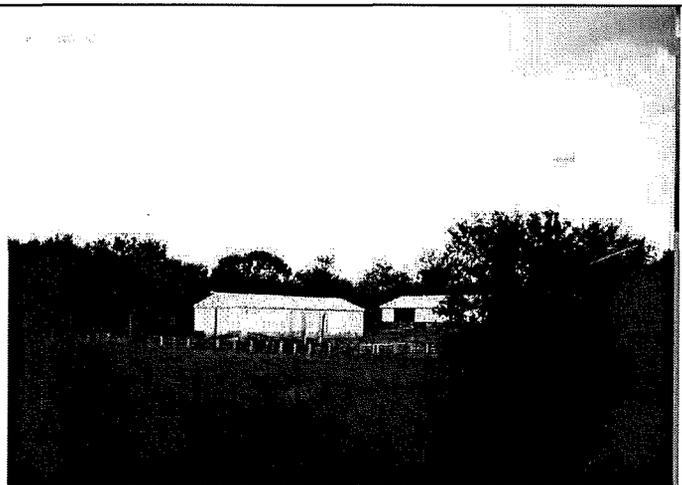
<b>Circa:</b> 1940	<b>Condition:</b> Good	<b>Integrity:</b> Good
-----------------------	---------------------------	---------------------------

<b>Materials:</b>	<b>HISTORY:</b>  "Kuna" Farm
<b>Foundation:</b> Unknown	
<b>Walls:</b> Vertical plank	
<b>Roof:</b> Metal	
<b>Porch:</b>

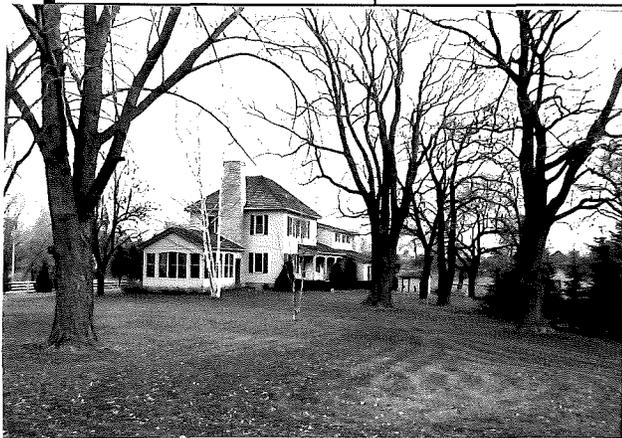
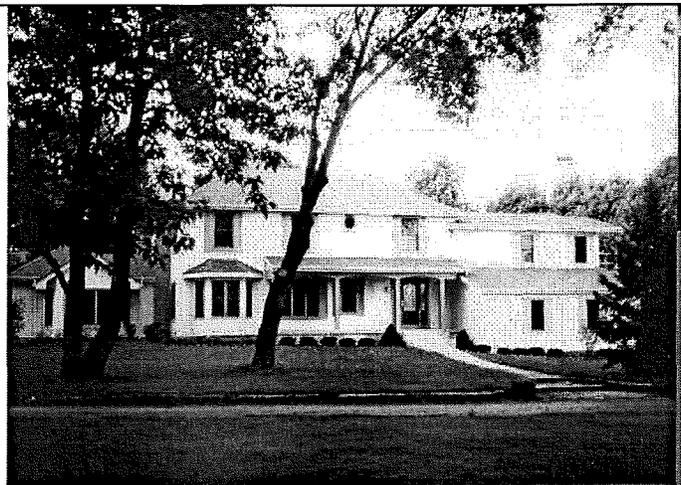
**Roll No./Neg.No.:** SS15

<b>Circa:</b> 1860-1890	<b>Condition:</b> Excellent	<b>Integrity:</b> Good
----------------------------	--------------------------------	---------------------------

<b>Materials:</b>	<b>HISTORY:</b>
<b>Foundation:</b> Concrete	2-story structure presently unoccupied.  Sign reads "Twin Brooks Farm."  Previous site = 4695
<b>Walls:</b> Metal siding	
<b>Roof:</b> Asphalt shingle	
<b>Porch:</b>

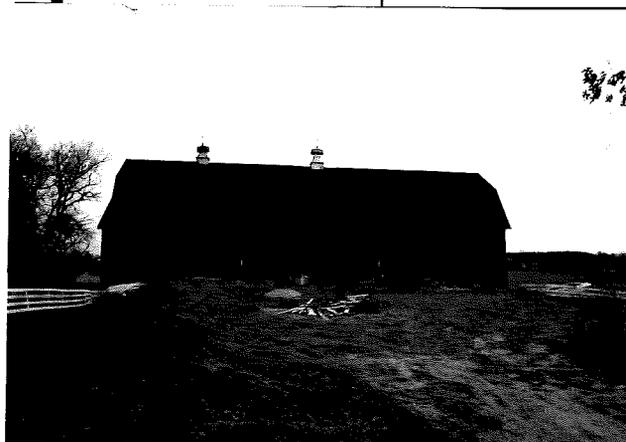
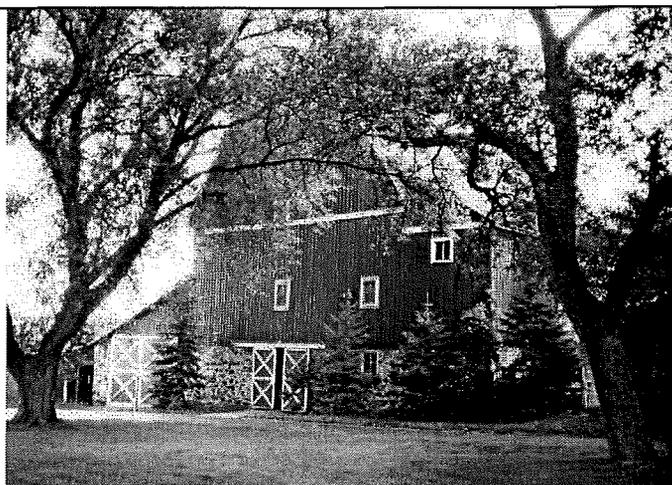
**Roll No./Neg.No.:** SS16

<b>Circa:</b> 1890-1910	<b>Condition:</b> Excellent	<b>Integrity:</b> Excellent
----------------------------	--------------------------------	--------------------------------

<b>Materials:</b>	<b>HISTORY:</b>
<b>Foundation:</b> Stone	Double vented
<b>Walls:</b> Vertical plank	Transverse aisle
<b>Roof:</b> Asphalt shingle	Ramped with extensions on sides
<b>Porch:</b>

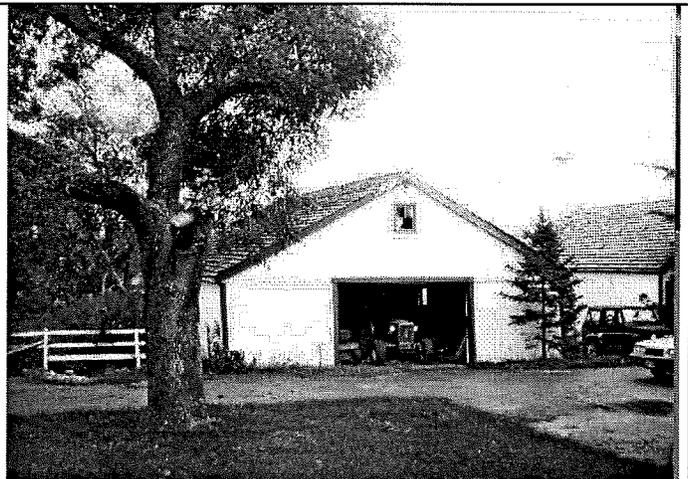
<b>Circa:</b> 1940 - 1950	<b>Condition:</b> Excellent	<b>Integrity:</b> Excellent
------------------------------	--------------------------------	--------------------------------

<b>Materials:</b>	<b>HISTORY:</b>  Up and over door
<b>Foundation:</b> Concrete	
<b>Walls:</b> Vertical plank	
<b>Roof:</b> Wood shingle	
<b>Porch:</b>

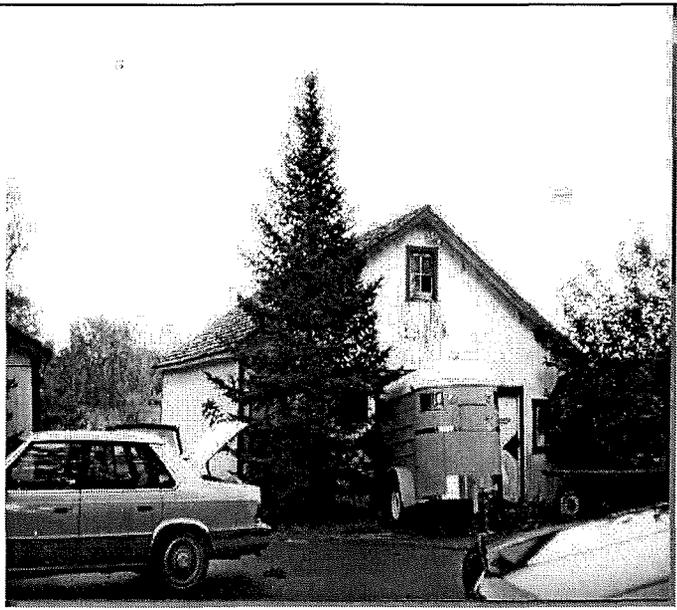
**Roll No./Neg.No.:** SS18

<b>Circa:</b> 1940	<b>Condition:</b> Good	<b>Integrity:</b> Excellent
-----------------------	---------------------------	--------------------------------

<b>Materials:</b>	<b>HISTORY:</b>
<b>Foundation:</b> Concrete	Sliding doors
<b>Walls:</b> Vertical plank	
<b>Roof:</b> Wood shingle	
<b>Porch:</b>

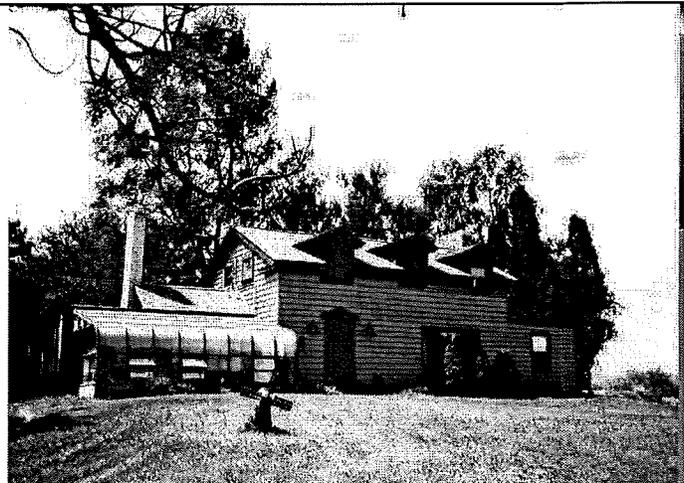
<b>Function:</b>	<b>Vernacular Type:</b>	<b>Arch. Style:</b>	<b>Alterations:</b>
Residence	Upright and wing	Greek revival	Major addition Replacement windows New siding

<b>Circa:</b> 1850-1870	<b>Condition:</b> Good	<b>Integrity:</b> Poor
----------------------------	---------------------------	---------------------------

<b>Materials:</b>	<b>HISTORY:</b>
<b>Foundation:</b> Stone and concrete <b>Walls:</b> Clapboard <b>Roof:</b> Wood shingle <b>Porch:</b> Enclosed	3 dormer windows, major additions, large chimney at end of building, side gable.  Previous site = 2166

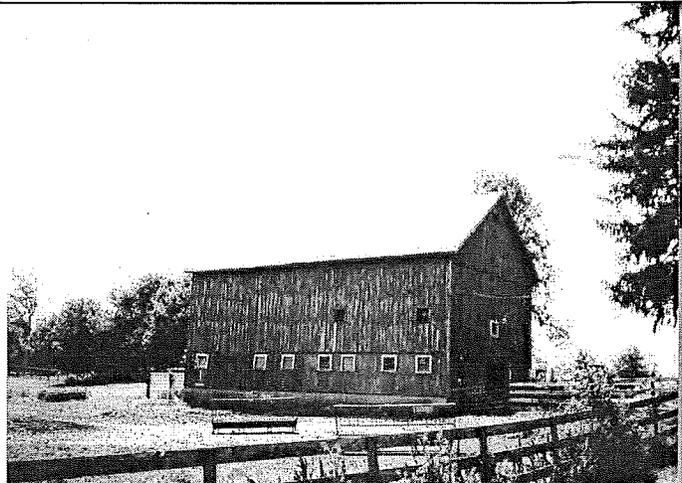
<b>Circa:</b> 1910-1945	<b>Condition:</b> Good	<b>Integrity:</b> Good
----------------------------	---------------------------	---------------------------

<b>Materials:</b>	<b>HISTORY:</b>
<b>Foundation:</b> Poured concrete <b>Walls:</b> Vertical plank <b>Roof:</b> Asphalt shingle <b>Porch:</b>	Ramped, transverse aisle, no vents

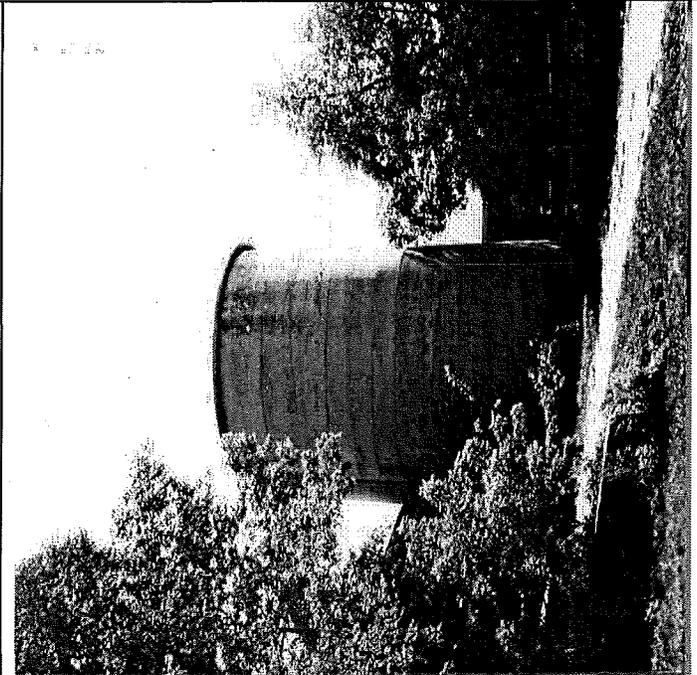
<b>Circa:</b> 1920	<b>Condition:</b> Good	<b>Integrity:</b> Good
-----------------------	---------------------------	---------------------------

<b>Materials:</b>	<b>HISTORY:</b>
<b>Foundation:</b> Concrete	
<b>Walls:</b> Poured concrete	
<b>Roof:</b> Concrete	
<b>Porch:</b>

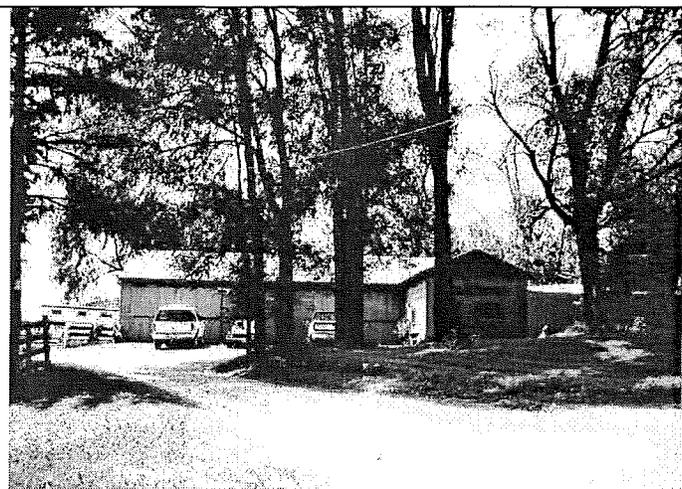
<b>Circa:</b> 1920 - 1940	<b>Condition:</b> Good	<b>Integrity:</b> Good
------------------------------	---------------------------	---------------------------

<b>Materials:</b>	<b>HISTORY:</b>  Gable, single story stables
<b>Foundation:</b> Concrete	
<b>Walls:</b> Clapboard	
<b>Roof:</b> Asphalt shingle	
<b>Porch:</b>

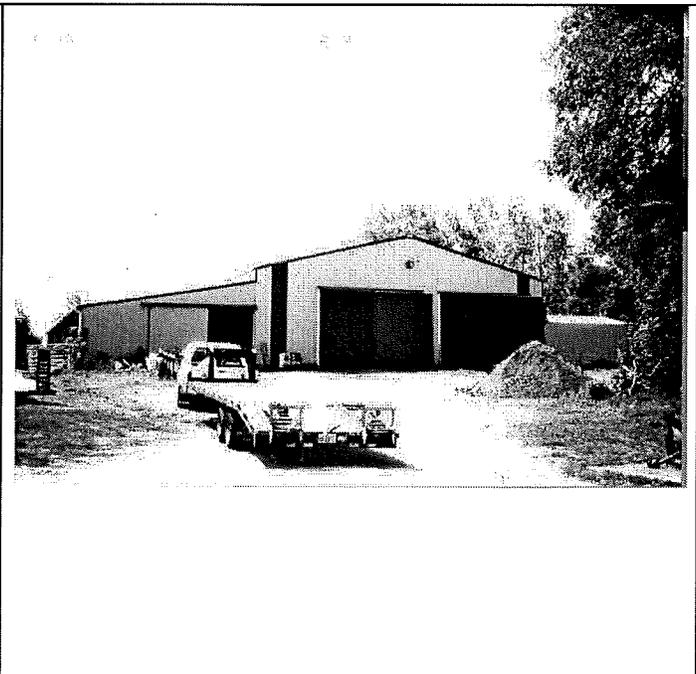
**Roll No./Neg.No.:** CC21

<b>Circa:</b> Post 1945	<b>Condition:</b> Excellent	<b>Integrity:</b> Good
----------------------------	--------------------------------	---------------------------

<b>Materials:</b>	<b>HISTORY:</b>
<b>Foundation:</b> Concrete	
<b>Walls:</b> Metal	
<b>Roof:</b> Metal	
<b>Porch:</b>

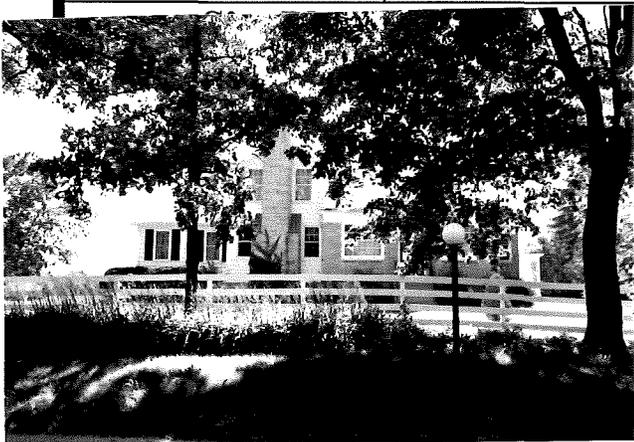
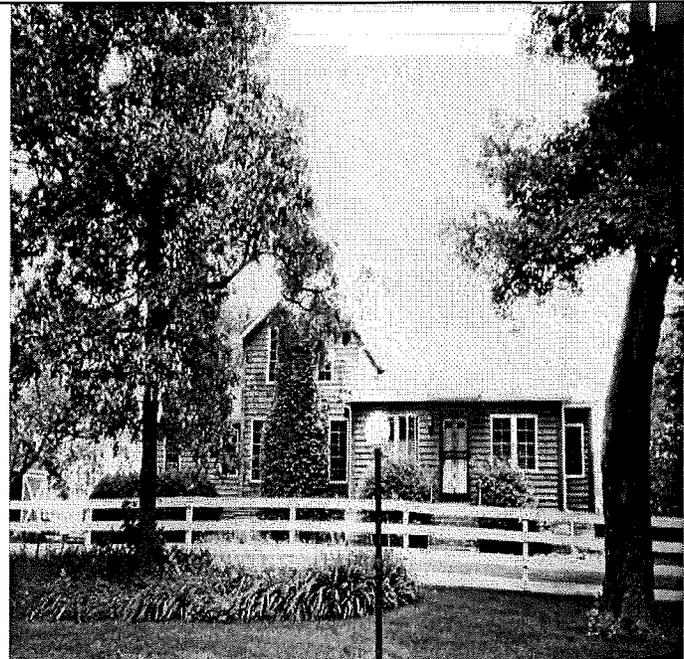
**Roll No./Neg.No.:** CC26

<b>Function:</b>	<b>Vernacular Type:</b>	<b>Arch. Style:</b>	<b>Alterations:</b>
Residence	Upright and wing		Major addition Replacement windows

<b>Circa:</b> 1860-1890	<b>Condition:</b> Excellent	<b>Integrity:</b> Poor
----------------------------	--------------------------------	---------------------------

<b>Materials:</b> <b>Foundation:</b> Flagstone <b>Walls:</b> New clapboard <b>Roof:</b> Asphalt shingle <b>Porch:</b> <i>Enclosed</i>	<b>HISTORY:</b>  Major part is 2 story gable with flagstone chimney, lots of additions all around  Previous survey = 1392
---	---

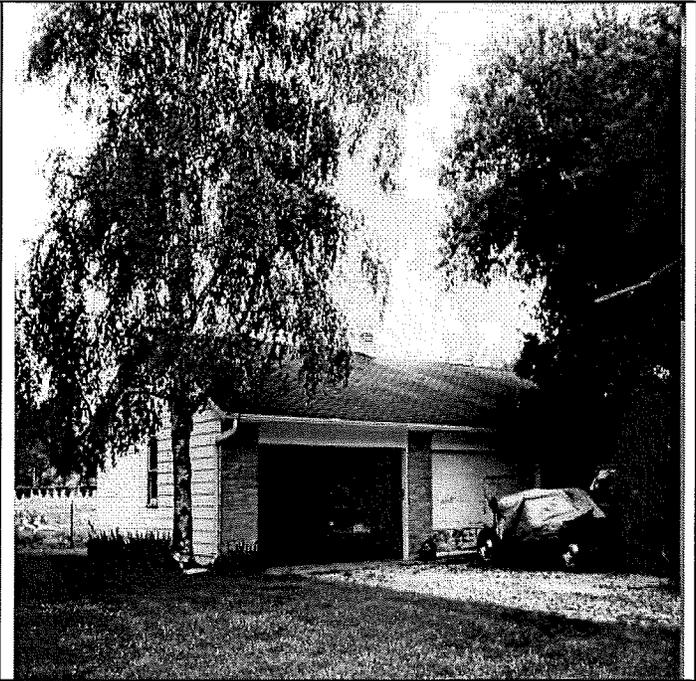
<b>Circa:</b> Post 1945	<b>Condition:</b> Excellent	<b>Integrity:</b> Good
----------------------------	--------------------------------	---------------------------

<b>Materials:</b>	<b>HISTORY:</b>
<b>Foundation:</b> Flagstone	
<b>Walls:</b> Flagstone	
<b>Roof:</b> Asphalt shingle	
<b>Porch:</b>

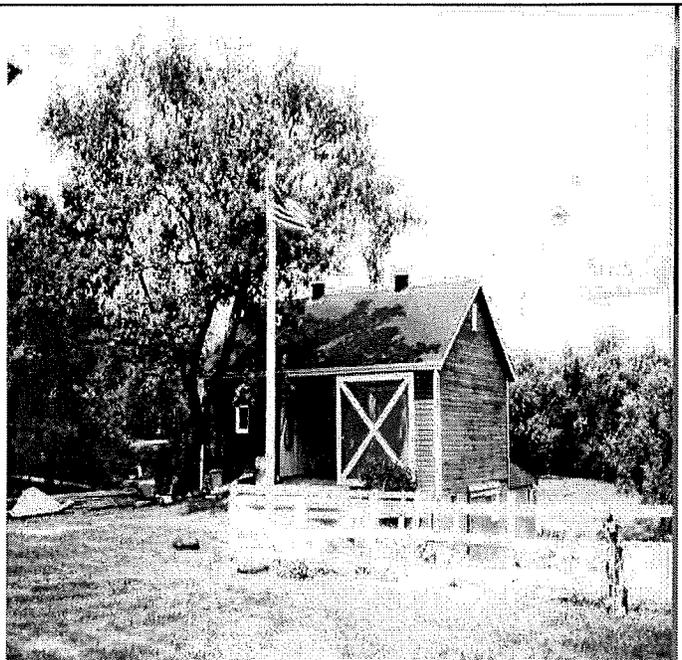
<b>Circa:</b> 1890-1910	<b>Condition:</b> Excellent	<b>Integrity:</b> Good
----------------------------	--------------------------------	---------------------------

<b>Materials:</b>	<b>HISTORY:</b>  Ramped, double vented, transverse aisle
<b>Foundation:</b> Concrete block	
<b>Walls:</b> Clapboard	
<b>Roof:</b> Asphalt shingle	
<b>Porch:</b>

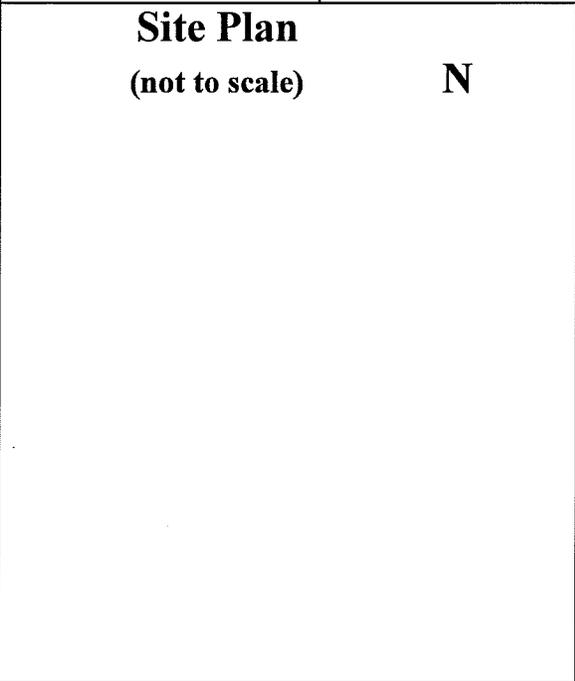
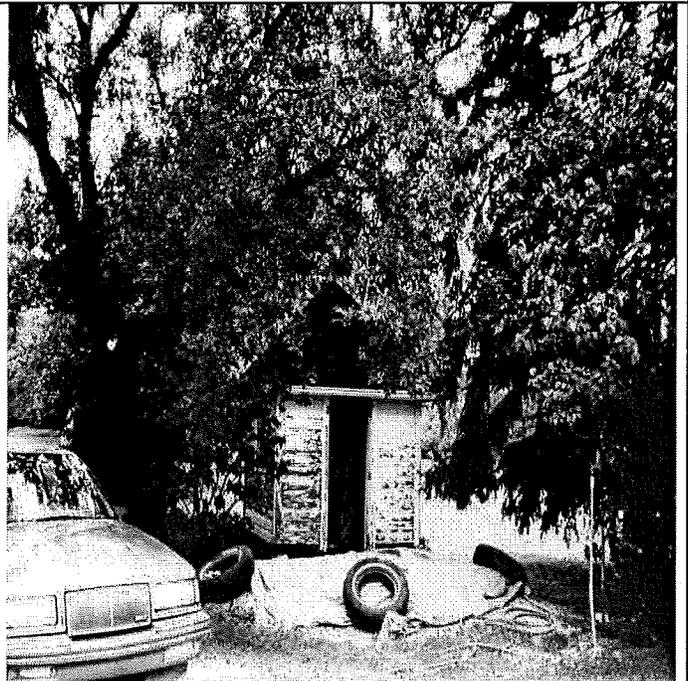
**Roll No./Neg.No.:** CC28

<b>Materials:</b> <b>Foundation:</b> Concrete block <b>Walls:</b> Clapboard <b>Roof:</b> Asphalt shingle <b>Porch:</b>	<b>HISTORY:</b>  Perhaps it had a previous function as a pumphouse or outhouse. <i>Hipped, pyramidal roof</i>  <i>↳ Note: Photo elongated ↴</i>
--	--

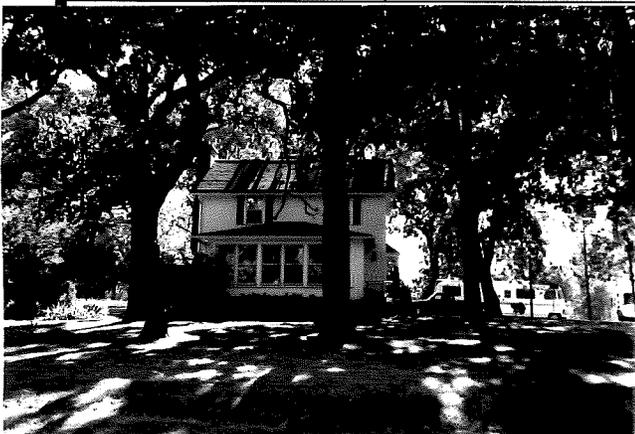
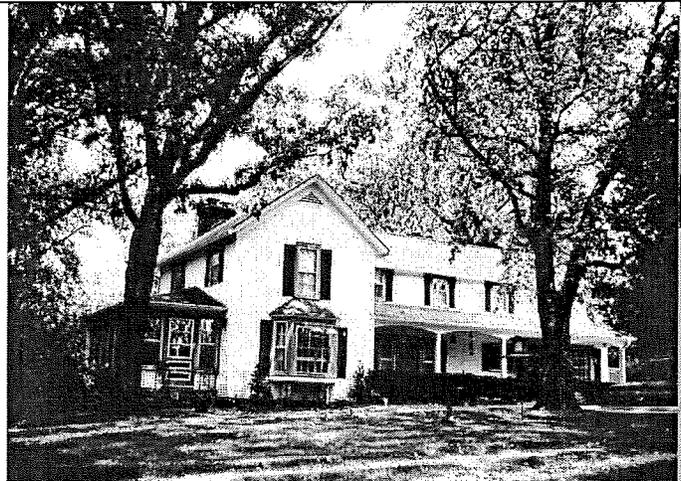
**Roll No./Neg.No.:** CC23

<b>Circa:</b> 1910-1945	<b>Condition:</b> Excellent	<b>Integrity:</b> Good
----------------------------	--------------------------------	---------------------------

<b>Materials:</b>	<b>HISTORY:</b>
<b>Foundation:</b> Concrete	2 story, chimney at rear of intersection
<b>Walls:</b> Clapboard	Oriented perpendicular to road, enclosed porch on side close to road  (possibly an add-on)
<b>Roof:</b> Asphalt shingle	
<b>Porch:</b> In crook of "L"	Previous site = 1393

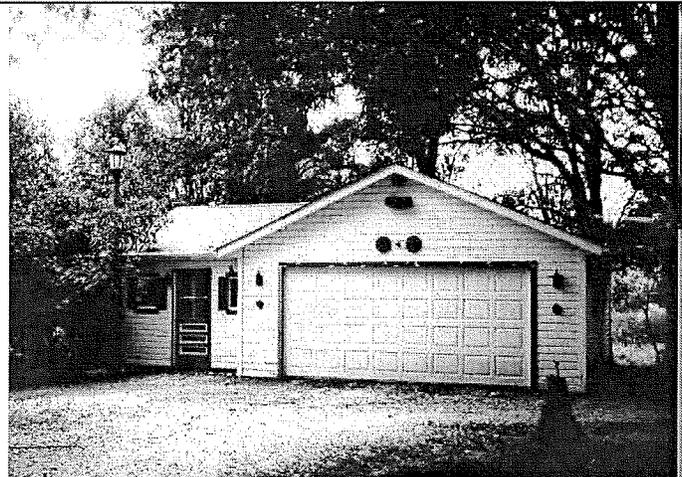
**Roll No./Neg.No.:** CC24

<b>Circa:</b> 1940	<b>Condition:</b> Excellent	<b>Integrity:</b> Good
-----------------------	--------------------------------	---------------------------

<b>Materials:</b>	<b>HISTORY:</b>  Up and over 2 car garage door
<b>Foundation:</b> Concrete	
<b>Walls:</b> Beveled clapboard	
<b>Roof:</b> Asphalt shingle	
<b>Porch:</b>

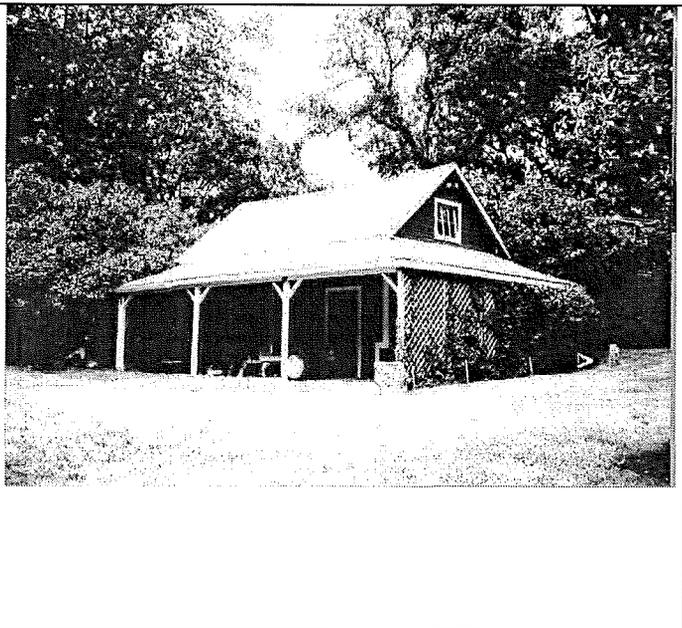
**Roll No./Neg.No.:** CC25

<b>Circa:</b> 1930	<b>Condition:</b> Excellent	<b>Integrity:</b> Good
-----------------------	--------------------------------	---------------------------

<b>Materials:</b>	<b>HISTORY:</b>  Single story
<b>Foundation:</b> Concrete and block	
<b>Walls:</b> Clapboard	
<b>Roof:</b> Asphalt shingle	
<b>Porch:</b>
