McHenry County

Rural Survey

***Nunda Township***

***FIELD DATA SHEETS***

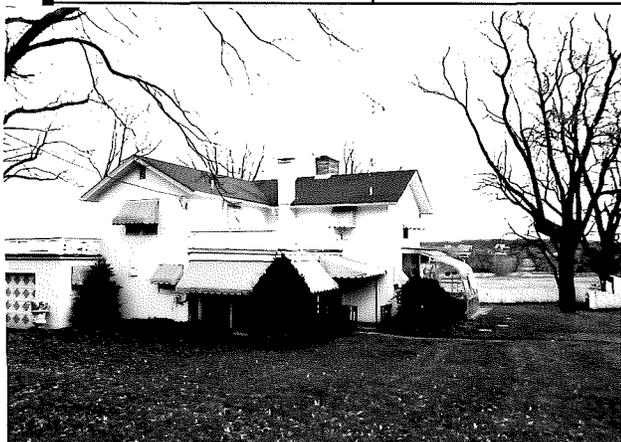
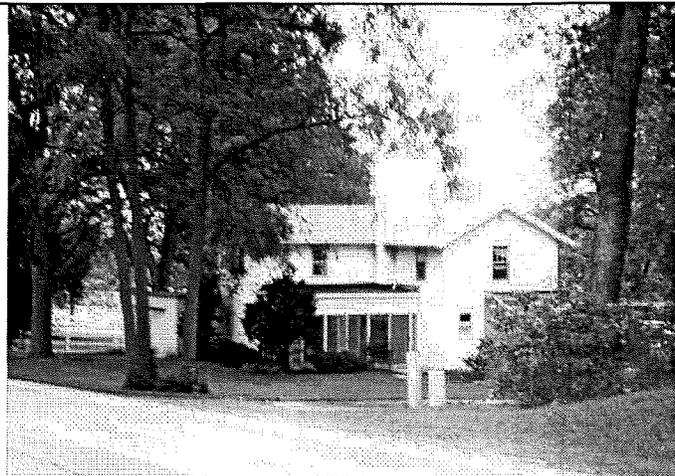
**Roll No./Neg.No.:** SS13

<b>Circa:</b> 1860-1910	<b>Condition:</b> Excellent	<b>Integrity:</b> Good
----------------------------	--------------------------------	---------------------------

<b>Materials:</b>	<b>HISTORY:</b>
<b>Foundation:</b> Concrete	Does not look right from aerial, but 1872 plat shows a farm in this area
<b>Walls:</b> Stucco	
<b>Roof:</b> Asphalt shingle	
<b>Porch:</b>	
	Previous site = 4694

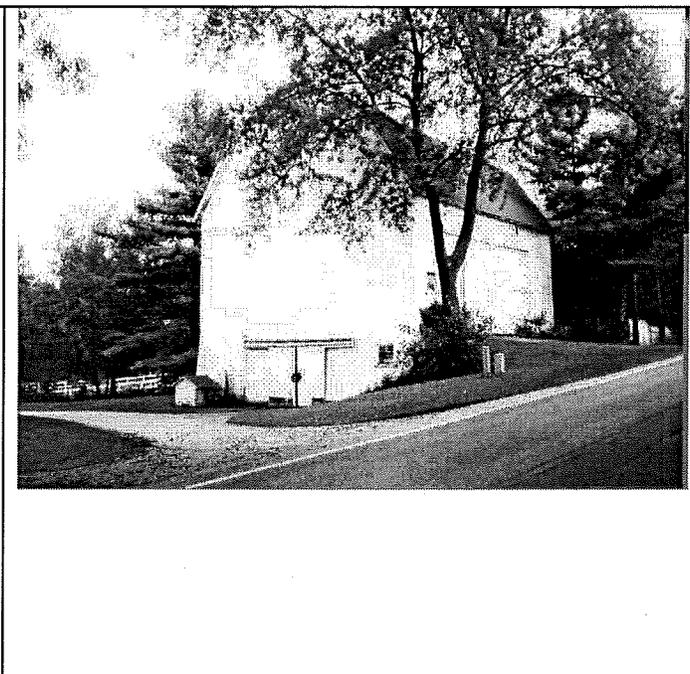
<b>Circa:</b> 1900-1910	<b>Condition:</b> Good	<b>Integrity:</b> Excellent
----------------------------	---------------------------	--------------------------------

<b>Materials:</b>	<b>HISTORY:</b>  Ramped with transverse aisle
<b>Foundation:</b> Stone	
<b>Walls:</b> Asbestos	
<b>Roof:</b> Asphalt shingle	
<b>Porch:</b>

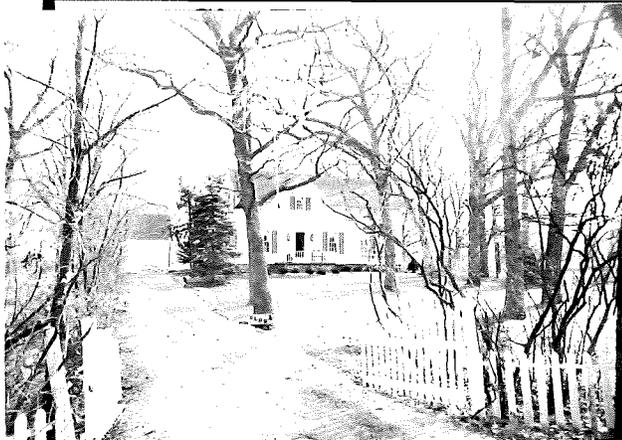
**Roll No./Neg.No.:** BB25

<b>Circa:</b> 1860 - 1870	<b>Condition:</b> Excellent	<b>Integrity:</b> Poor
------------------------------	--------------------------------	---------------------------

<b>Materials:</b>	<b>HISTORY:</b> Bay window added.
<b>Foundation:</b> Stone	
<b>Walls:</b> Synthetic siding	
<b>Roof:</b> Asphalt shingle	
<b>Porch:</b>	Previous site = 4693

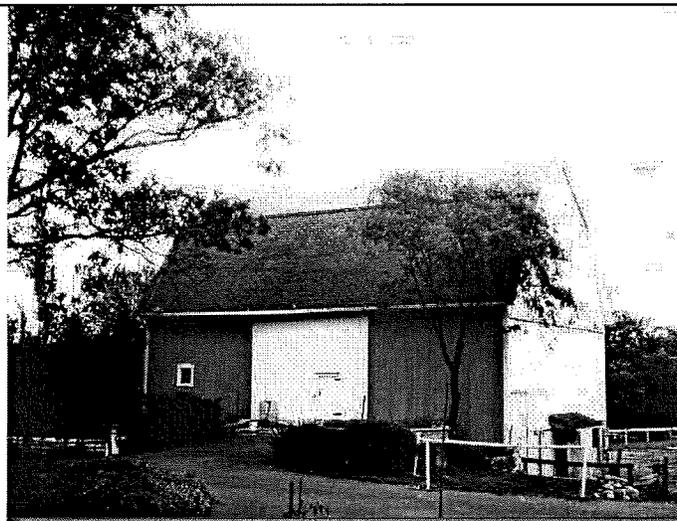
<b>Circa:</b> 1917	<b>Condition:</b> Good	<b>Integrity:</b> Good
-----------------------	---------------------------	---------------------------

<b>Materials:</b>	<b>HISTORY:</b> According to resident the barn was built in 1917. Ramped with sliding doors, banked entry, transverse aisle. Was part of a horse farm. Silo foundation remains and was used as a bomb shelter.
<b>Foundation:</b> Stone	
<b>Walls:</b> Vertical plank	
<b>Roof:</b> Asphalt shingle	
<b>Porch:</b>

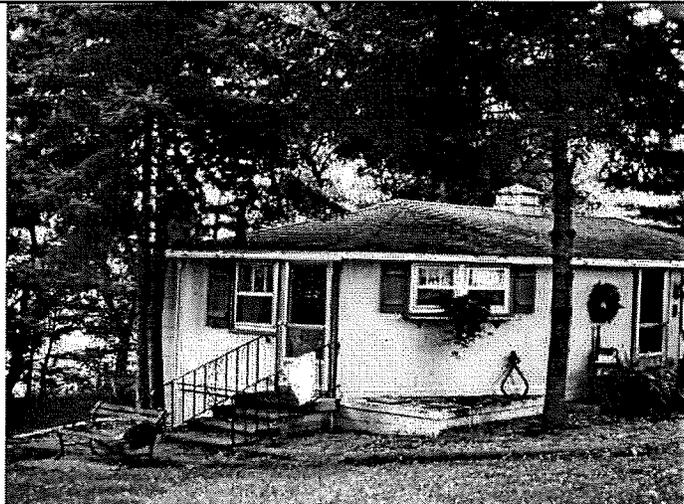
**Roll No./Neg.No.:** BB20

<b>Circa:</b> 1920	<b>Condition:</b> Good	<b>Integrity:</b> Poor
-----------------------	---------------------------	---------------------------

<b>Materials:</b>	<b>HISTORY:</b> Modular chicken or hog house from Sears or Wards, converted and used as a residence. Very unique, cupola vent, has a walkout basement.
<b>Foundation:</b> Poured and block	
<b>Walls:</b> Vertical plank	
<b>Roof:</b> Asphalt shingle	
<b>Porch:</b>

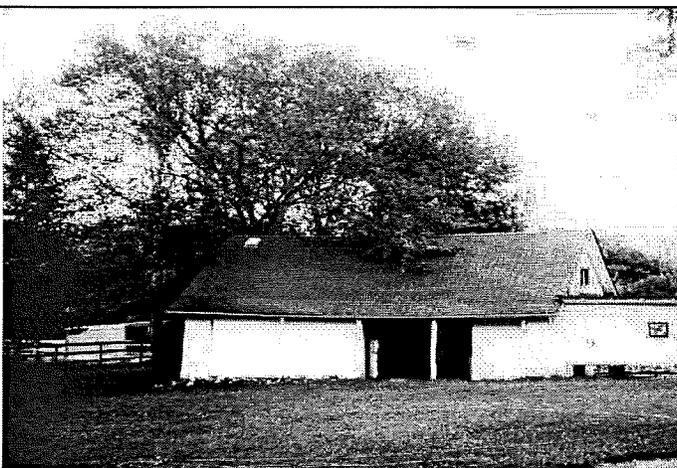
<b>Circa:</b> 1920	<b>Condition:</b> Good	<b>Integrity:</b> Poor
-----------------------	---------------------------	---------------------------

<b>Materials:</b>	<b>HISTORY:</b>  Appears to have been converted from a small storage barn to an ad hoc stable.
<b>Foundation:</b> Stone	
<b>Walls:</b> Vertical plank	
<b>Roof:</b> Asphalt shingle	
<b>Porch:</b>

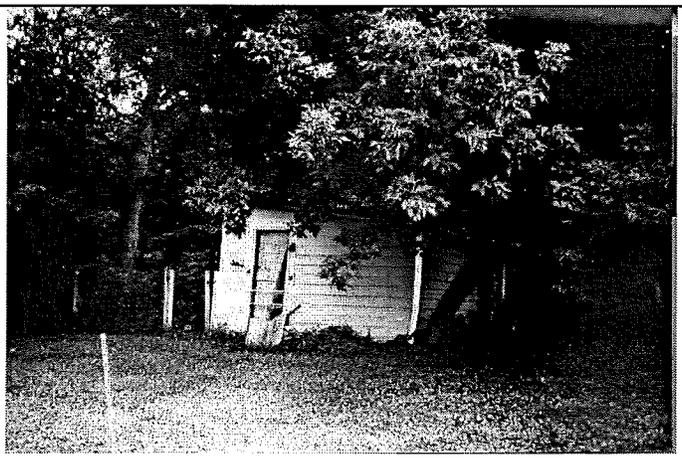
<b>Circa:</b> 1920	<b>Condition:</b> Poor	<b>Integrity:</b> Poor
-----------------------	---------------------------	---------------------------

<b>Materials:</b>	<b>HISTORY:</b>
<b>Foundation:</b> Concrete	
<b>Walls:</b> Clap board	
<b>Roof:</b> Asphalt shingle	
<b>Porch:</b>

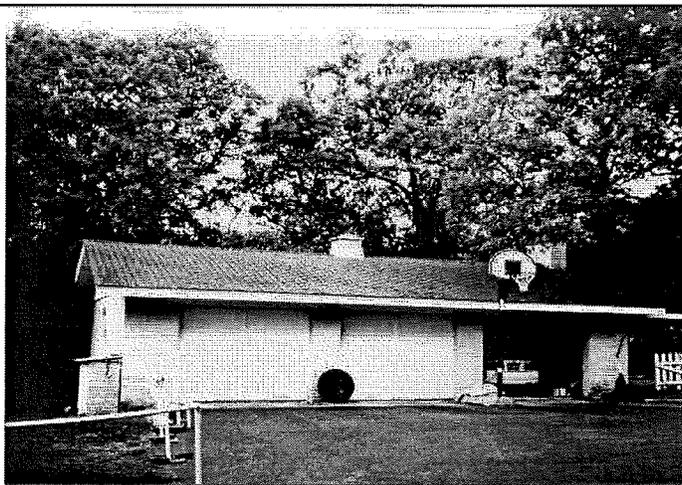
<b>Circa:</b> Post 1945	<b>Condition:</b> Excellent	<b>Integrity:</b> Excellent
----------------------------	--------------------------------	--------------------------------

<b>Materials:</b>	<b>HISTORY:</b>
<b>Foundation:</b> Concrete	3 car garage, modern, vented
<b>Walls:</b> Brick	
<b>Roof:</b> Asphalt shingle	
<b>Porch:</b>

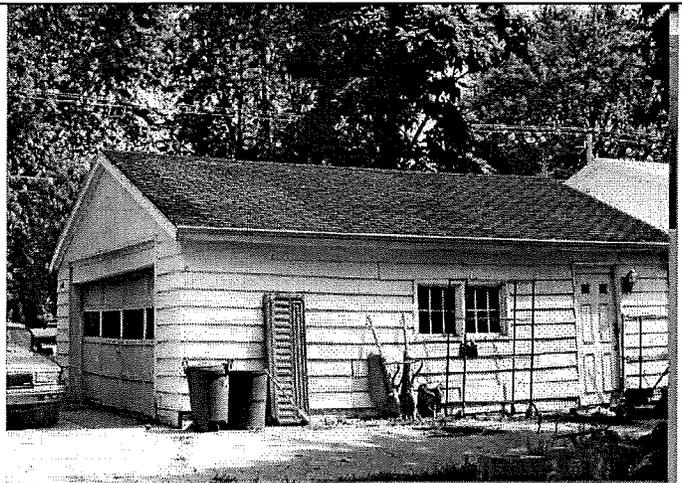
**Roll No./Neg.No.:** T18      **Surveyed by:** LM&KD      **Date:** 7-12-98

<b>Circa:</b> 1930	<b>Condition:</b> Poor	<b>Integrity:</b> Good
-----------------------	---------------------------	---------------------------

<b>Materials:</b>	<b>HISTORY:</b>  2 car garage
<b>Foundation:</b> Concrete	
<b>Walls:</b> <i>Wide</i> Clapboard	
<b>Roof:</b> Asphalt shingle	
<b>Porch:</b>

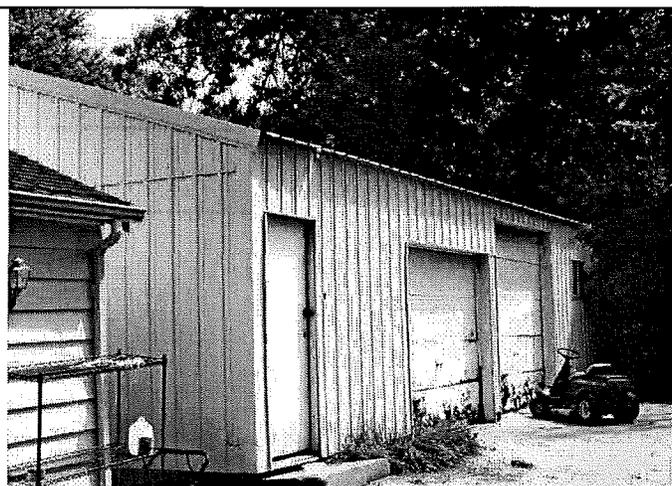
**Roll No./Neg.No.:** T19

<b>Circa:</b> Post 1940	<b>Condition:</b> Good	<b>Integrity:</b> Poor
----------------------------	---------------------------	---------------------------

<b>Materials:</b>	<b>HISTORY:</b>  Metal pole building
<b>Foundation:</b> Concrete	
<b>Walls:</b> Batten metal	
<b>Roof:</b> Batten metal	
<b>Porch:</b>

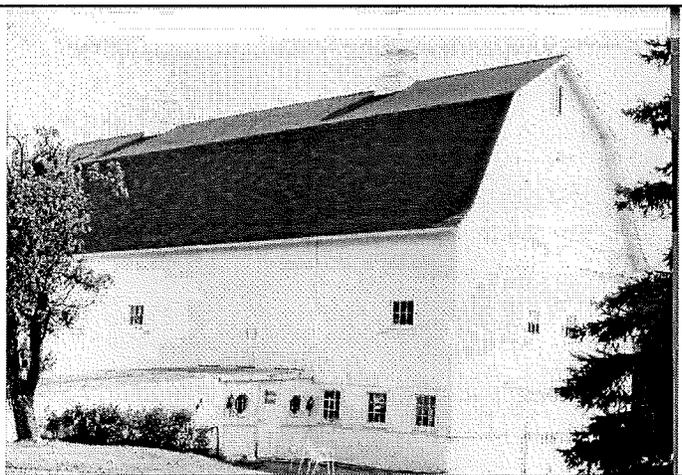
**Roll No./Neg.No.:** T15

<b>Circa:</b> 1920 - 1940	<b>Condition:</b> Excellent	<b>Integrity:</b> Good
------------------------------	--------------------------------	---------------------------

<b>Materials:</b>	<b>HISTORY:</b>
<b>Foundation:</b> Poured concrete	Looks as though it was used to be part of 14-20-200-012
<b>Walls:</b> Vertical plank	Ramped
<b>Roof:</b> Asphalt shingle	Transverse
<b>Porch:</b>	<i>Not on previous survey</i>

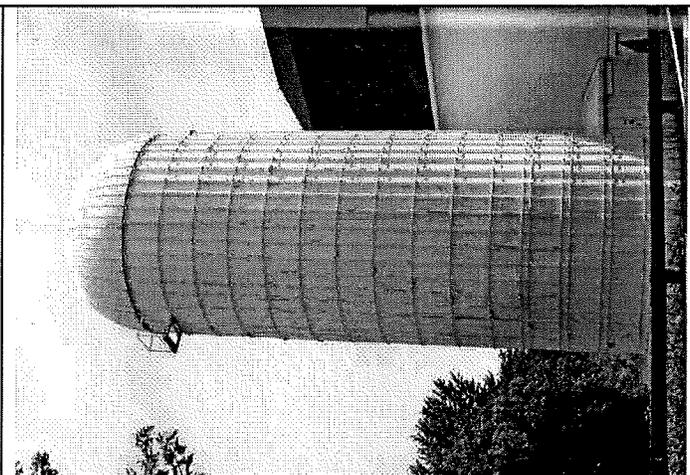
**Roll No./Neg.No.:** T16      **Surveyed by:** LM&KD      **Date:** 7-12-98

<b>Circa:</b> 1940	<b>Condition:</b> Good	<b>Integrity:</b> Good
-----------------------	---------------------------	---------------------------

<b>Materials:</b>	<b>HISTORY:</b>
<b>Foundation:</b> Poured concrete <b>Walls:</b> Staved concrete <b>Roof:</b> Metal dome <b>Porch:</b>	Viewing platform in disrepair

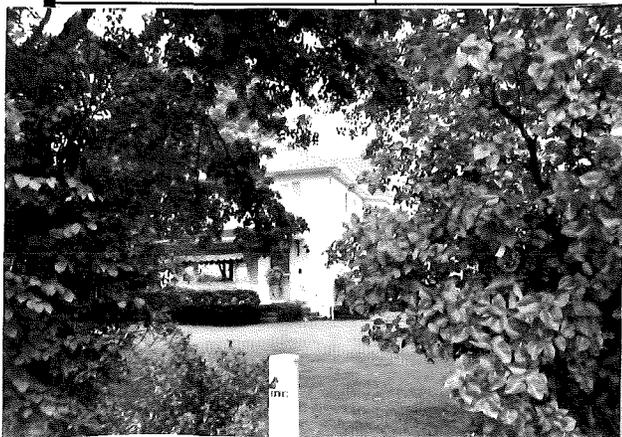
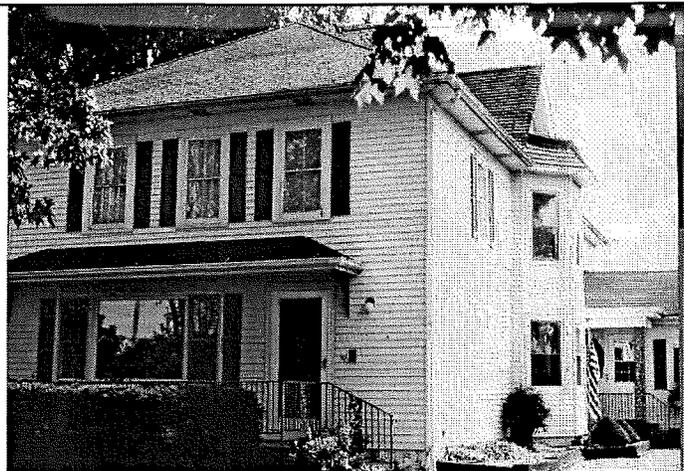
**Roll No./Neg.No.:** T11

<b>Circa:</b> 1880-1910	<b>Condition:</b> Excellent	<b>Integrity:</b> Poor
----------------------------	--------------------------------	---------------------------

<b>Materials:</b>	<b>HISTORY:</b>
<b>Foundation:</b> Poured	85 years old according to resident 2 chimneys
<b>Walls:</b> Synthetic siding	Round widows in attic, in very good shape Garage in rear in concrete block
<b>Roof:</b> Asphalt shingle	Bay windows on 2 stories Has a number of additions, enclosed in rear
<b>Porch:</b>	Previous site = 2177

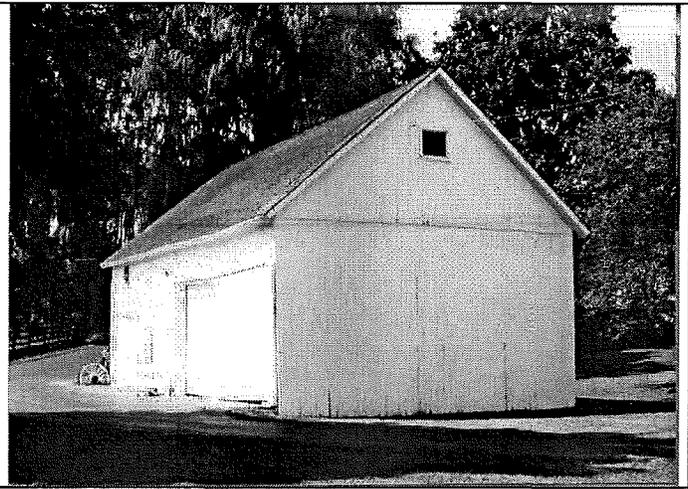
<b>Circa:</b> 1910	<b>Condition:</b> Good	<b>Integrity:</b> Good
-----------------------	---------------------------	---------------------------

<b>Materials:</b>	<b>HISTORY:</b>
<b>Foundation:</b> Poured concrete	Roof is sagging, but otherwise well kept
<b>Walls:</b> Vertical plank and batten vertical plank	Sliding doors
<b>Roof:</b> Asphalt shingle	
<b>Porch:</b>

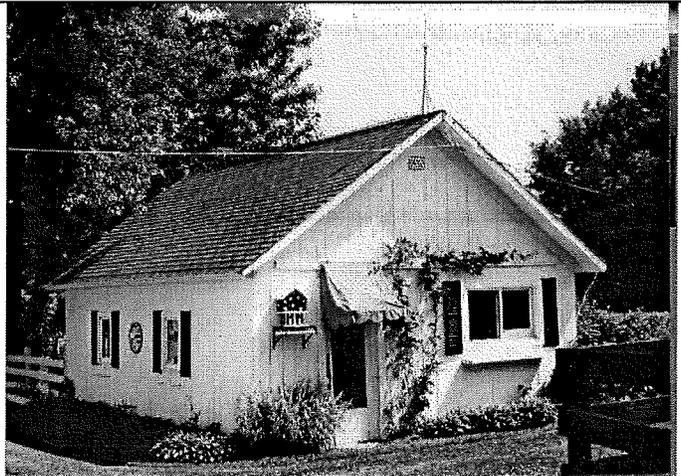
**Roll No./Neg.No.:** T13

<b>Circa:</b> 1925	<b>Condition:</b> Excellent	<b>Integrity:</b> Good
-----------------------	--------------------------------	---------------------------

<b>Materials:</b>	<b>HISTORY:</b>
<b>Foundation:</b> Poured concrete	Has residence, like front with glass door and shuttered windows
<b>Walls:</b> Vertical plank	Has 30 small holes (vents) on the front wall near the roof
<b>Roof:</b> Asphalt shingle	
<b>Porch:</b>

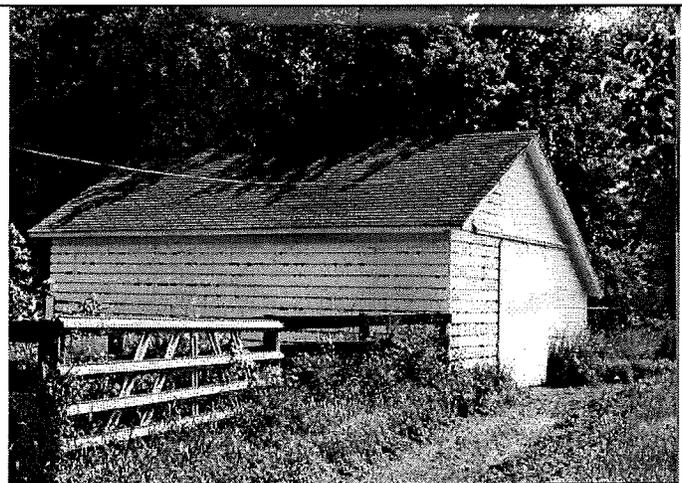
<b>Circa:</b> 1910	<b>Condition:</b> Good	<b>Integrity:</b> Good
-----------------------	---------------------------	---------------------------

<b>Materials:</b>	<b>HISTORY:</b>
<b>Foundation:</b> Concrete	Central aisle
<b>Walls:</b> Open slats, clapboard	Sliding wide door
<b>Roof:</b> Asphalt shingle	
<b>Porch:</b>

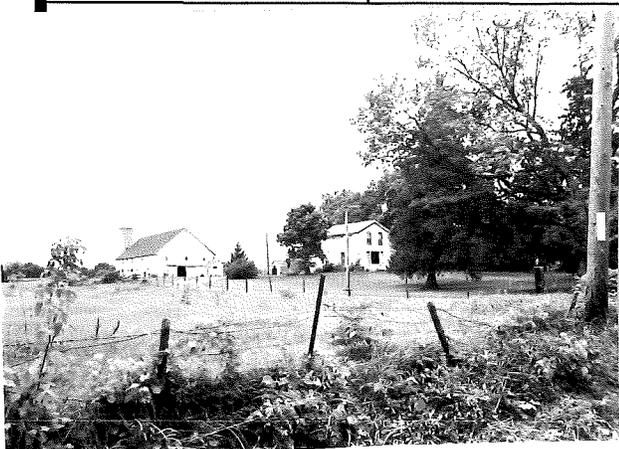
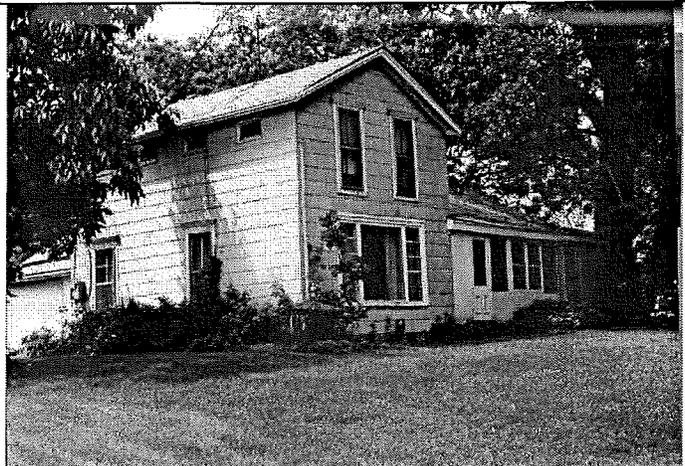
**Roll No./Neg.No.:** S19

<b>Function:</b>	<b>Vernacular Type:</b>	<b>Arch. Style:</b>	<b>Alterations:</b>
Residence	Upright and wing		Garage added Some windows changed Resided
<b>Circa:</b> 1860 - 1880	<b>Condition:</b> Poor	<b>Integrity:</b> Poor	
<b>Source:</b> 1872 Plat book	<b>Landmark Evaluation:</b> TBD		
<b>Architect/Builder:</b> Unknown	<b>Individual:</b>	<b>Farmstead:</b>	<b>National Register:</b> <b>Local:</b>
	<b>Criteria:</b> /14	<b>(See reverse side of criteria listing)</b>	
<b>Materials:</b>	<b>HISTORY:</b>		
<b>Foundation:</b> Concrete	A number of additions		
<b>Walls:</b> Asbestos	Single chimney on the wing side		
<b>Roof:</b> Asphalt shingle	Needs some repairs		
<b>Porch:</b> Side, enclosed	3 chimneys total Previous site = 2580

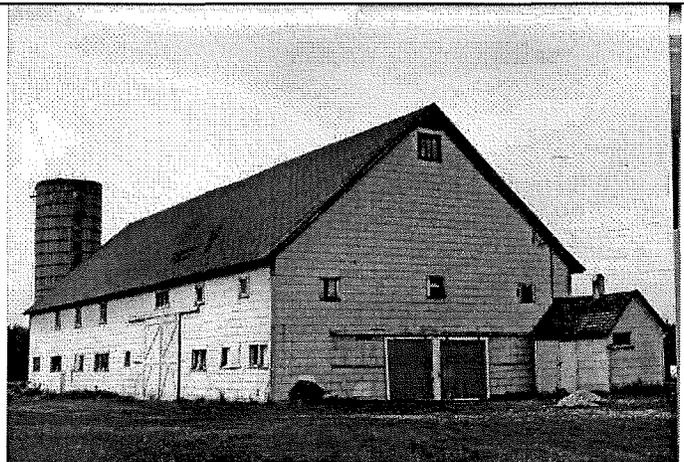
**Roll No./Neg.No.:** S21

<b>Circa:</b> 1900 -1910	<b>Condition:</b> Poor	<b>Integrity:</b> Good
-----------------------------	---------------------------	---------------------------

<b>Materials:</b>	<b>HISTORY:</b>
<b>Foundation:</b> Concrete	Transverse aisle and central aisle
<b>Walls:</b> Asbestos	Looks run down and dirty
<b>Roof:</b> Asphalt shingle	Silo is concrete staved and roofless
<b>Porch:</b>

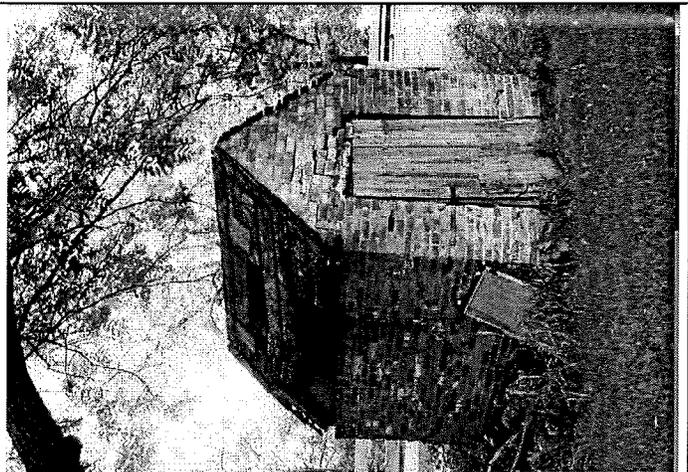
**Roll No./Neg.No.:** S23

<b>Circa:</b> 1870-1890	<b>Condition:</b> Poor	<b>Integrity:</b> Poor
----------------------------	---------------------------	---------------------------

<b>Materials:</b>	<b>HISTORY:</b>
<b>Foundation:</b> None	
<b>Walls:</b> Brick	
<b>Roof:</b> Horizontal plank-wood	
<b>Porch:</b>

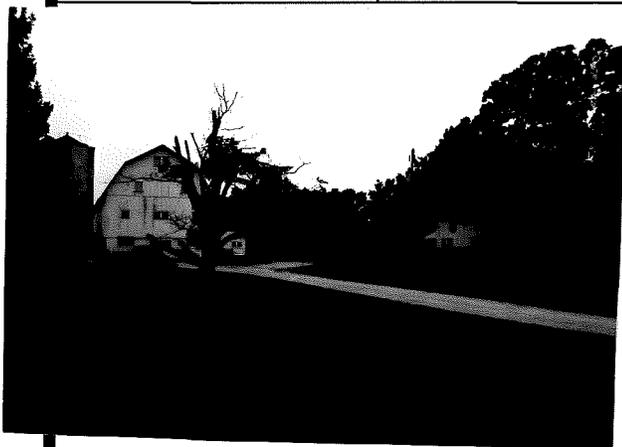
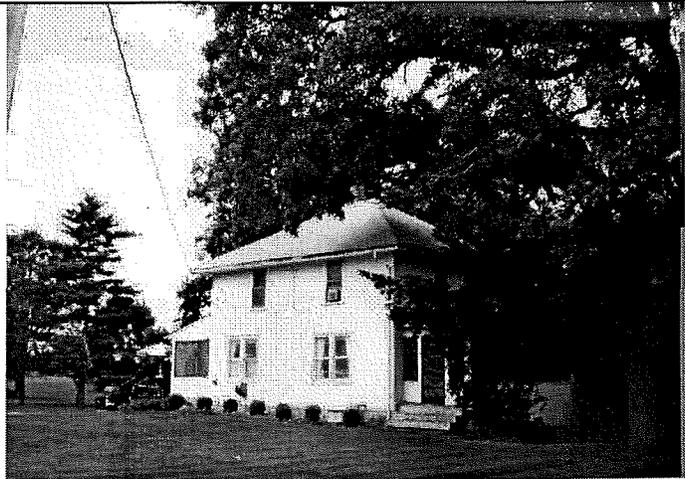
<b>Function:</b>	<b>Vernacular Type:</b>	<b>Arch. Style:</b>	<b>Alterations:</b>
Residence	Four square		Major addition
<b>Circa:</b> 1920's		<b>Condition:</b> Good	<b>Integrity:</b> Good
<b>Source:</b> 1872 Plat book 1995 Sidwell maps		<b>Landmark Evaluation:</b> TBD	
<b>Architect/Builder:</b> Unknown		<b>Individual:</b> <b>Criteria:</b> /14	<b>Farmstead:</b> <b>National Register:</b> <b>Local:</b> (See reverse side of criteria listing)
<b>Materials:</b>  <b>Foundation:</b> Poured <b>Walls:</b> Clapboard <b>Roof:</b> Asphalt shingle <b>Porch:</b> Front & rear, screened in		<b>HISTORY:</b>  Brick chimney in center, in need of some repair, but structure sound, hipped roof. "Shine " family farm.  Previous site = 2575

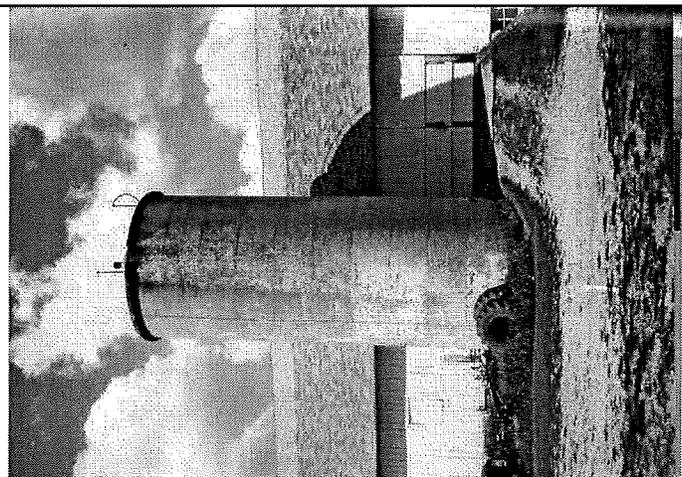
<b>Materials:</b>	<b>HISTORY:</b>
<b>Foundation:</b> Concrete	
<b>Walls:</b> Concrete, poured	
<b>Roof:</b> Missing	
<b>Porch:</b>

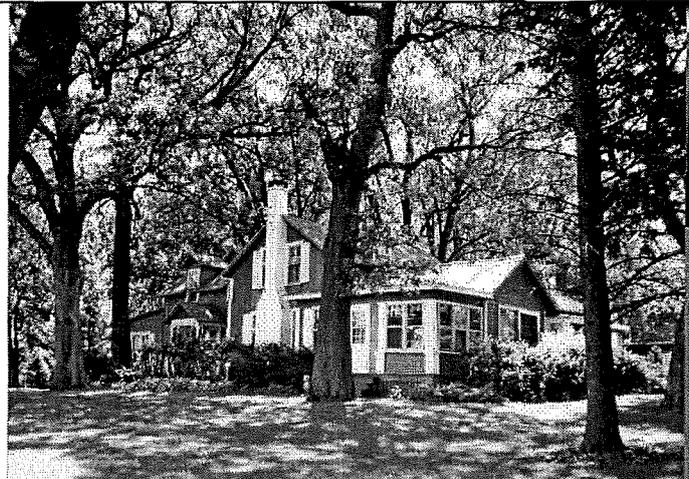
**Roll No./Neg.No.:** AA6

<b>Materials:</b>	<b>HISTORY:</b>
<b>Foundation:</b> Stone <b>Walls:</b> Modern vertical plank <b>Roof:</b> Asphalt shingle <b>Porch:</b>	<p>2<sup>nd</sup> homestead for James McMillian, the son of the original McMillian partner. 1920 was the last addition. Addition has poured foundation. Structure has 8 fireplaces. Original section is from chimney to chimney; (brick) single gable of two stories.</p> <p>Previous site = 2579</p>

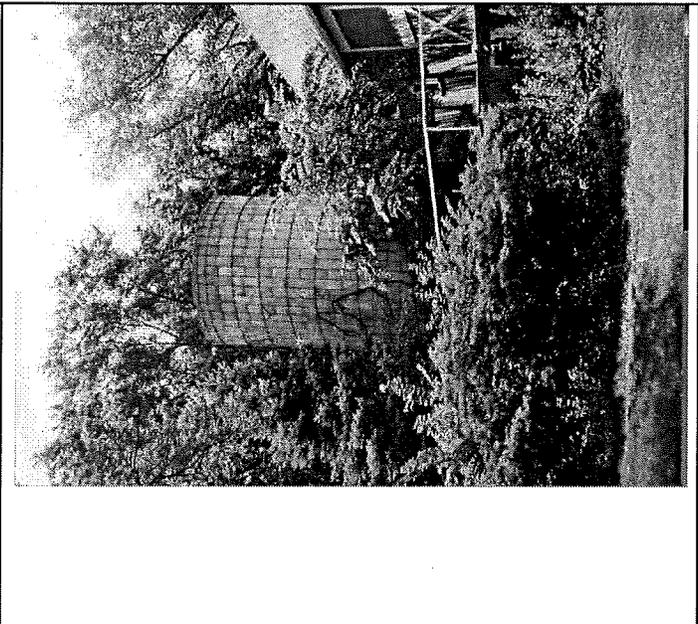
**Roll No./Neg.No.:** AA9

<b>Materials:</b>	<b>HISTORY:</b>  Roofless
<b>Foundation:</b> Concrete	
<b>Walls:</b> Staved concrete	
<b>Roof:</b> Missing	
<b>Porch:</b>

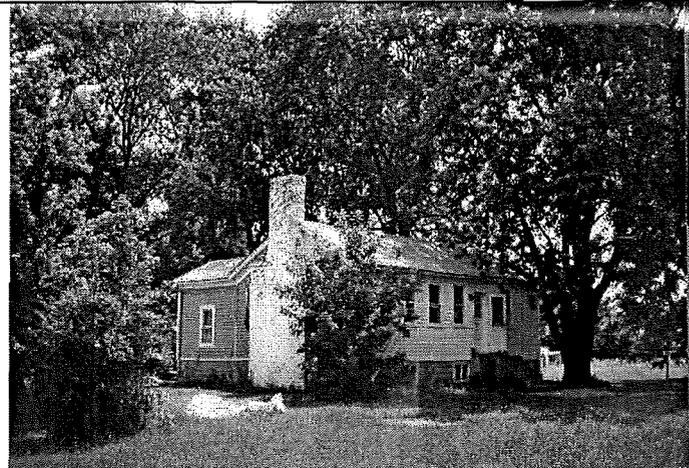
**Roll No./Neg.No.: AA12**

<b>Materials:</b>	<b>HISTORY:</b>
<b>Foundation:</b> Concrete block <b>Walls:</b> Clapboard <b>Roof:</b> Asphalt shingle <b>Porch:</b>	<p>Brick chimney, now used as a rental house. Structure in disrepair. "Old District 44" schoolhouse until 1960. Next door neighbor says it is the oldest one room schoolhouse in the County. Helga Johnson who lives on Ames Rd (1<sup>st</sup> house on south side) was the last to graduate from the school.</p> <p>Previous site = 2578</p>

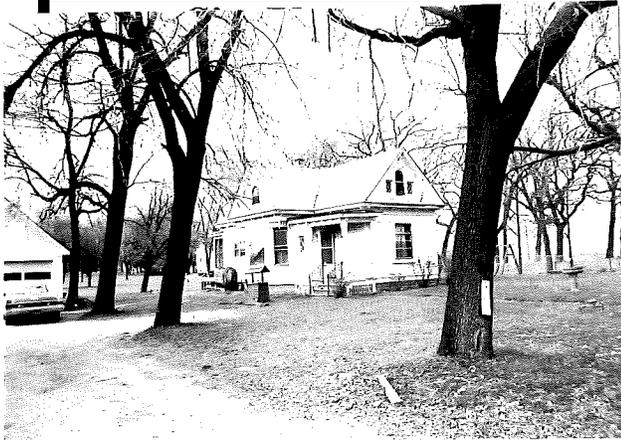
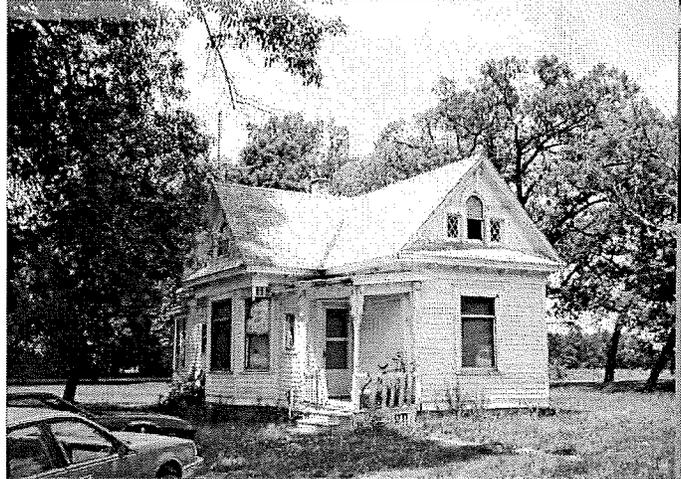
**Roll No./Neg.No.:** AA15

<b>Circa:</b> 1890 - 1910	<b>Condition:</b> Poor	<b>Integrity:</b> Good
------------------------------	---------------------------	---------------------------

<b>Materials:</b>	<b>HISTORY:</b>
<b>Foundation:</b> Block	Is being demolished by abuse. In very bad shape.
<b>Walls:</b> Clapboard	Now home of "Greg's Auto Service." Decorative trellises and carved wood in eaves, central brick chimney.
<b>Roof:</b> Asphalt shingle	This one should have been saved, but might be in too bad of shape, much worse condition then when this photo was taken.
<b>Porch:</b>	Previous site = 4687

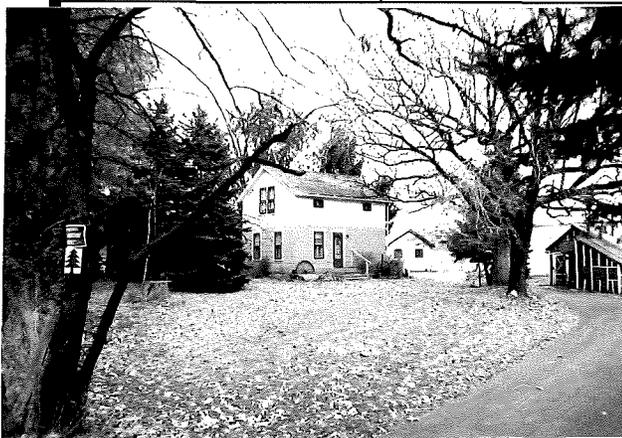
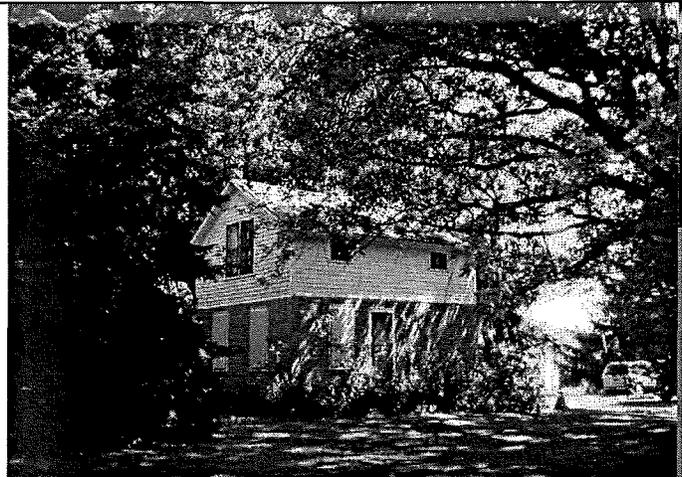
**Roll No./Neg.No.:** Z17

<b>Materials:</b>	<b>HISTORY:</b>
<b>Foundation:</b> Brick	One room wide, gable at front, has been boarded up, no longer lived in.
<b>Walls:</b> Clap board, asbestos, brick	
<b>Roof:</b> Asphalt shingle	
<b>Porch:</b>	Previous site = 4686

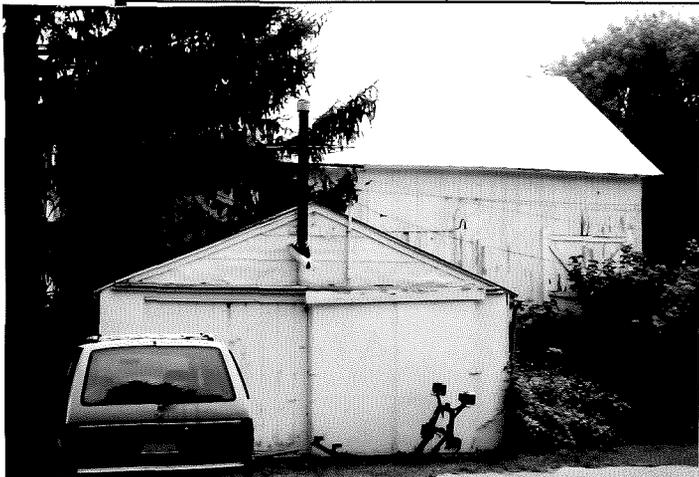
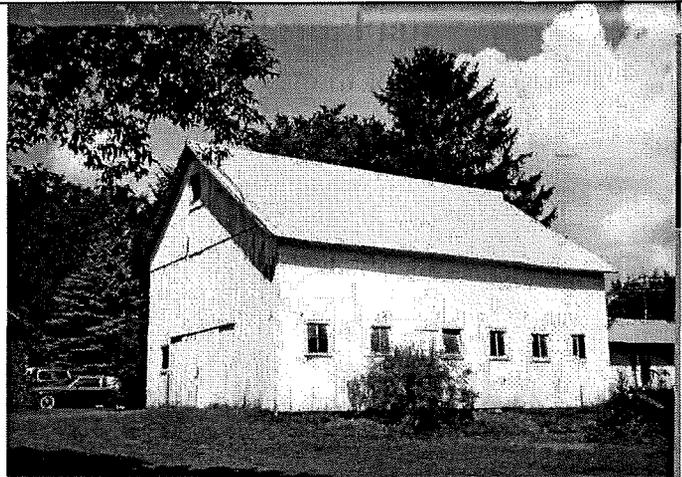
**Roll No./Neg.No.:** Z22,23

<b>Circa:</b> 1890	<b>Condition:</b> Poor	<b>Integrity:</b> Poor
-----------------------	---------------------------	---------------------------

<b>Materials:</b>	<b>HISTORY:</b>
<b>Foundation:</b> Concrete	Ramped at one time, has shed attached to it with sliding doors
<b>Walls:</b> Vertical plank	
<b>Roof:</b> Metal	
<b>Porch:</b>

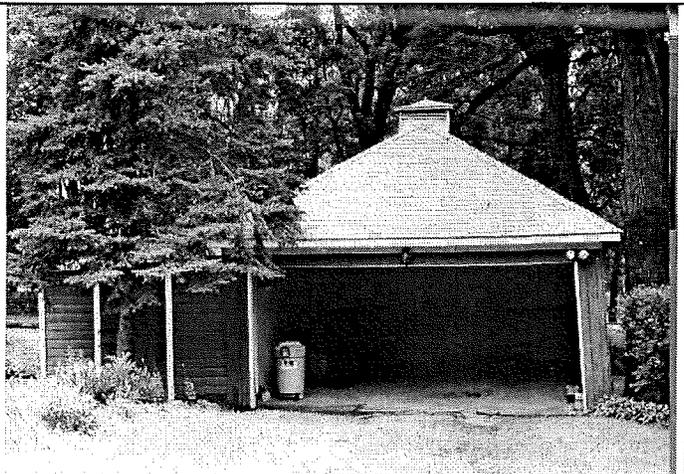
**Roll No./Neg.No.:** S27

<b>Circa:</b> 1940	<b>Condition:</b> Excellent	<b>Integrity:</b> Poor
-----------------------	--------------------------------	---------------------------

<b>Materials:</b>	<b>HISTORY:</b>  Single vent
<b>Foundation:</b> Concrete	
<b>Walls:</b> Vertical plank (modern siding)	
<b>Roof:</b> Asphalt shingle	
<b>Porch:</b>

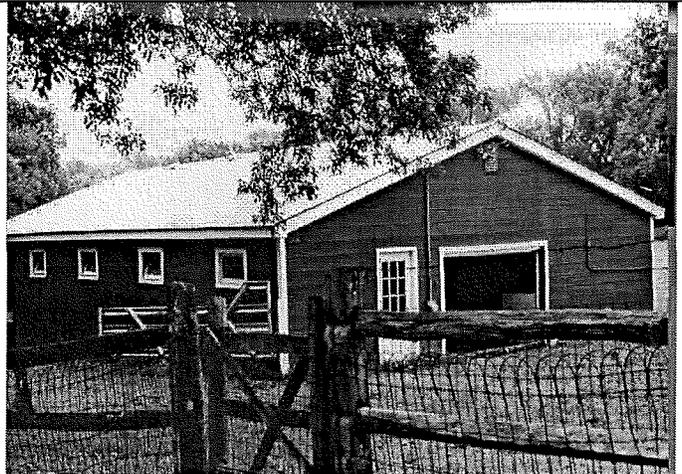
**Roll No./Neg.No.:** S28

<b>Circa:</b> 1940	<b>Condition:</b> Excellent	<b>Integrity:</b> Excellent
-----------------------	--------------------------------	--------------------------------

<b>Materials:</b>	<b>HISTORY:</b>  Stable with transverse aisle
<b>Foundation:</b> Concrete	
<b>Walls:</b> Clapboard	
<b>Roof:</b> Asphalt shingle	
<b>Porch:</b>

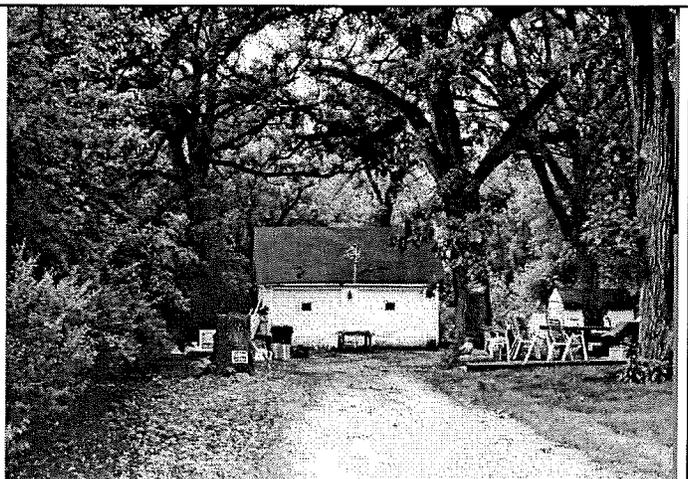
<b>Circa:</b> 1940	<b>Condition:</b> Good	<b>Integrity:</b> Poor
-----------------------	---------------------------	---------------------------

<b>Materials:</b>	<b>HISTORY:</b>  Has extensive additions in rear  2 car garage
<b>Foundation:</b> Concrete	
<b>Walls:</b> Clapboard	
<b>Roof:</b> Asphalt shingle	
<b>Porch:</b>

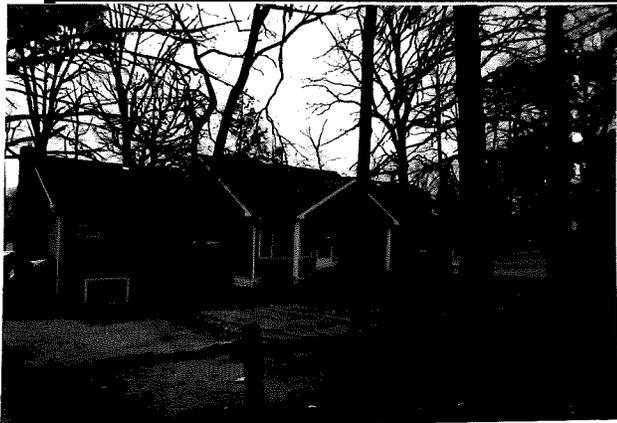
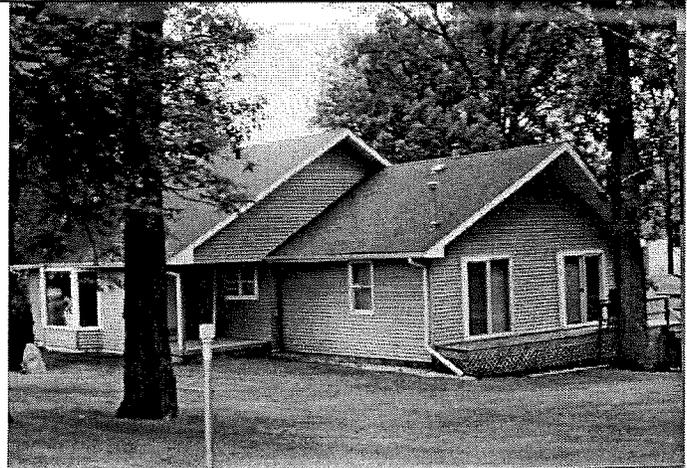
**Roll No./Neg.No.:** S30

<b>Circa:</b> 1930 - 1945	<b>Condition:</b> Excellent	<b>Integrity:</b> Poor
------------------------------	--------------------------------	---------------------------

<b>Materials:</b>	<b>HISTORY:</b>
<b>Foundation:</b> Concrete	Major additions since 1986
<b>Walls:</b> Synthetic siding	All new roof line
<b>Roof:</b> Asphalt shingle	
<b>Porch:</b>	Previous site = 4697

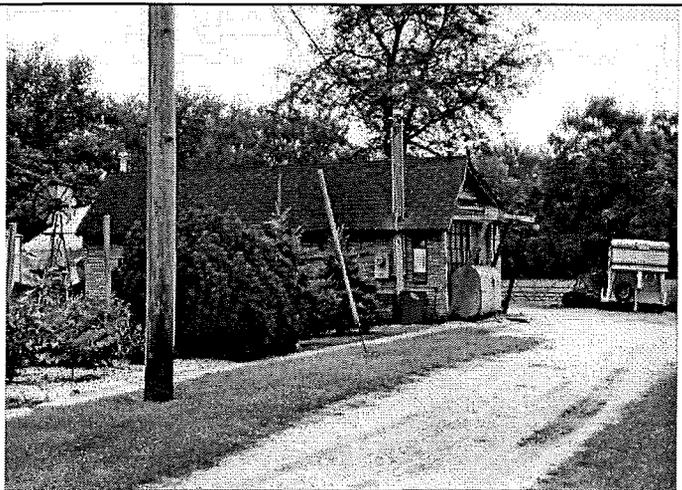
<b>Circa:</b> 1930	<b>Condition:</b> Poor	<b>Integrity:</b> Poor
-----------------------	---------------------------	---------------------------

<b>Materials:</b>	<b>HISTORY:</b>
<b>Foundation:</b> Concrete <b>Walls:</b> Asphalt "Faux" stone <b>Roof:</b> Asphalt shingle <b>Porch:</b>

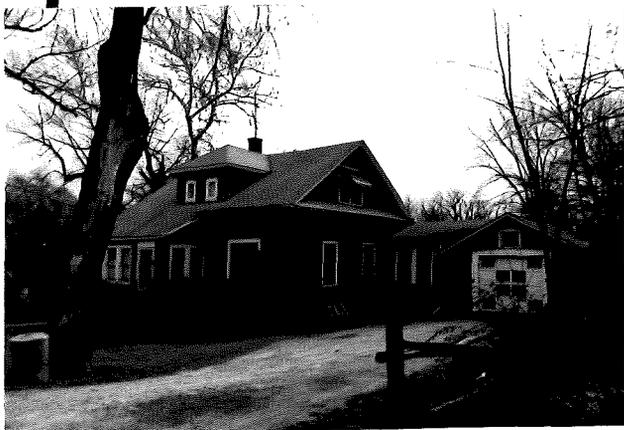
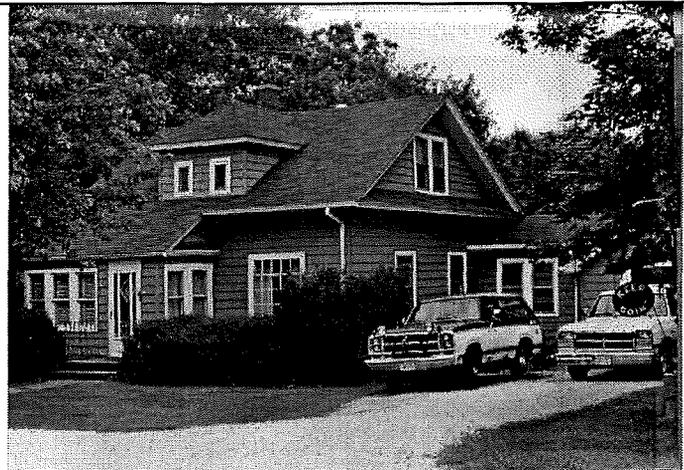
**Roll No./Neg.No.:** S31

<b>Circa:</b> 1920-1945	<b>Condition:</b> Excellent	<b>Integrity:</b> Good
----------------------------	--------------------------------	---------------------------

<b>Materials:</b>	<b>HISTORY:</b>
<b>Foundation:</b> Block and poured concrete	Front dormer
<b>Walls:</b> Metal	
<b>Roof:</b> Asphalt shingle	
<b>Porch:</b> Enclosed	Previous site = 4698

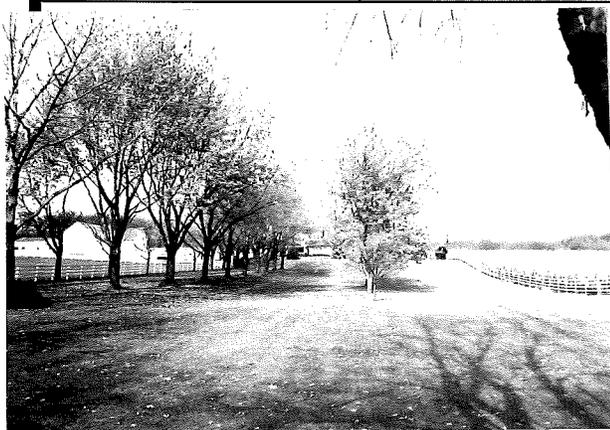
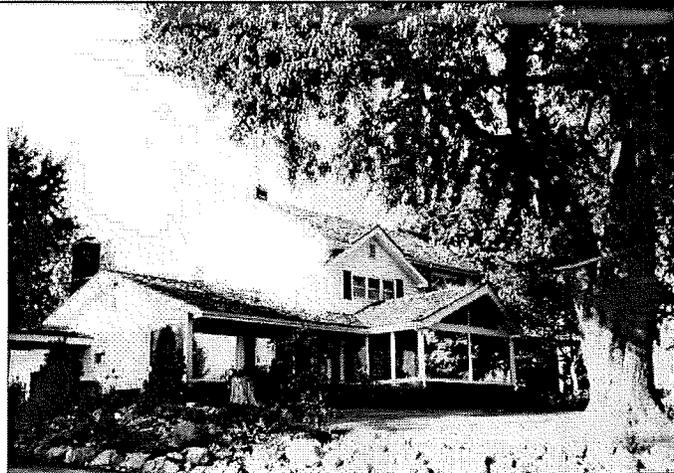
<b>Circa:</b> 1860-1910	<b>Condition:</b> Excellent	<b>Integrity:</b> Poor
----------------------------	--------------------------------	---------------------------

<b>Materials:</b>	<b>HISTORY:</b>
<b>Foundation:</b> Concrete (original)	Many alterations, hard to tell what was original, chimneys at ends of main gable, chimney on single-story addition.
<b>Walls:</b> Clapboard	
<b>Roof:</b> Wood shingles	
<b>Porch:</b> Enclosed front

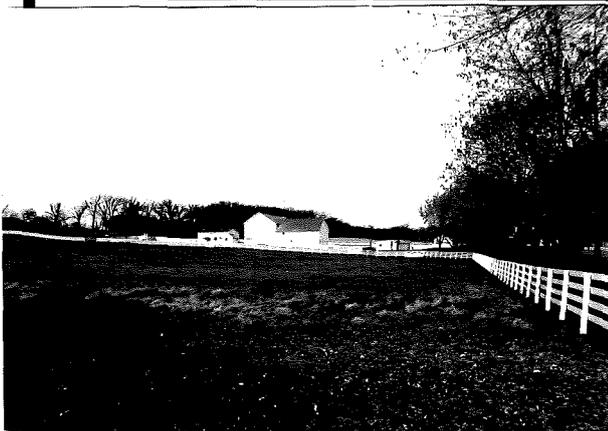
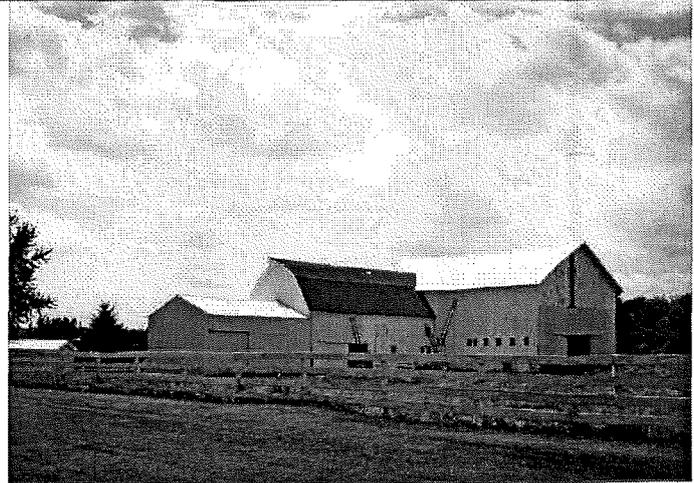
**Roll No./Neg.No.:** AA18

<b>Circa:</b> 1920	<b>Condition:</b> Good	<b>Integrity:</b> Poor
-----------------------	---------------------------	---------------------------

<b>Materials:</b>	<b>HISTORY:</b>
<p><b>Foundation:</b> Stone</p> <p><b>Walls:</b> Vertical</p> <p><b>Roof:</b> Asphalt shingle &amp; metal</p> <p><b>Porch:</b></p>	<p>3 structure composite, gambrel, gable, modern pole building; these two are the original structure built together, gambrel and gable. Has saw-milled beams, used as a dairy barn, unique because original barn was a composite too.</p>

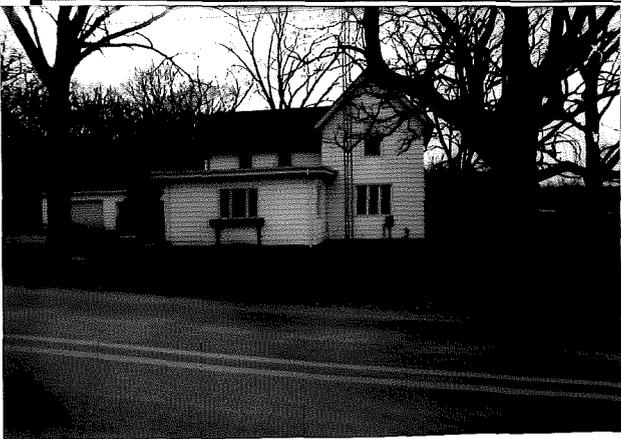
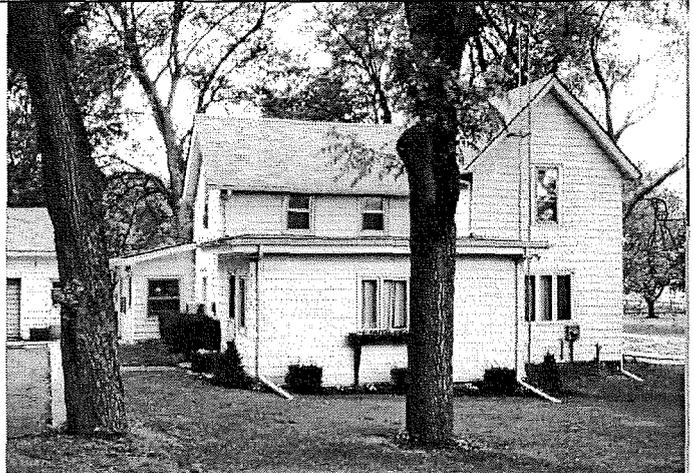
**Roll No./Neg.No.:** CL 11

<b>Circa:</b> 1880 - 1900	<b>Condition:</b> Excellent	<b>Integrity:</b> Poor
------------------------------	--------------------------------	---------------------------

<b>Materials:</b>	<b>HISTORY:</b>
<b>Foundation:</b> Stone	Gable
<b>Walls:</b> Metal siding	Small porch
<b>Roof:</b> Asphalt shingle	2story
<b>Porch:</b> Enclosed	Windows changed

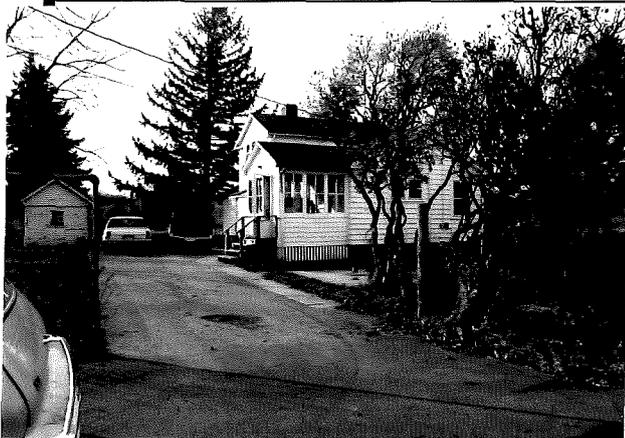
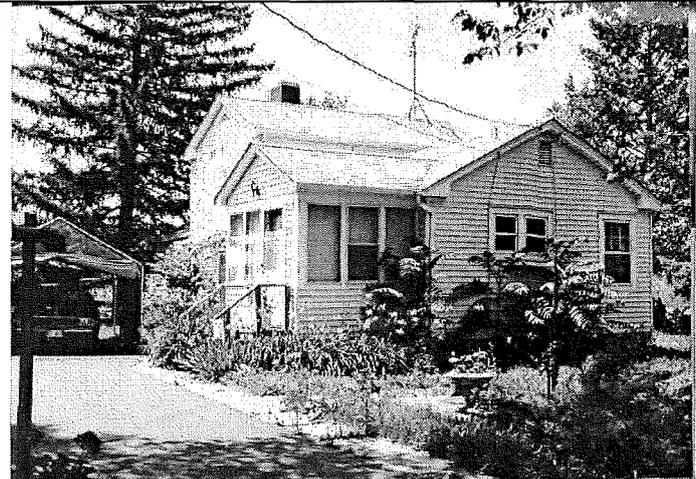
**Roll No./Neg.No.:** CL 29

<b>Circa:</b> 1860-1880	<b>Condition:</b> Excellent	<b>Integrity:</b> Poor
----------------------------	--------------------------------	---------------------------

<b>Materials:</b>	<b>HISTORY:</b>
<b>Foundation:</b> Poured	Meyer's Farm
<b>Walls:</b> Synthetic siding	Gable roof
<b>Roof:</b> Asphalt shingles	Brick chimney
<b>Porch:</b> Enclosed and gabled	2-Story
	Original pump house still here
	Some original six-over-six windows still exist
	Previous site = 4742

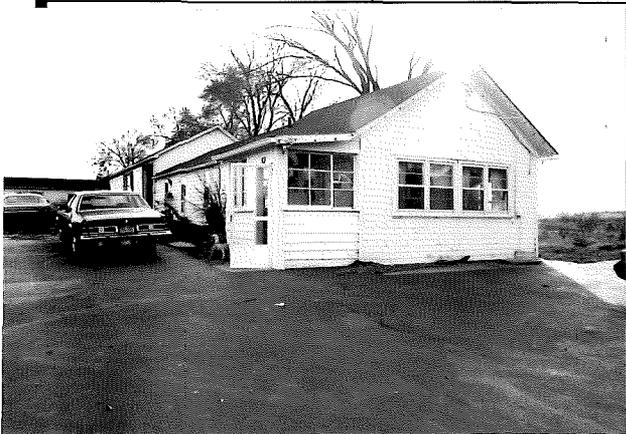
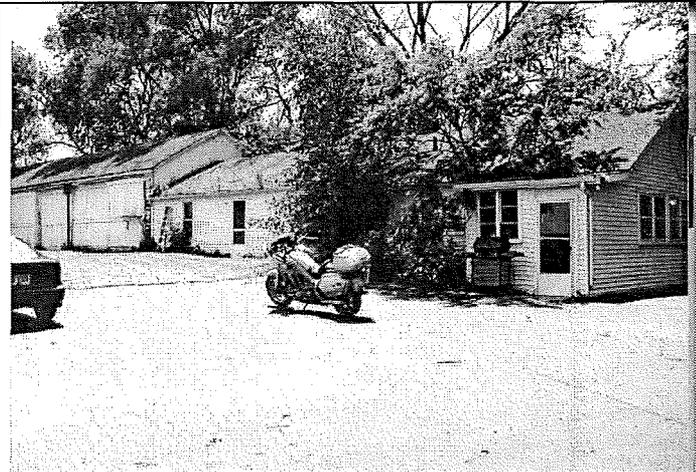
**Roll No./Neg.No.:** CL 30

<b>Circa:</b> 1910 - 1930	<b>Condition:</b> Good	<b>Integrity:</b> Good
------------------------------	---------------------------	---------------------------

<b>Materials:</b>	<b>HISTORY:</b>
<b>Foundation:</b> Poured and block	Milkhouse from dairy farm
<b>Walls:</b> Clapboard and some vertical	Now an apartment
<b>Roof:</b> Asphalt shingle	Lots of extensions
<b>Porch:</b>	All gable

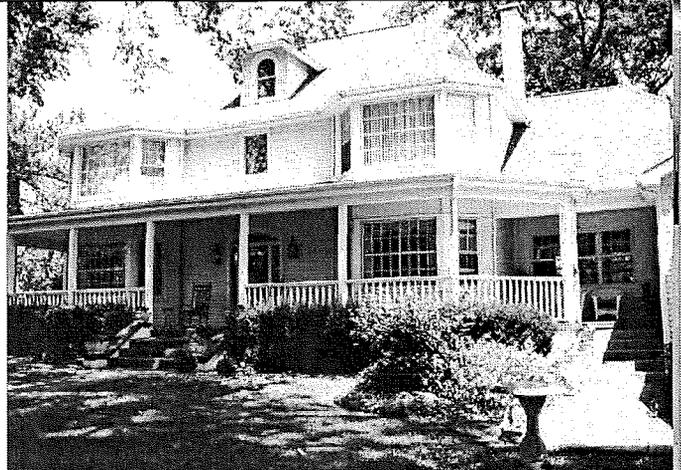
**Roll No./Neg.No.:** CL 19

Function:	Vernacular Type:	Arch. Style:	Alterations:
Residence	"I"-House		Major addition to side Replacement windows

<b>Circa:</b> 1895	<b>Condition:</b> Excellent	<b>Integrity:</b> Good
-----------------------	--------------------------------	---------------------------

<b>Materials:</b>	<b>HISTORY:</b> 2-story with 2 story full bays Clipped gable Brick chimney on each side Dormer window Built 1895 Garage addition part gabled Re-stoned wrap around porch, overhang Current owners renovated it back to original appearance (with exception of the new garage)
<b>Foundation:</b> Stone	
<b>Walls:</b> Clapboard	
<b>Roof:</b> Asphalt shingle	
<b>Porch:</b> Overhanging roof	
Previous survey=2581

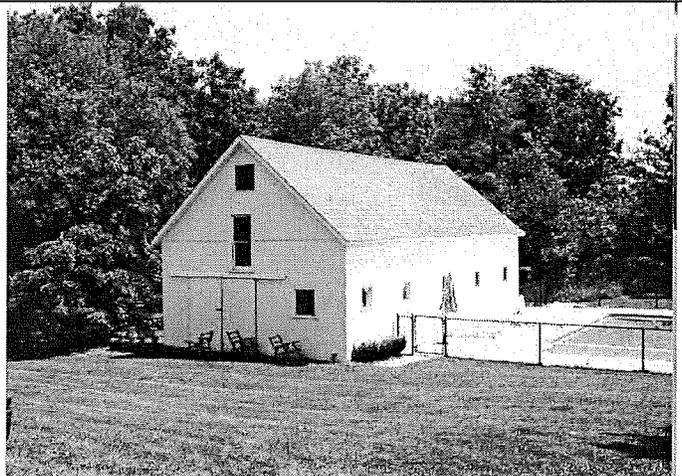
**Roll No./Neg.No.:** CL 20

<b>Circa:</b> 1910-1945	<b>Condition:</b> Excellent	<b>Integrity:</b> Excellent
----------------------------	--------------------------------	--------------------------------

<b>Materials:</b>	<b>HISTORY:</b>
<b>Foundation:</b> Poured	1910 or so
<b>Walls:</b> Vertical	Gable roof
<b>Roof:</b> Asphalt shingle	5-bay windows on side
<b>Porch:</b>	Originally horse barn, now a pool house

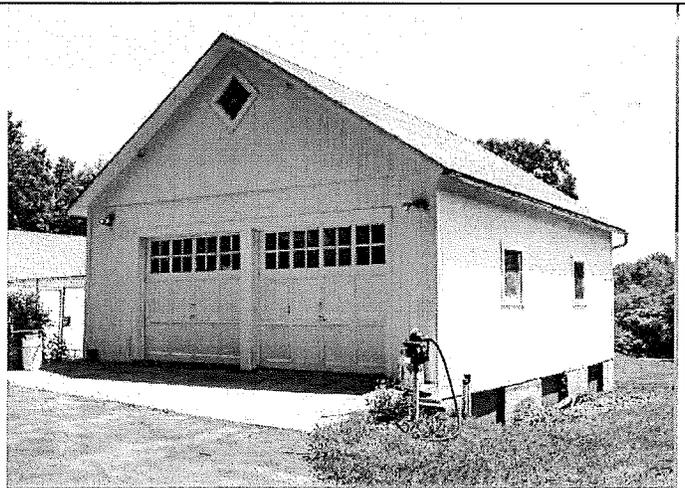
**Roll No./Neg.No.:** CL 21

<b>Circa:</b> 1910's	<b>Condition:</b> Excellent	<b>Integrity:</b> Good
-------------------------	--------------------------------	---------------------------

<b>Materials:</b>	<b>HISTORY:</b>
<b>Foundation:</b> Block	Gable roof
<b>Walls:</b> Vertical	2 up-and-over doors
<b>Roof:</b> Asphalt shingle	Originally animal shed/garage
<b>Porch:</b>	Has diamond window in gable

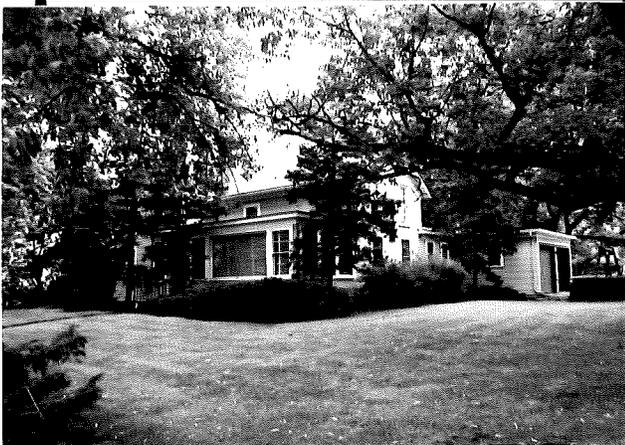
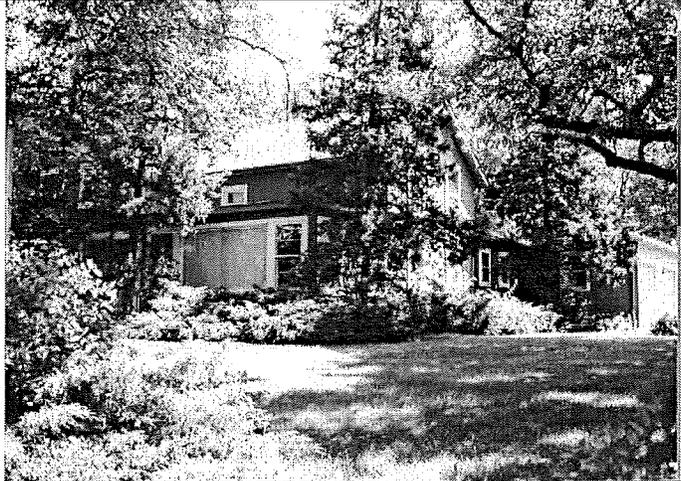
**Roll No./Neg.No.:** CL 33

<b>Circa:</b> 1860-1880	<b>Condition:</b> Good	<b>Integrity:</b> Poor
----------------------------	---------------------------	---------------------------

<b>Materials:</b>	<b>HISTORY:</b>
<b>Foundation:</b> Stone	Gable roof
<b>Walls:</b> Clapboard & asbestos	2 stories
<b>Roof:</b> Asphalt shingle	Garage has flat roof
<b>Porch:</b> <i>Enclosed</i>	
	Previous site = 2582
