McHenry County

Rural Survey

***Nunda Township***

***FIELD DATA SHEETS***

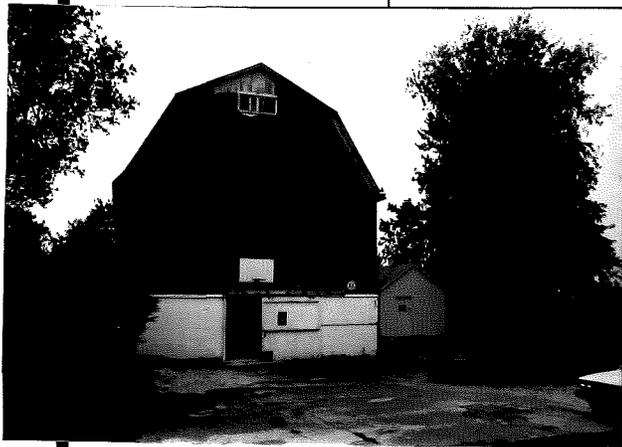
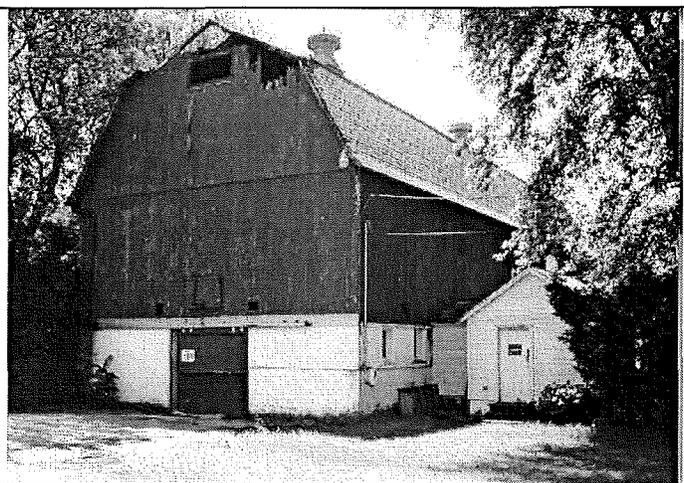
**Roll No./Neg.No.:** CL 17

<b>Circa:</b> 1910-1945	<b>Condition:</b> Poor	<b>Integrity:</b> Excellent
----------------------------	---------------------------	--------------------------------

<b>Materials:</b>	<b>HISTORY:</b>
<b>Foundation:</b> Poured	Previous survey notes that barn was rebuilt in 1920's or 1930's
<b>Walls:</b> Vertical	Milk house with gable roof
<b>Roof:</b> Asphalt shingle	Double vented
<b>Porch:</b>	Holes in roof

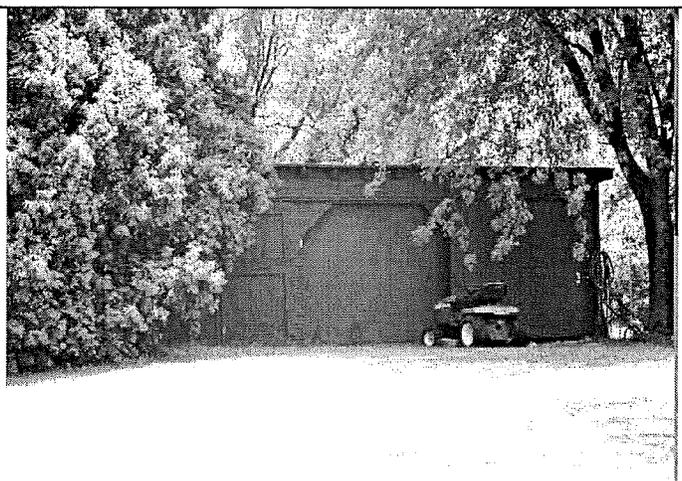
**Roll No./Neg.No.:** CL 18

<b>Circa:</b> <i>1930-1945</i>	<b>Condition:</b> Poor	<b>Integrity:</b> Excellent
-----------------------------------	---------------------------	--------------------------------

<b>Materials:</b>	<b>HISTORY:</b>
<b>Foundation:</b> Poured	Flat roof
<b>Walls:</b> Clapboard	Sliding doors
<b>Roof:</b> <i>Asphalt</i>	<i>Used as a garage</i>
<b>Porch:</b>

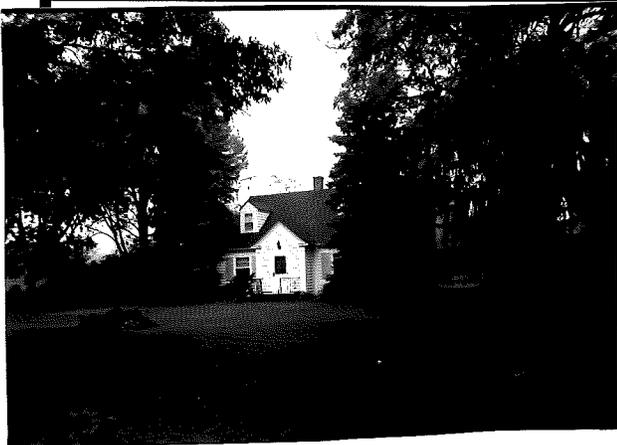
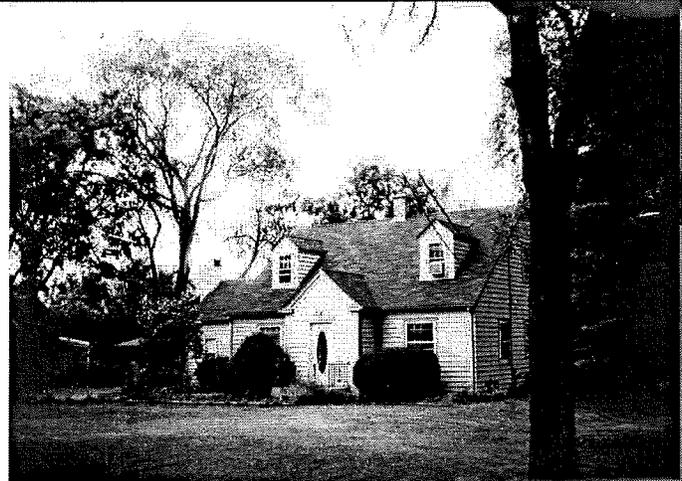
<b>Circa:</b> 1910 - 1945	<b>Condition:</b> Excellent	<b>Integrity:</b> Excellent
------------------------------	--------------------------------	--------------------------------

<b>Materials:</b>	<b>HISTORY:</b>
<b>Foundation:</b> Poured concrete	2 front dormers, central brick chimney
<b>Walls:</b> Clapboard	
<b>Roof:</b> Asphalt shingle	
<b>Porch:</b>	
	<i>Previous site = 2186</i>

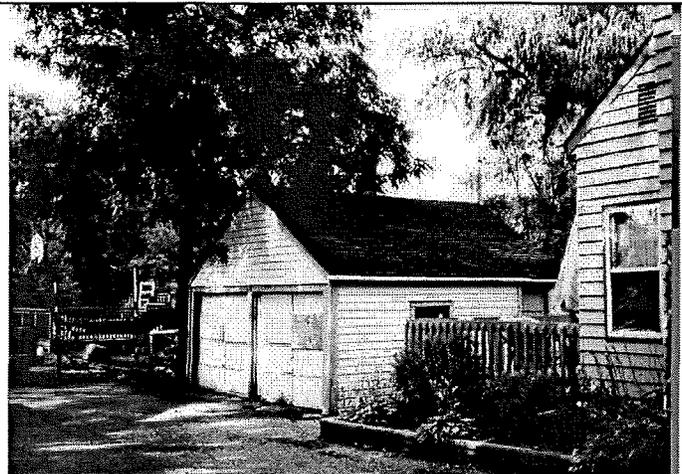
<b>Circa:</b> 1940	<b>Condition:</b> Good	<b>Integrity:</b> Good
-----------------------	---------------------------	---------------------------

<b>Materials:</b>	<b>HISTORY:</b>
<b>Foundation:</b> Concrete	
<b>Walls:</b> Clapboard	
<b>Roof:</b> Asphalt shingle	
<b>Porch:</b>

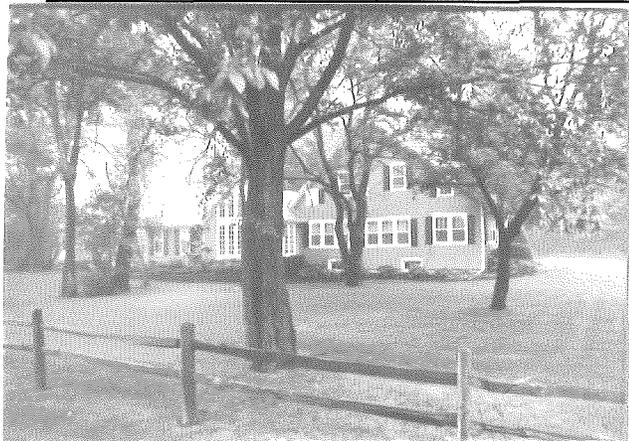
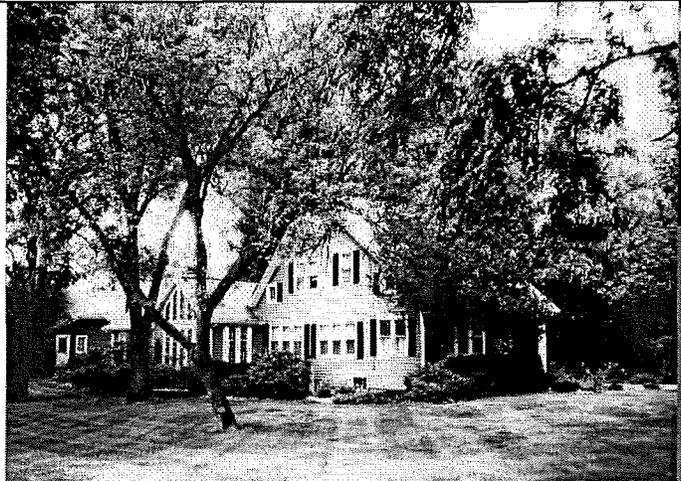
<b>Circa:</b> 1920 - 1930	<b>Condition:</b> Excellent	<b>Integrity:</b> Poor
------------------------------	--------------------------------	---------------------------

<b>Materials:</b>	<b>HISTORY:</b>
<b>Foundation:</b> Poured concrete	
<b>Walls:</b> Clapboard	
<b>Roof:</b> Asphalt shingle	
<b>Porch:</b>	
	Extensions to house destroy original integrity.
	Previous site = 2185

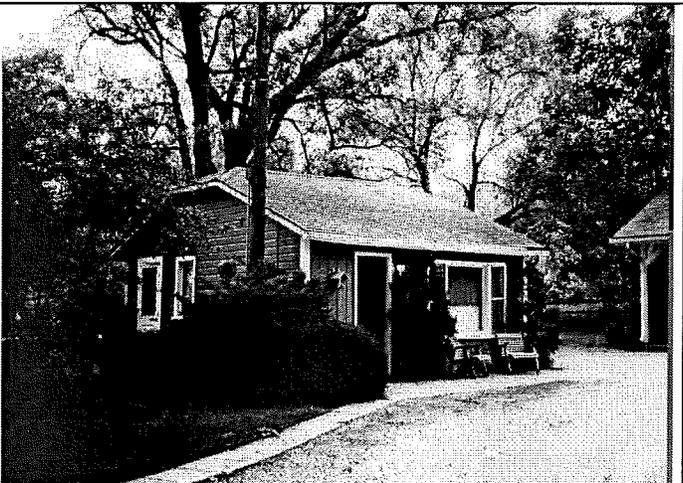
**Roll No./Neg.No.:** BB9

<b>Circa:</b> 1935	<b>Condition:</b> Excellent	<b>Integrity:</b> Excellent
-----------------------	--------------------------------	--------------------------------

<b>Materials:</b>	<b>HISTORY:</b>
<b>Foundation:</b> Concrete <b>Walls:</b> Clapboard modern vertical plank <b>Roof:</b> Asphalt shingle <b>Porch:</b>	Now a 2 <sup>nd</sup> residence, windows added, gable roof with jerkin ends.

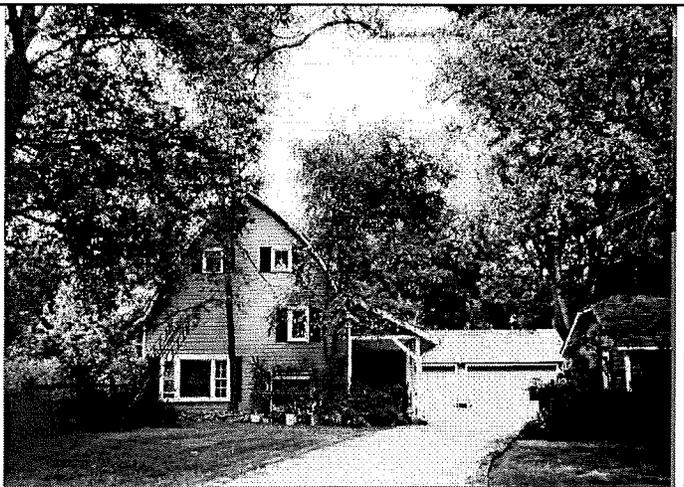
<b>Circa:</b> 1900	<b>Condition:</b> Excellent	<b>Integrity:</b> Poor
-----------------------	--------------------------------	---------------------------

<b>Materials:</b>	<b>HISTORY:</b>  Has been converted to living space, 3 car garage added on.
<b>Foundation:</b> Concrete	
<b>Walls:</b> Clapboard	
<b>Roof:</b> Asphalt shingle	
<b>Porch:</b>

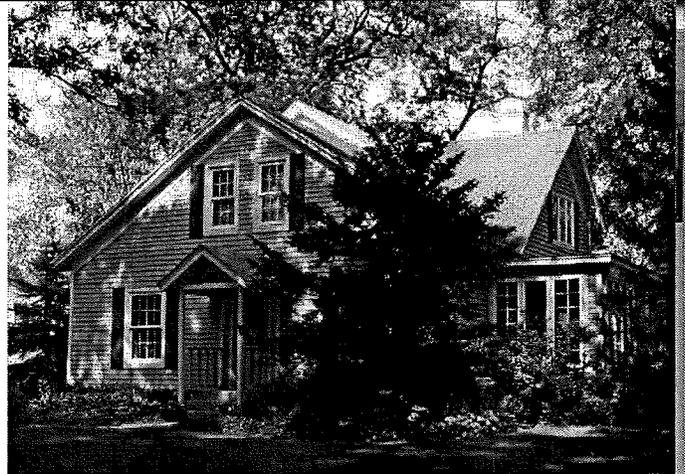
**Roll No./Neg.No.:** V16

<b>Circa:</b> 1910-1945	<b>Condition:</b> Excellent	<b>Integrity:</b> Poor
----------------------------	--------------------------------	---------------------------

<b>Materials:</b>	<b>HISTORY:</b>
<b>Foundation:</b> Poured concrete	Cidnet says parcel was deleted in 1997 to create 14-29-153-019 & 018
<b>Walls:</b> Clapboard and brick	
<b>Roof:</b> Asphalt shingle	
<b>Porch:</b>	
	Previous site = 2184

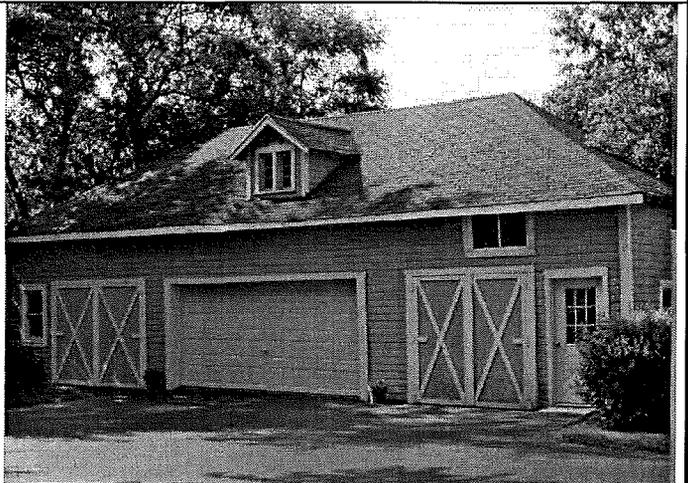
**Roll No./Neg.No.:** V14      **Surveyed by:** LM&KD      **Date:** 7-13-98

<b>Circa:</b> 1920	<b>Condition:</b> Excellent	<b>Integrity:</b> Poor
-----------------------	--------------------------------	---------------------------

<b>Materials:</b>	<b>HISTORY:</b>
<b>Foundation:</b> Concrete	2 car garage with 2 sets of barn doors
<b>Walls:</b> Beveled clapboard	Hipped roof with dormer
<b>Roof:</b> Asphalt shingle	
<b>Porch:</b>

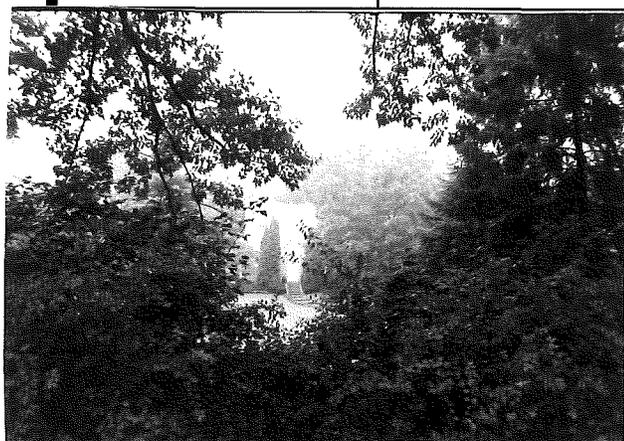
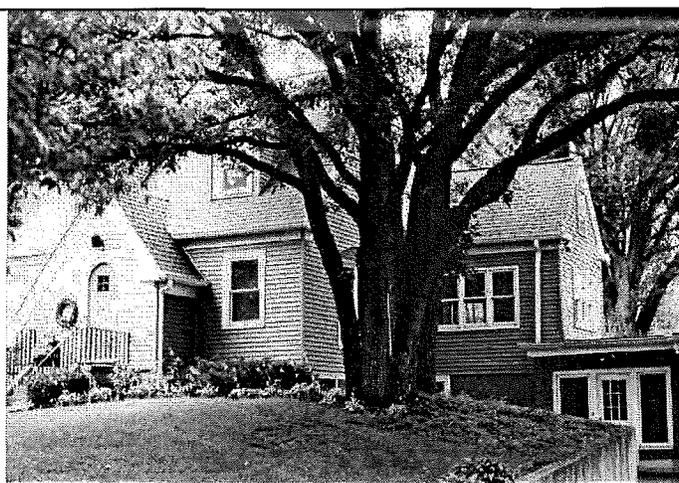
**Roll No./Neg.No.:** T5

<b>Circa:</b> 1920 - 1940	<b>Condition:</b> Excellent	<b>Integrity:</b> Poor
------------------------------	--------------------------------	---------------------------

<b>Materials:</b>	<b>HISTORY:</b>
<b>Foundation:</b> Poured	Attached 3 <sup>-car</sup> garage
<b>Walls:</b> Synthetic siding	2 dormered windows on front w/ front saltbox entry
<b>Roof:</b> Asphalt shingle	Cape cod style
<b>Porch:</b>	Previous site = 2183

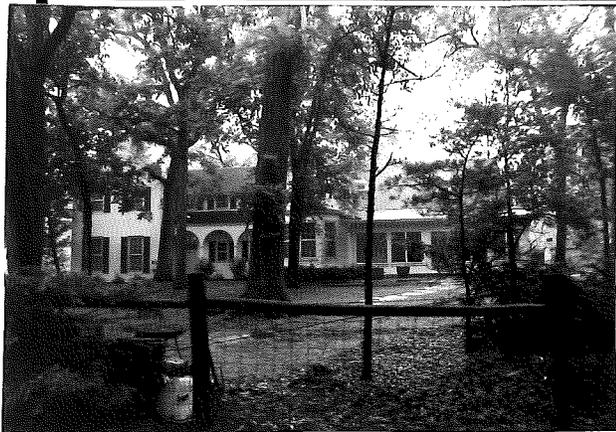
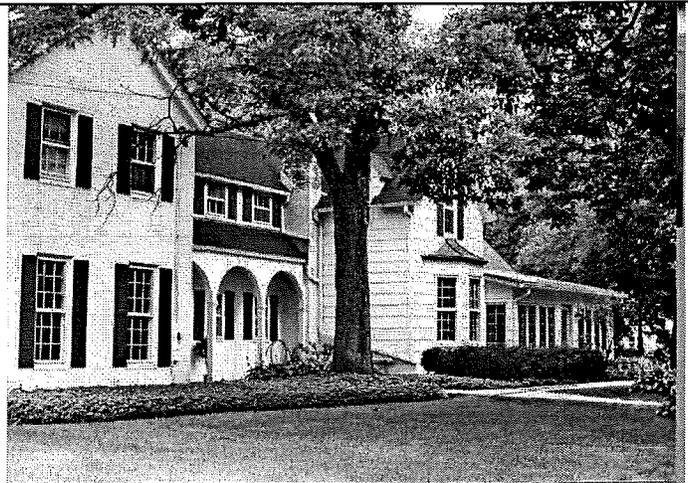
**Roll No./Neg.No.:** T7

<b>Circa:</b> 1860-1872	<b>Condition:</b> Excellent	<b>Integrity:</b> Poor
----------------------------	--------------------------------	---------------------------

<b>Materials:</b>	<b>HISTORY:</b>
<b>Foundation:</b> Poured concrete	Various gables
<b>Walls:</b> Brick and clapboard	
<b>Roof:</b> Asphalt shingle	
<b>Porch:</b>	
	Previous site = 2182

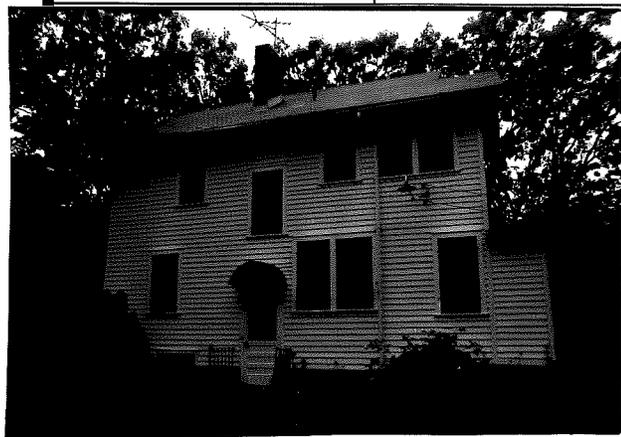
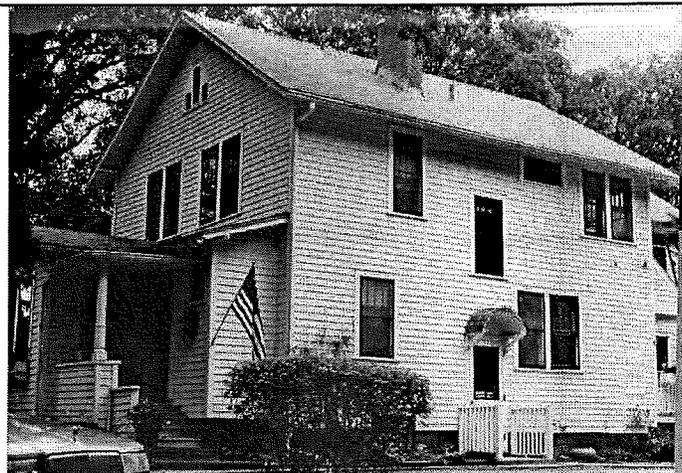
**Roll No./Neg.No.:** T4

<b>Circa:</b> 1920 - 1930	<b>Condition:</b> Excellent	<b>Integrity:</b> Good
------------------------------	--------------------------------	---------------------------

<b>Materials:</b>	<b>HISTORY:</b>
<b>Foundation:</b> Poured	Major addition in rear
<b>Walls:</b> Clapboard	1926 according to resident
<b>Roof:</b> Asphalt shingle	
<b>Porch:</b> Front enclosed, entry porch	Previous site = 2180

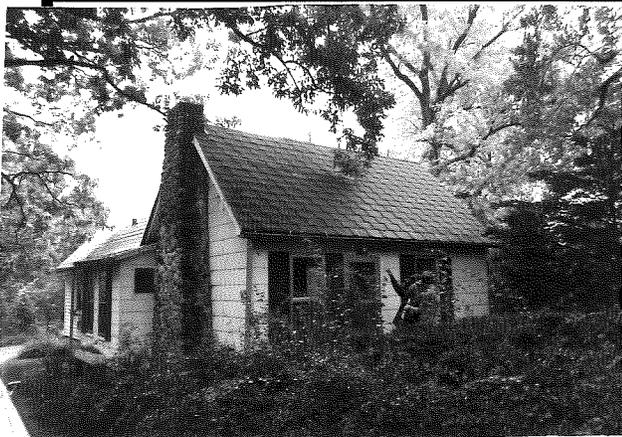
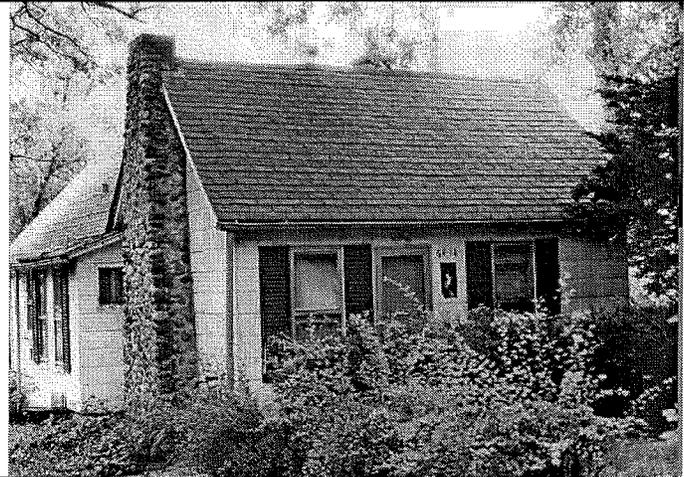
**Roll No./Neg.No.:** S34&S35

<b>Circa:</b> 1910 - 1940	<b>Condition:</b> Poor	<b>Integrity:</b> Good
------------------------------	---------------------------	---------------------------

<b>Materials:</b>	<b>HISTORY:</b>
<b>Foundation:</b> Concrete and stone	Stone chimney
<b>Walls:</b> Asbestos and synthetic siding	Owned by a Japanese couple for many years
<b>Roof:</b> Asphalt shingle	Has rear ramp going into garage under the house
<b>Porch:</b> enclosed	<i>rear view on back →</i>
	Previous site-2181

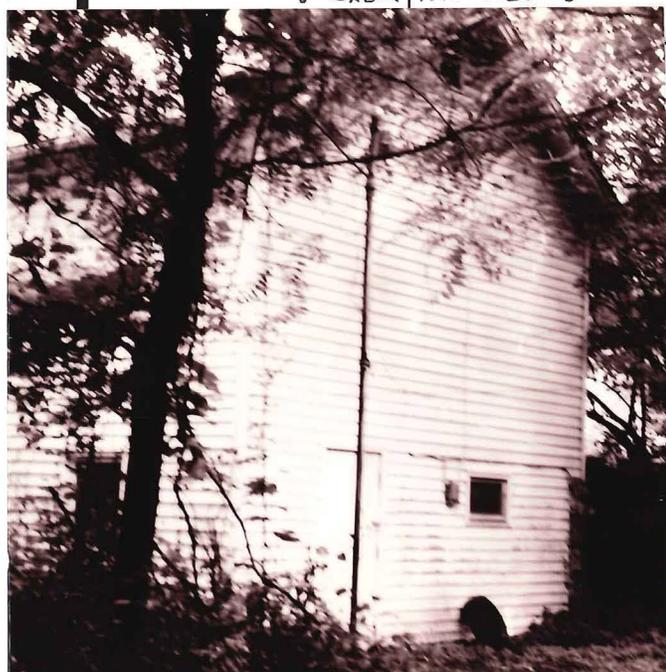
<b>Materials:</b>	<b>HISTORY:</b>
<b>Foundation:</b> Concrete	2 stories
<b>Walls:</b> Synthetic siding	built on part of old stone foundation of barn
<b>Roof:</b> Asphalt shingle	2 <sup>nd</sup> story entrance where ramped barn entry would have been
<b>Porch:</b>	<i>✓ extra 1998 view ✓</i>

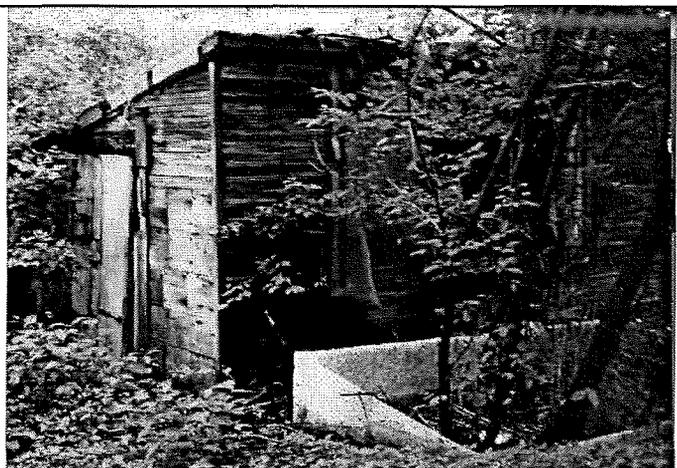
**Roll No./Neg.No.:** T2      **Surveyed by:** LM&KD      **Date:** 7-7-98

<b>Circa:</b> 1930	<b>Condition:</b> Poor	<b>Integrity:</b> Good
-----------------------	---------------------------	---------------------------

<b>Materials:</b>	<b>HISTORY:</b>  Slanted roof
<b>Foundation:</b>	
<b>Walls:</b> Clapboard	
<b>Roof:</b> Metal and asphalt	
<b>Porch:</b>

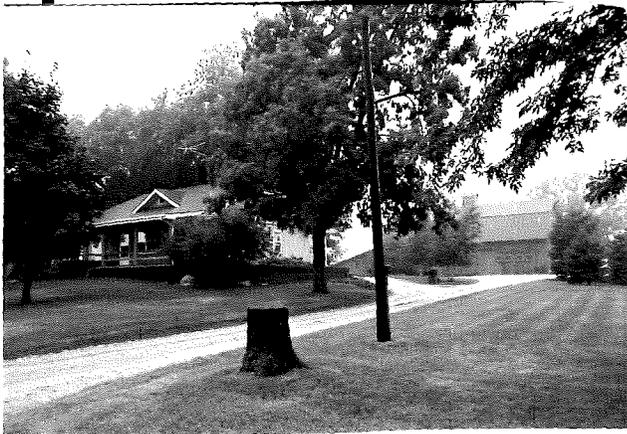
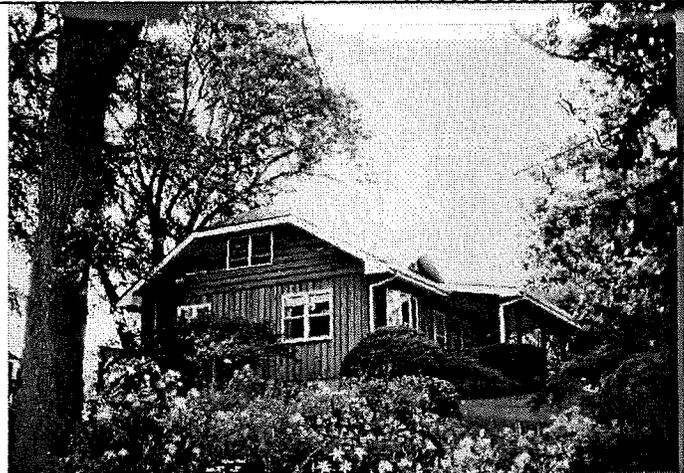
**Roll No./Neg.No.:** BB19

Circa:	Condition:	Integrity:
1920	Excellent	Poor

Materials:	HISTORY:
<b>Foundation:</b> Stone and poured <b>Walls:</b> Vertical (modern) <b>Roof:</b> Asphalt shingle <b>Porch:</b>	<i>Original</i> 1920's house burned down, front gable dormer, gable with jerkin ends          Previous site = 2187

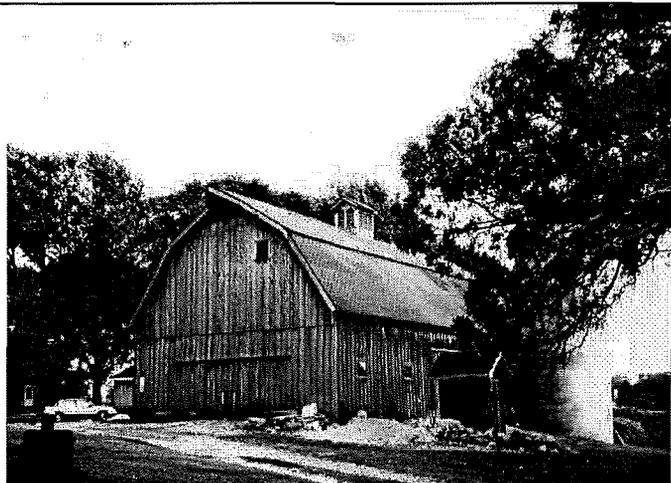
<b>Circa:</b> 1902 (as per resident)	<b>Condition:</b> Good	<b>Integrity:</b> Good
---	---------------------------	---------------------------

<b>Materials:</b>	<b>HISTORY:</b>  Wooden cupola, sliding doors, ramped, 1853 farm existed at 100 acres, - grappling hook extension
<b>Foundation:</b> Stone	
<b>Walls:</b> Vertical plank (batten)	
<b>Roof:</b> Asphalt shingle	
<b>Porch:</b>

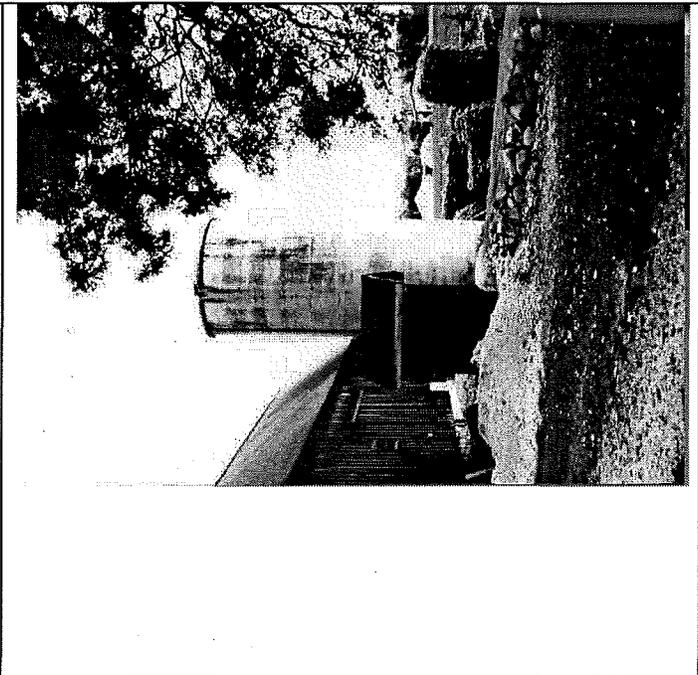
<b>Circa:</b> 1920	<b>Condition:</b> Good	<b>Integrity:</b> Good
-----------------------	---------------------------	---------------------------

<b>Materials:</b>	<b>HISTORY:</b>  Side flanking
<b>Foundation:</b> Concrete	
<b>Walls:</b> Concrete, <i>poured</i>	
<b>Roof:</b> Concrete cone	
<b>Porch:</b>

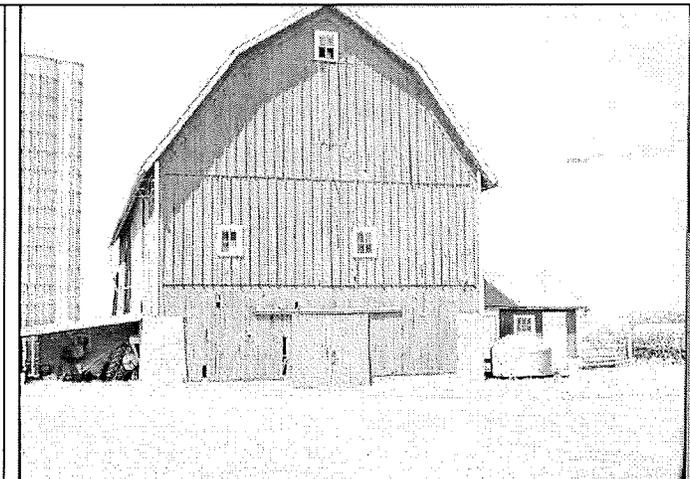
**Roll No./Neg.No.:** CL3/6      **Surveyed by:** CL      **Date:** 7/1

<b>Circa:</b> 1910 - 1930	<b>Condition:</b> Poor	<b>Integrity:</b> Excellent
------------------------------	---------------------------	--------------------------------

<b>Materials:</b>	<b>HISTORY:</b>
<b>Foundation:</b> Stone	Partial banked
<b>Walls:</b> Vertical	Milkhouse attached
<b>Roof:</b> Asphalt shingle	
<b>Porch:</b>

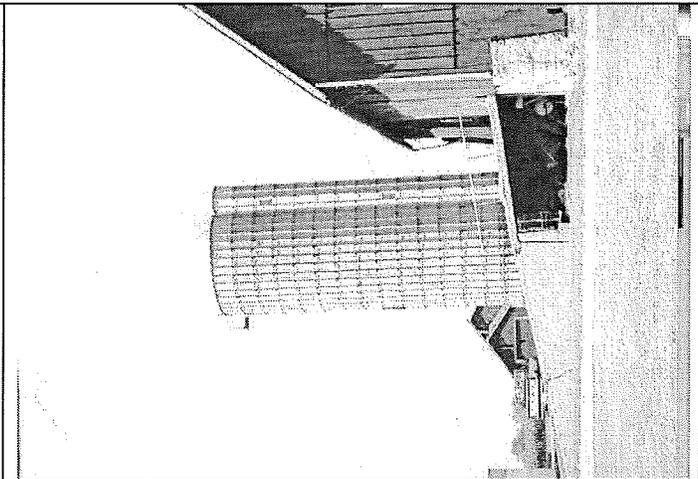
Roll No./Neg.No.: CL3/6	Surveyed by: CL	Date: 7/1
-------------------------	-----------------	-----------

<b>Circa:</b> 1910 - 1930	<b>Condition:</b> Excellent	<b>Integrity:</b> Excellent
------------------------------	--------------------------------	--------------------------------

<b>Materials:</b>	<b>HISTORY:</b>
<b>Foundation:</b>	
<b>Walls:</b> Staved concrete	
<b>Roof:</b> Metal dome	
<b>Porch:</b>

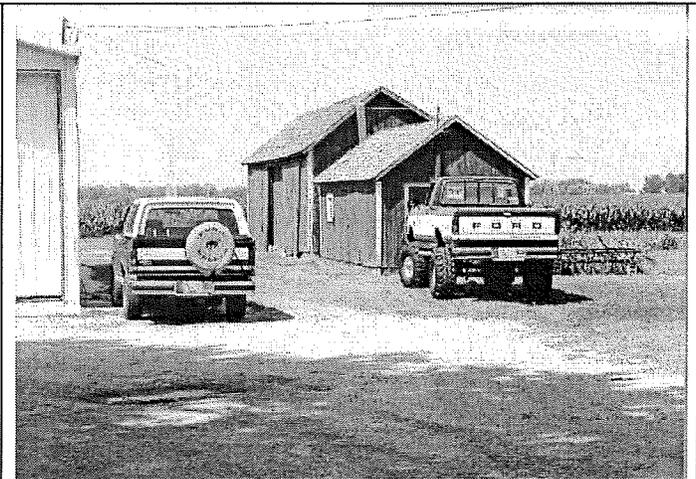
**Roll No./Neg.No.:** CL3/6

<b>Circa:</b> 1900 - 1930	<b>Condition:</b> Fair	<b>Integrity:</b> Fair
------------------------------	---------------------------	---------------------------

<b>Materials:</b>	<b>HISTORY:</b>
<b>Foundation:</b>	
<b>Walls:</b> Wood plank	
<b>Roof:</b> Wood shingle	
<b>Porch:</b>

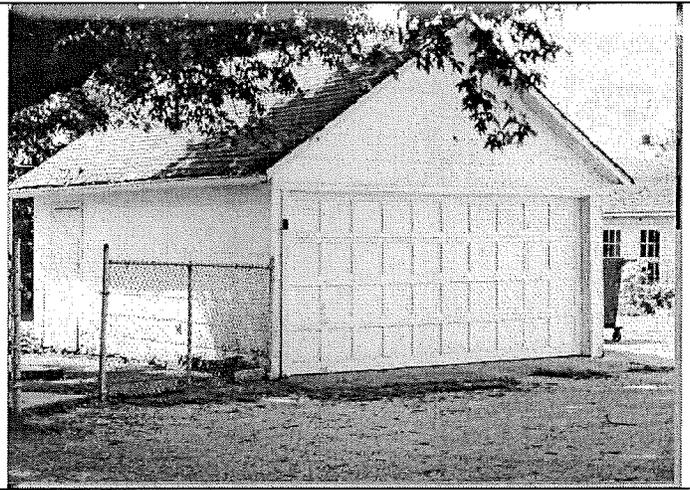
**Roll No./Neg.No.:** CL3/6      **Surveyed by:** CL      **Date:** 7/1

<b>Circa:</b> 1900 - 1930	<b>Condition:</b> Good	<b>Integrity:</b> Good
------------------------------	---------------------------	---------------------------

<b>Materials:</b>	<b>HISTORY:</b>
<b>Foundation:</b> Paved	
<b>Walls:</b> Asbestos	
<b>Roof:</b> Asphalt shingle	
<b>Porch:</b>

Gable roof  
One up-and-over door

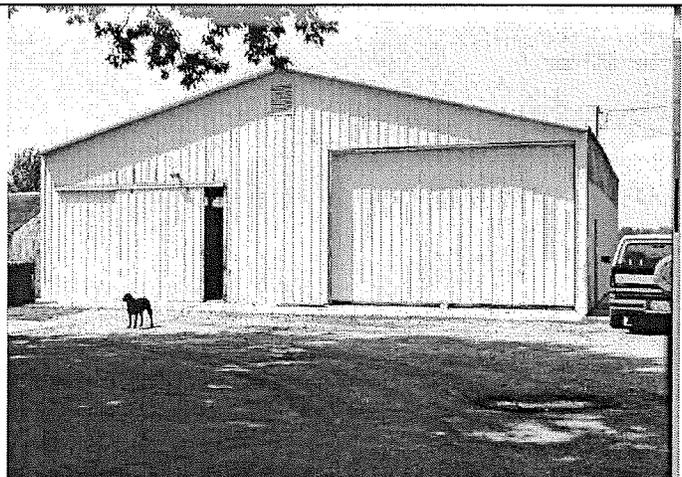
**Roll No./Neg.No.:** CL3/6

<b>Circa:</b> Post 1945	<b>Condition:</b> Good	<b>Integrity:</b> Good
----------------------------	---------------------------	---------------------------

<b>Materials:</b>	<b>HISTORY:</b>
<b>Foundation:</b> Concrete slab <b>Walls:</b> Vertical metal <b>Roof:</b> Metal <b>Porch:</b>	Gable

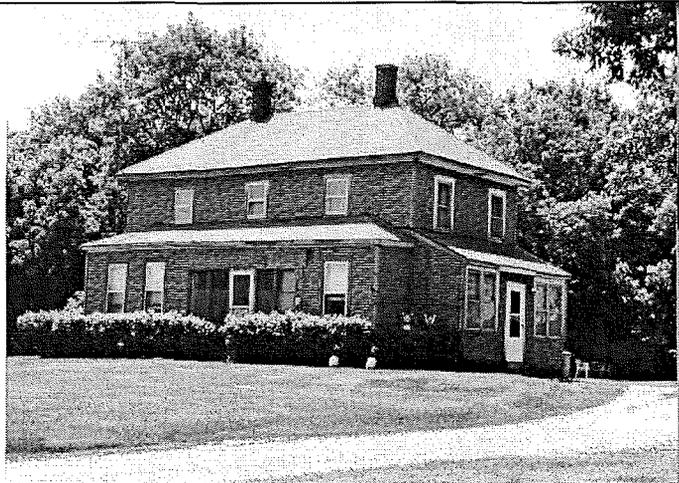
**Roll No./Neg.No.:** CL3/3

<b>Circa:</b> 1860 - 1880	<b>Condition:</b> Poor	<b>Integrity:</b> Good
------------------------------	---------------------------	---------------------------

<b>Materials:</b>	<b>HISTORY:</b>
<b>Foundation:</b> Poured concrete	Hipped roof
<b>Walls:</b> Asbestos	Twin brick chimney internal to house
<b>Roof:</b> Wood shingle	Windows changed
<b>Porch:</b> Enclosed	
	Previous site = 2000

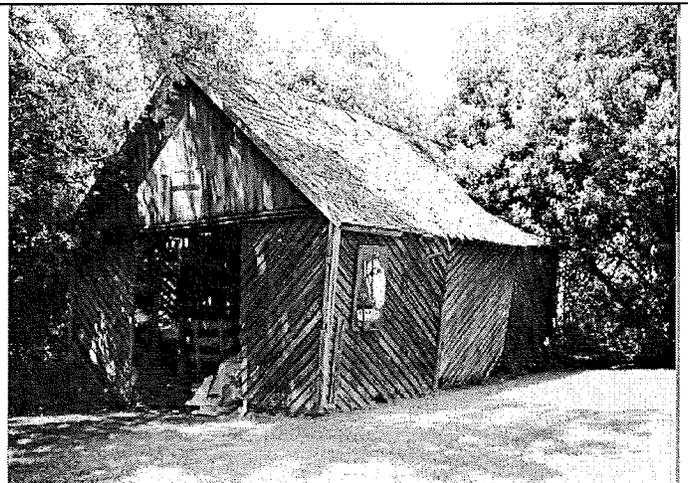
<b>Circa:</b> 1880 - 1900	<b>Condition:</b> Poor	<b>Integrity:</b> Good
------------------------------	---------------------------	---------------------------

<b>Materials:</b>	<b>HISTORY:</b>
<b>Foundation:</b>	
<b>Walls:</b> Diagonal wood slats	
<b>Roof:</b> Wood shingle	
<b>Porch:</b>	
	Previous site = 2000

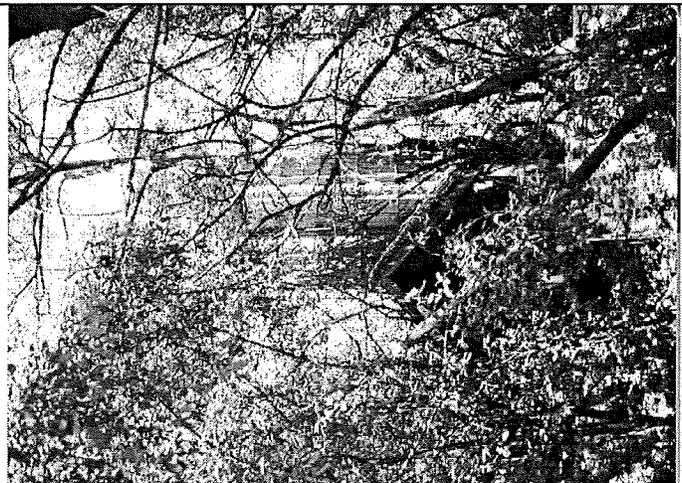
<b>Circa:</b> 1880 - 1930	<b>Condition:</b> Poor	<b>Integrity:</b> Good
------------------------------	---------------------------	---------------------------

<b>Materials:</b>	<b>HISTORY:</b>
<b>Foundation:</b> Concrete	Staved concrete
<b>Walls:</b> Concrete staved	Flanked by the barn's old fieldstone foundation
<b>Roof:</b> Metal dome	Gable entrance with wood shingle
<b>Porch:</b>	Round metal top
	Surrounded by trees and underbrush on all sides, did not get good photo
	Previous site = 2000

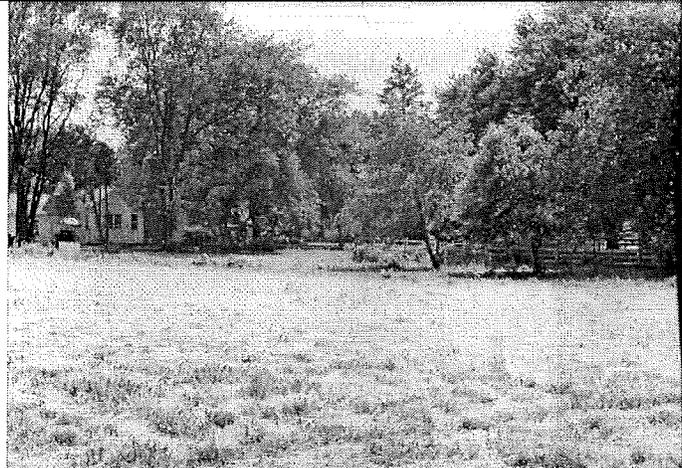
**Roll No./Neg.No.:** CL3/14

<b>Circa:</b> 1900 - 1920	<b>Condition:</b> Fair	<b>Integrity:</b> Fair
------------------------------	---------------------------	---------------------------

<b>Materials:</b>	<b>HISTORY:</b>
<b>Foundation:</b> Poured	Gabled roof
<b>Walls:</b> Clapboard	Brick chimney at side
<b>Roof:</b> Asphlat shingle	2 story
<b>Porch:</b> Enclosed	Previous site = 2588

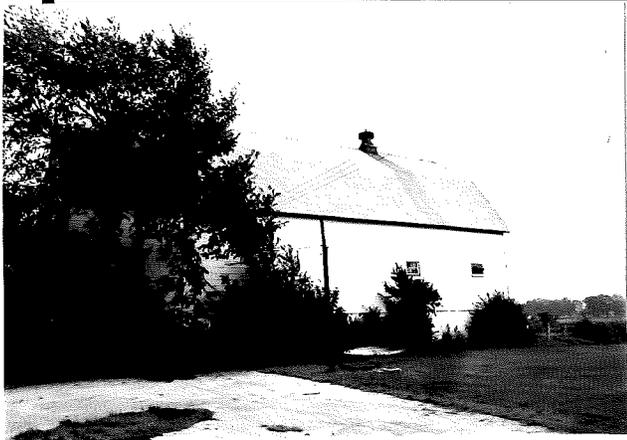
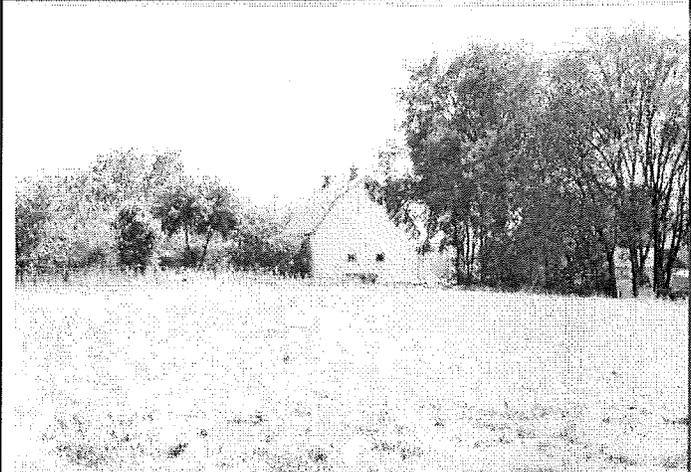
**Roll No./Neg.No.:** CL3/13

<b>Circa:</b> 1890 - 1910	<b>Condition:</b> Good	<b>Integrity:</b> Excellent
------------------------------	---------------------------	--------------------------------

<b>Materials:</b>	<b>HISTORY:</b>
<b>Foundation:</b> Stone	Double vent
<b>Walls:</b> Asbestos	
<b>Roof:</b> Asph. t shingle	
<b>Porch:</b>	Previous site = 2588

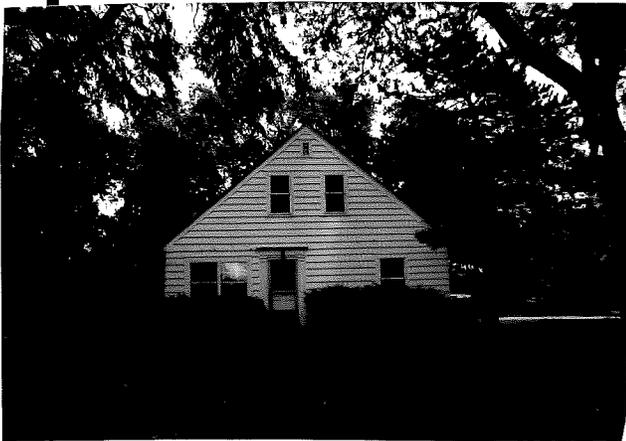
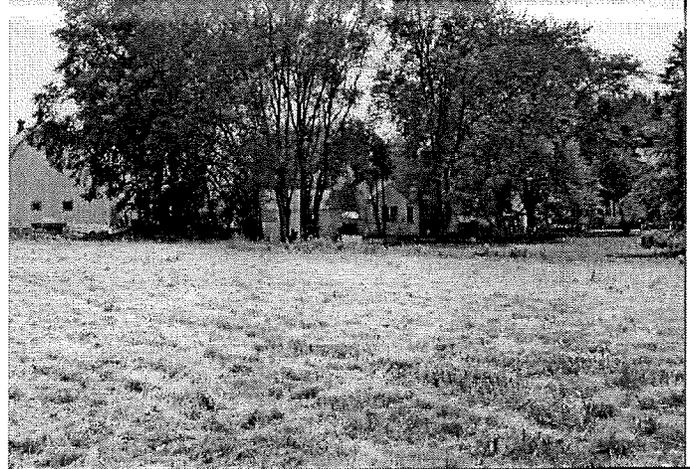
**Roll No./Neg.No.:** CL3/12

<b>Circa:</b> 1970 - 1940	<b>Condition:</b> Fair	<b>Integrity:</b> Fair
------------------------------	---------------------------	---------------------------

<b>Materials:</b>	<b>HISTORY:</b>
<b>Foundation:</b> Stone	
<b>Walls:</b> Clapboard	
<b>Roof:</b> Asphlat shingle	
<b>Porch:</b>	
	1 ½ story
	Brick chimney at front
	Previous site = 2589

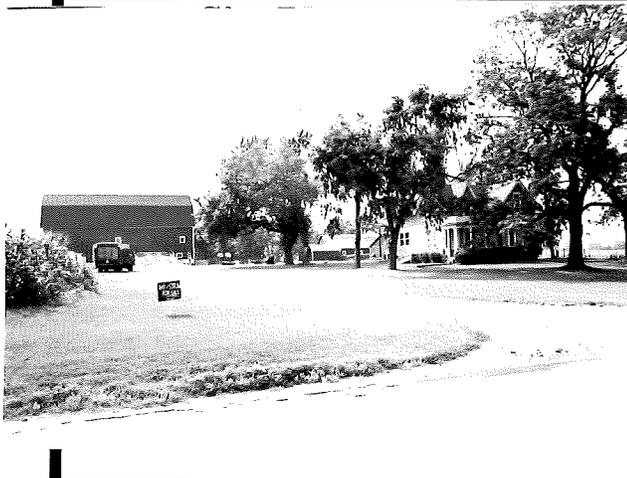
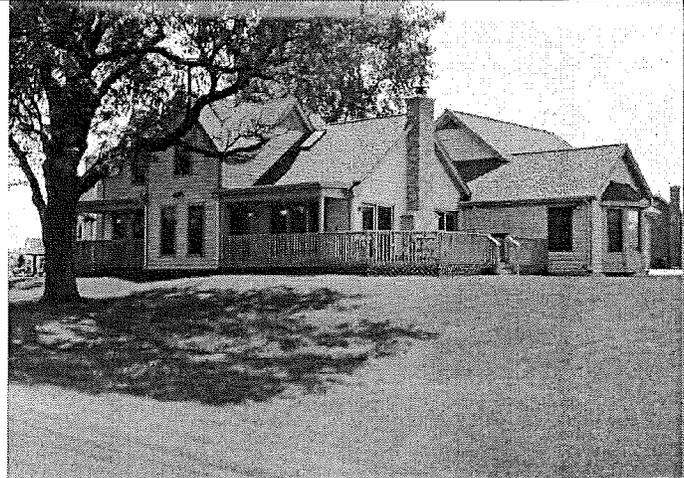
**Roll No./Neg.No.:** GG/30

<b>Circa:</b> 1880 - 1910	<b>Condition:</b> Excellent	<b>Integrity:</b> Poor
------------------------------	--------------------------------	---------------------------

<b>Materials:</b>	<b>HISTORY:</b>
<b>Foundation:</b> Stone	Looks as though it disappeared as Royal Woods developed
<b>Walls:</b> Asbestos	Cidnet notes that it is detached, single family home
<b>Roof:</b> Asphalt shingle	Lots of moderizations, extra gables, porch extensions
<b>Porch:</b> Open, but altered	Barn and out outbuilding gone
	Previous site = 1997

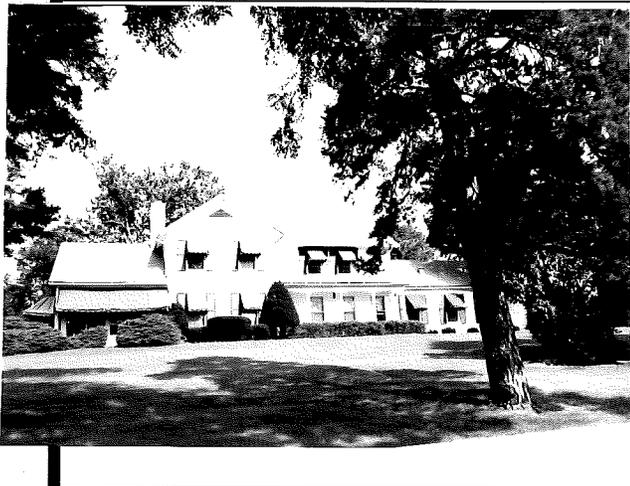
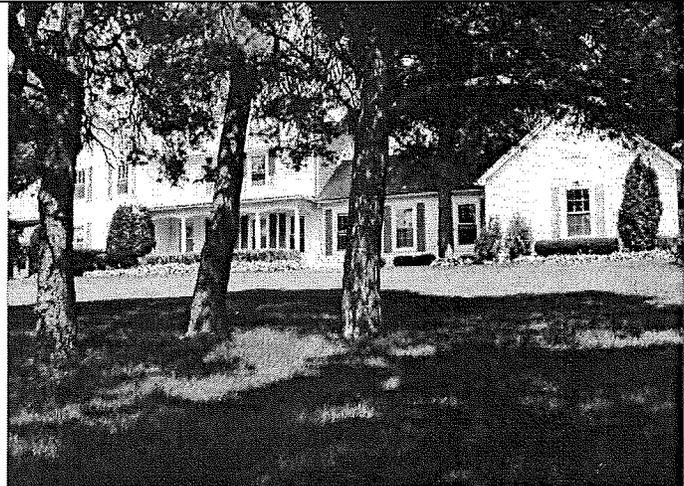
**Roll No./Neg.No.:** CL3/3

<b>Circa:</b> 1870 - 1890	<b>Condition:</b> Poor	<b>Integrity:</b> Excellent
------------------------------	---------------------------	--------------------------------

<b>Materials:</b>	<b>HISTORY:</b>
<b>Foundation:</b> Unknown	Gable upright wing
<b>Walls:</b> Clapboard	
<b>Roof:</b> Asphalt shingle	
<b>Porch:</b> Open

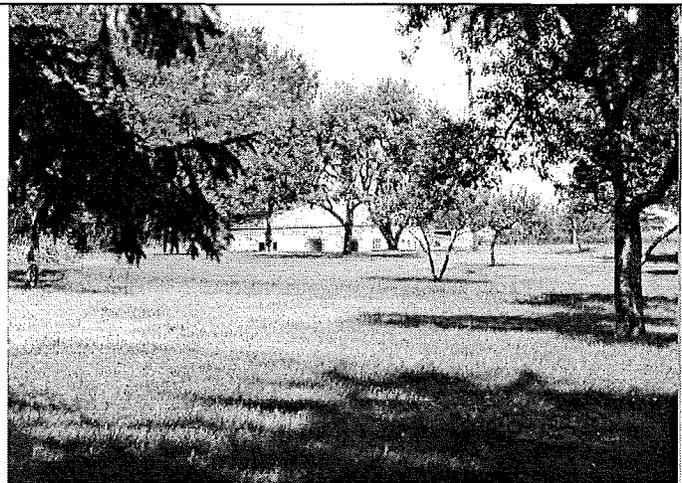
<b>Circa:</b> 1890 - 1920	<b>Condition:</b> Poor	<b>Integrity:</b> Excellent
------------------------------	---------------------------	--------------------------------

<b>Materials:</b>	<b>HISTORY:</b>
<b>Foundation:</b>	
<b>Walls:</b>	
<b>Roof:</b>	
<b>Porch:</b>	
	Looks hipped
	Looks like it is a double gable barn
	Could not get close enough
	Other buildings on site, but to far away to photograph
	Previous site = 1999

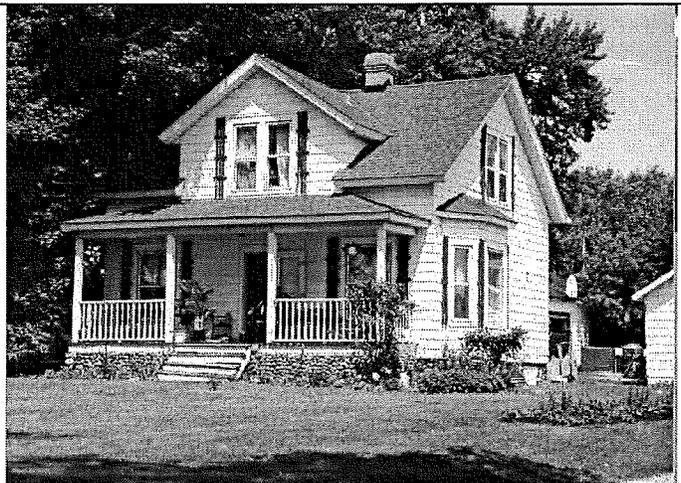
**Roll No./Neg.No.:** CL3/1

<b>Circa:</b> 1910 - 1930	<b>Condition:</b> Good	<b>Integrity:</b> Good
------------------------------	---------------------------	---------------------------

<b>Materials:</b>	<b>HISTORY:</b>
<b>Foundation:</b> Stone	Intersecting gable roof
<b>Walls:</b> Metal siding	2 story
<b>Roof:</b> Asphalt shingle	Interior brick chimney
<b>Porch:</b>	
	Previous site = 1998

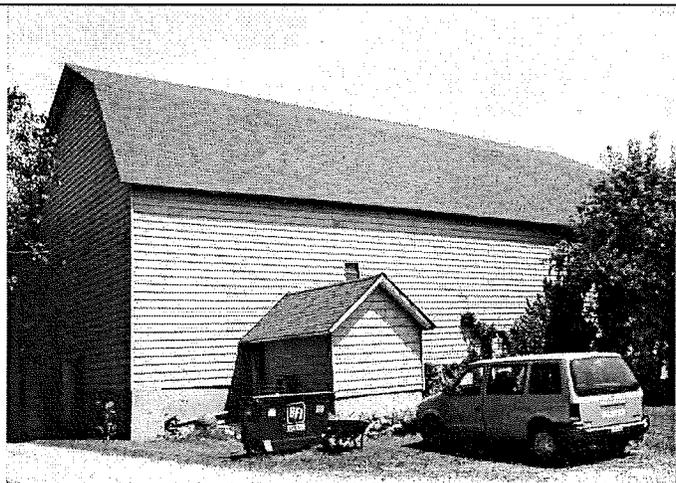
**Roll No./Neg.No.:** CL2/35

<b>Circa:</b> 1910 - 1930	<b>Condition:</b> Good	<b>Integrity:</b> Good
------------------------------	---------------------------	---------------------------

<b>Materials:</b>	<b>HISTORY:</b>
<b>Foundation:</b> Poured	New roof
<b>Walls:</b> Beveled clapboard	Banked in back with milkhouse
<b>Roof:</b> Asphalt shingle	
<b>Porch:</b>

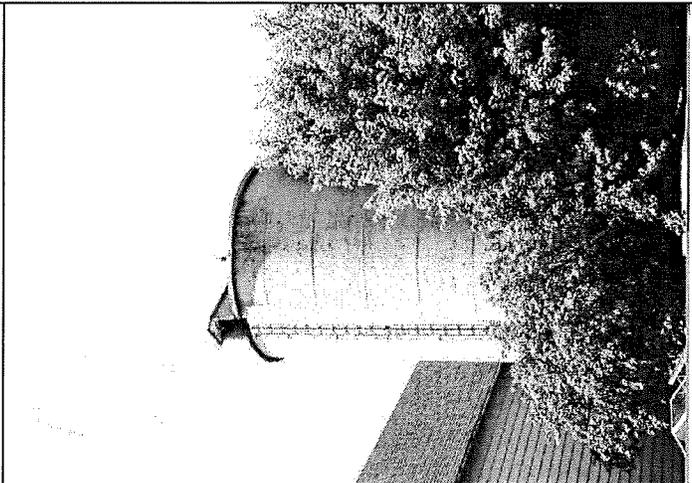
<b>Roll No./Neg.No.:</b> CL2/34	<b>Surveyed by:</b> CL	<b>Date:</b> 7/1/98
---------------------------------	------------------------	---------------------

<b>Circa:</b> 1900 - 1920	<b>Condition:</b> Good	<b>Integrity:</b> Good
------------------------------	---------------------------	---------------------------

<b>Materials:</b>	<b>HISTORY:</b>
<b>Foundation:</b> <i>Concrete</i>	
<b>Walls:</b> Poured concrete	
<b>Roof:</b> Concrete dome	
<b>Porch:</b>

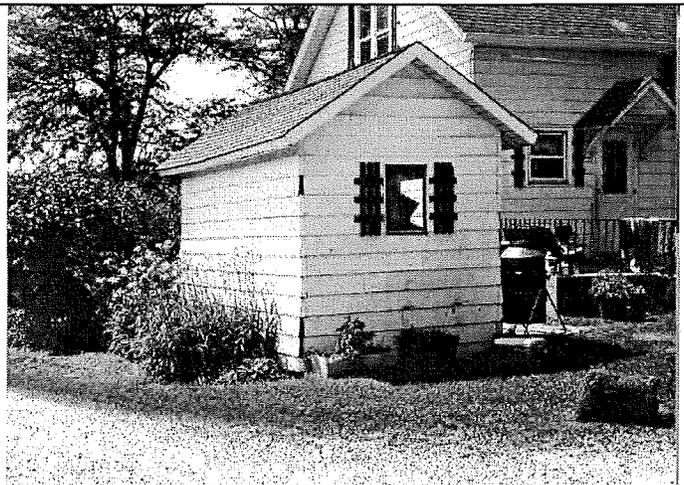
**Roll No./Neg.No.:** CL2/34

**Circa:** 1900 - 1920      **Condition:** Poor      **Integrity:** Good

<b>Materials:</b>	<b>HISTORY:</b>
<b>Foundation:</b> Brick <b>Walls:</b> Metal siding <b>Roof:</b> Asphalt shingle <b>Porch:</b>	Gable roof

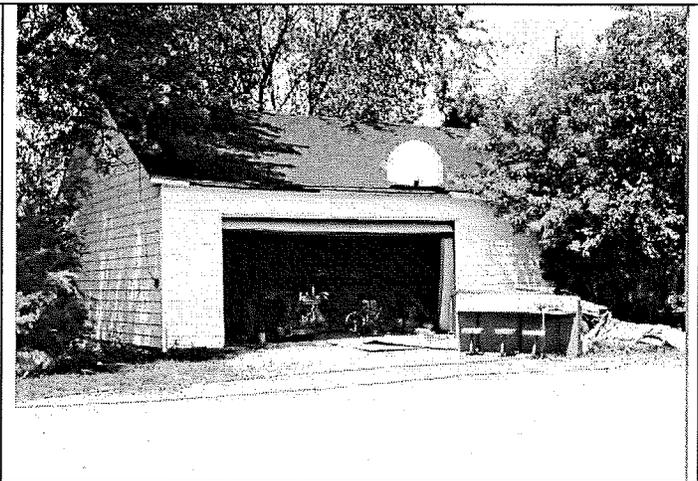
**Roll No./Neg.No.:** CL2/37      **Surveyed by:** CL      **Date:** 7/1/98

<b>Circa:</b> 1900 - 1940	<b>Condition:</b> Poor	<b>Integrity:</b> Excellent
------------------------------	---------------------------	--------------------------------

<b>Materials:</b>  <b>Foundation:</b> Poured <b>Walls:</b> Clapboard <b>Roof:</b> Asphalt shingle <b>Porch:</b>	<b>HISTORY:</b>  Gable roof
---	-----------------------------------

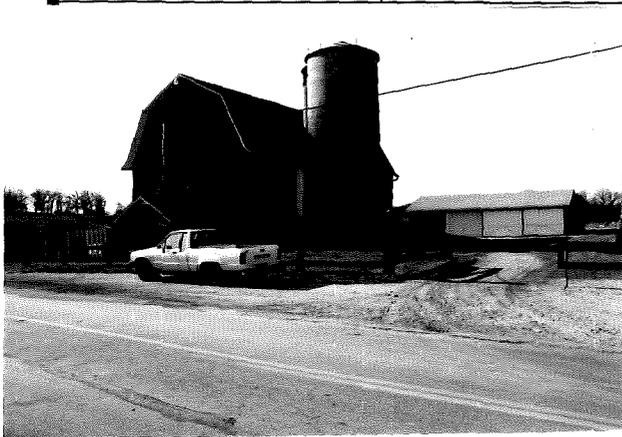
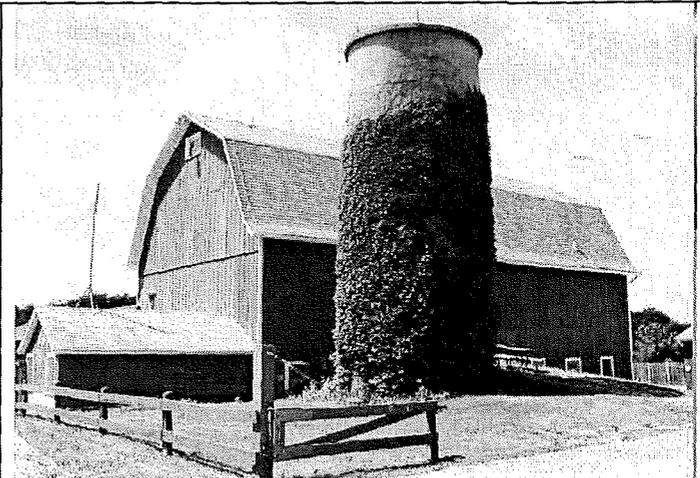
**Roll No./Neg.No.:** CL 25

<b>Circa:</b> 1860-1910	<b>Condition:</b> Excellent	<b>Integrity:</b> Excellent
----------------------------	--------------------------------	--------------------------------

<b>Materials:</b>	<b>HISTORY:</b>
<b>Foundation:</b> Block	<b>Cidnet says it is ILL Dept of Conservation, tax exempt</b>
<b>Walls:</b> Vertical	<b>Milkhouse with gable roof</b>
<b>Roof:</b> Asphalt shingle	<b>Banked barn with new up-and-over door</b>
<b>Porch:</b>	<b>Silo, poured concrete &amp; concrete roof</b>
	 <b>Previous survey = 4732</b>

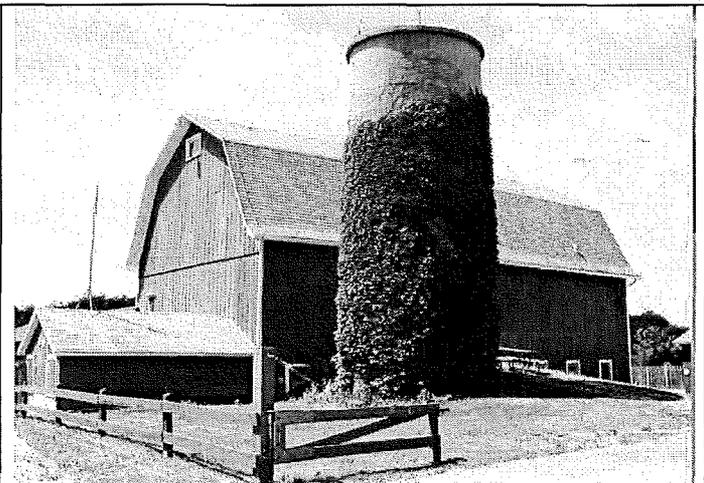
**Roll No./Neg.No.: CL 25**

<b>Circa:</b> 1900 - 1920	<b>Condition:</b> Good	<b>Integrity:</b> Good
------------------------------	---------------------------	---------------------------

<b>Materials:</b>	<b>HISTORY:</b>
<b>Foundation:</b> Poured concrete <b>Walls:</b> Poured concrete <b>Roof:</b> Concrete dome <b>Porch:</b>	Mid-flanking

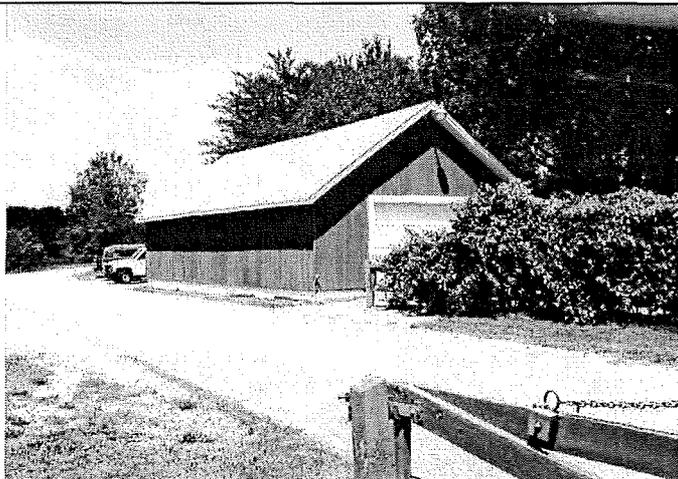
**Roll No./Neg.No.: CL 26**

<b>Circa:</b> Post 1948	<b>Condition:</b> Excellent	<b>Integrity:</b> Excellent
----------------------------	--------------------------------	--------------------------------

<b>Materials:</b>	<b>HISTORY:</b>
<b>Foundation:</b> Poured concrete	Post 1948
<b>Walls:</b> Vertical plank	Single overhead door
<b>Roof:</b> Asphalt shingle	Gable roof
<b>Porch:</b>

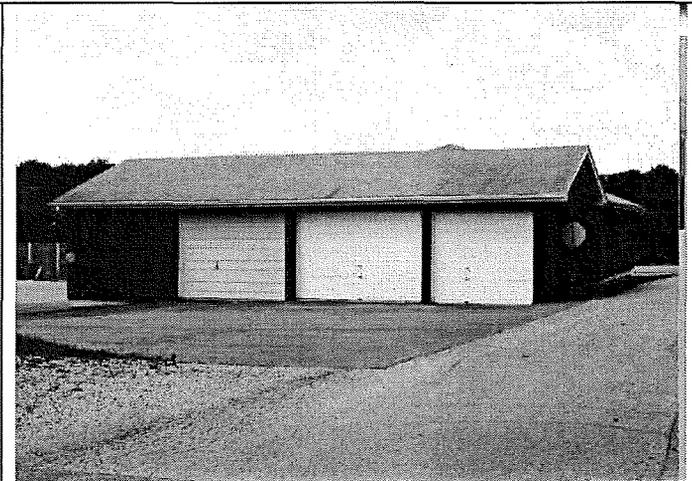
**Roll No./Neg.No.:** CL 27

<b>Circa:</b> Post 1948	<b>Condition:</b> Excellent	<b>Integrity:</b> Excellent
----------------------------	--------------------------------	--------------------------------

<b>Materials:</b>	<b>HISTORY:</b>
<b>Foundation:</b> Poured concrete <b>Walls:</b> Vertical plank <b>Roof:</b> Asphalt shingle <b>Porch:</b>	Post 1948  Triple door  Gable roof

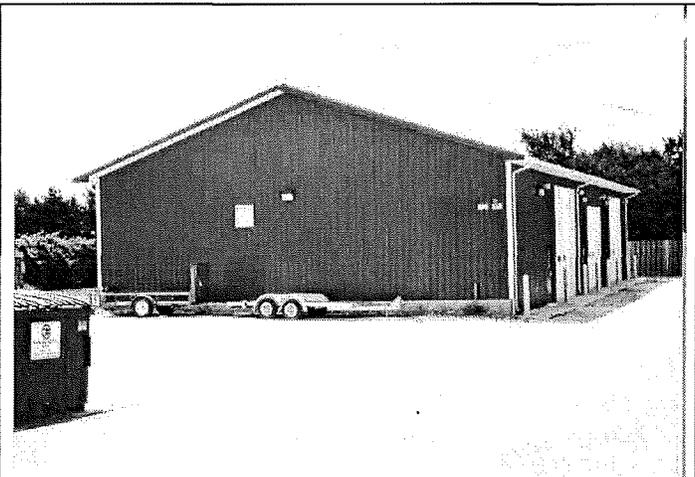
**Roll No./Neg.No.:** CL 28                      **Surveyed by:** CL                      **Date:** 6-30-98

<b>Circa:</b> Post 1948	<b>Condition:</b> Excellent	<b>Integrity:</b> Excellent
----------------------------	--------------------------------	--------------------------------

<b>Materials:</b>	<b>HISTORY:</b>
<b>Foundation:</b> Poured concrete	
<b>Walls:</b> Metal	
<b>Roof:</b> Metal	
<b>Porch:</b>
