McHenry County

Rural Survey

***Nunda Township***

***FIELD DATA SHEETS***

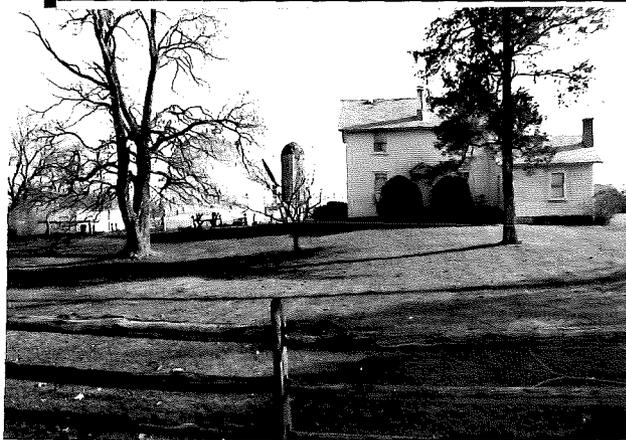
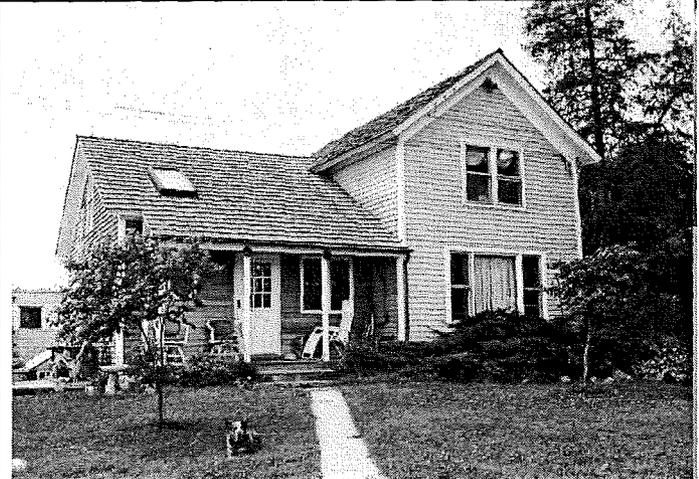
**Roll No./Neg.No.: CL 33      Surveyed by: CL      Date: 5-30-98**

<b>Circa:</b> 1880-1900	<b>Condition:</b> Excellent	<b>Integrity:</b> Fair
----------------------------	--------------------------------	---------------------------

<b>Materials:</b>	<b>HISTORY:</b>
<b>Foundation:</b>	
<b>Walls:</b> Clapboard	
<b>Roof:</b> Wood shingle	
<b>Porch:</b> At side

Skylight added

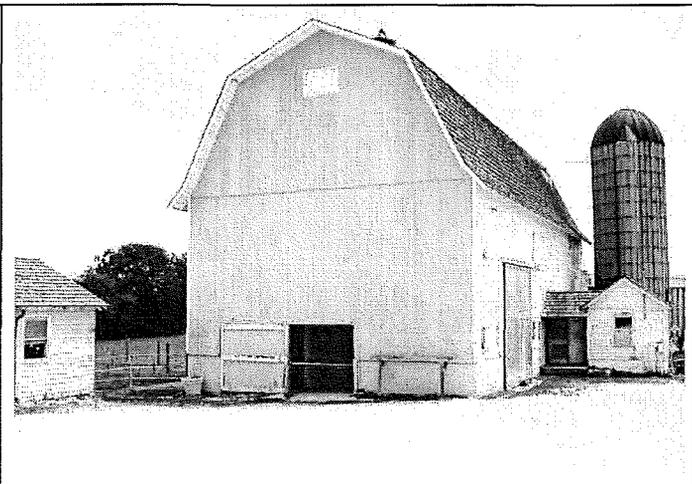
**Roll No./Neg.No.:** CL 30

<b>Circa:</b> 1890-1910	<b>Condition:</b> Good	<b>Integrity:</b> Excellent
----------------------------	---------------------------	--------------------------------

<b>Materials:</b>	<b>HISTORY:</b>
<b>Foundation:</b> Block	Milkhouse-gable roof
<b>Walls:</b> Vertical	Single vent with extensions
<b>Roof:</b> Wood shingle	
<b>Porch:</b>

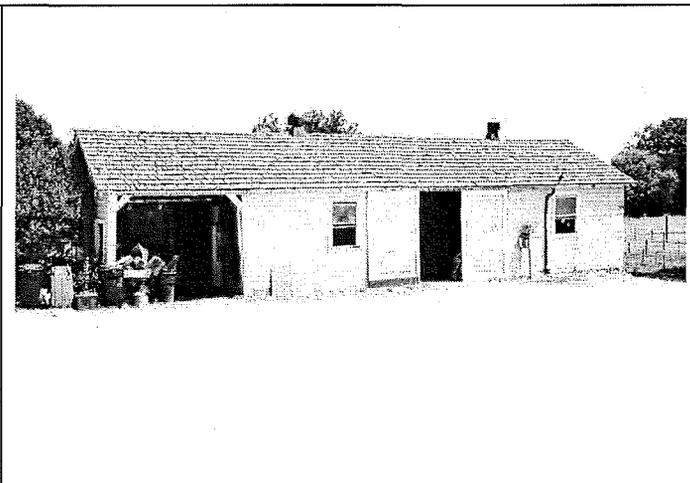
**Roll No./Neg.No.:** CL 29      **Surveyed by:** CL      **Date:** 5-30-98

<b>Circa:</b> 1900-1940	<b>Condition:</b> Excellent	<b>Integrity:</b> Excellent
----------------------------	--------------------------------	--------------------------------

<b>Materials:</b>	<b>HISTORY:</b>
<b>Foundation:</b> Poured	Gable
<b>Walls:</b> Clapboard	Double-vent
<b>Roof:</b> Wood shingle	
<b>Porch:</b>

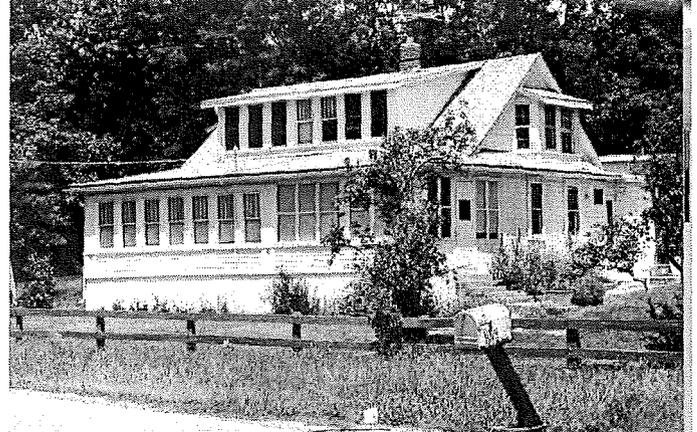
<b>Circa:</b> 1930-1945	<b>Condition:</b> Excellent	<b>Integrity:</b> Excellent
----------------------------	--------------------------------	--------------------------------

<b>Materials:</b>	<b>HISTORY:</b>
<b>Foundation:</b> Molded block	Cidnet puts Pin as IL. Dept of Conservation property
<b>Walls:</b> Clapboard	Gable roof overhead series of dormers
<b>Roof:</b> Asphalt shingle	Brick chimney
<b>Porch:</b>	Garage-hipped roof
	Asphalt shingle, poured foundation
	Double garage
	Previous site = 4727

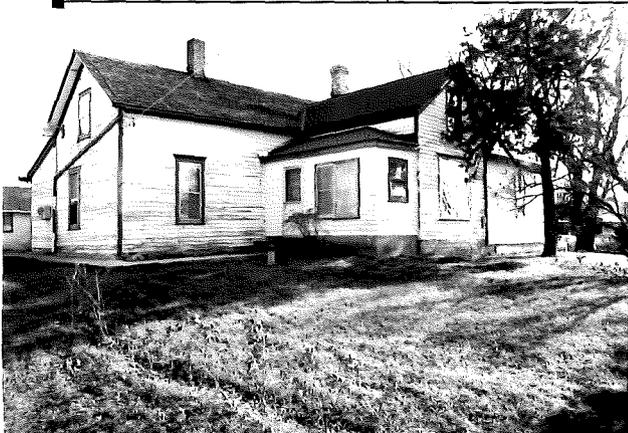
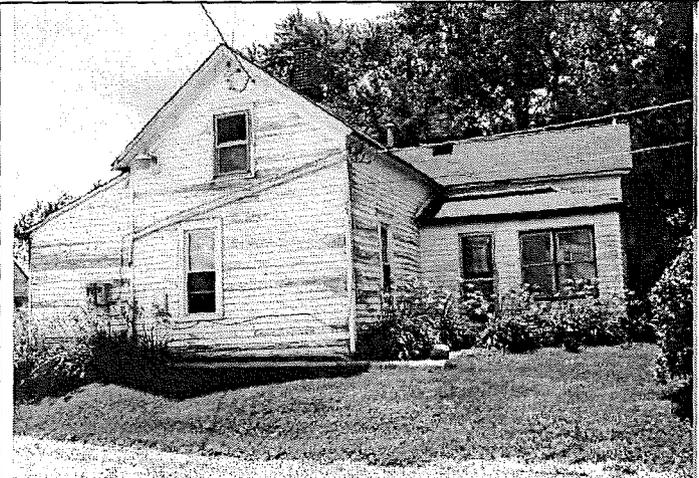
**Roll No./Neg.No.:** CL 38

Circa:	Condition:	Integrity:
1860-1880	Poor	Good

Materials:	HISTORY:
<b>Foundation:</b> Stone	1 ½ story
<b>Walls:</b> Clapboard	Gable with 1 brick chimney and 1 stone chimney
<b>Roof:</b> Wood shingle	Asbestos addition w/ cupoloa on top: this is at the side, see 1986
<b>Porch:</b>	Entire farmstead in poor condition
	Previous survey = 4730

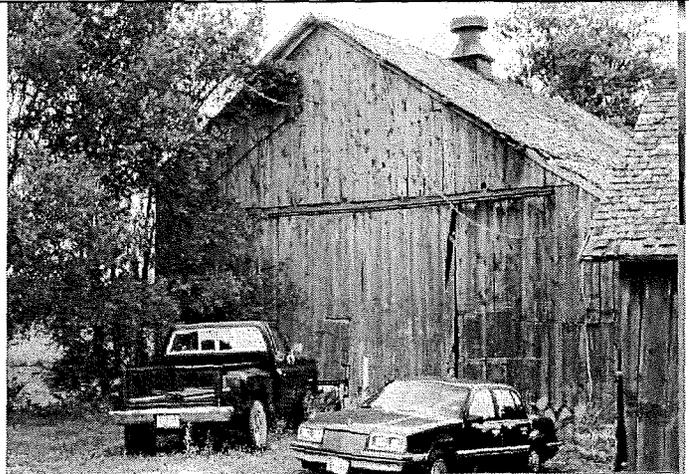
**Roll No./Neg.No.:** CL 34

<b>Circa:</b> 1860-1890	<b>Condition:</b> Poor	<b>Integrity:</b> Excellent
----------------------------	---------------------------	--------------------------------

<b>Materials:</b>	<b>HISTORY:</b>
<b>Foundation:</b> Stone	Single vent
<b>Walls:</b> Vertical	Shed extension that forms a saltbox shape
<b>Roof:</b> Wood shingle	
<b>Porch:</b>

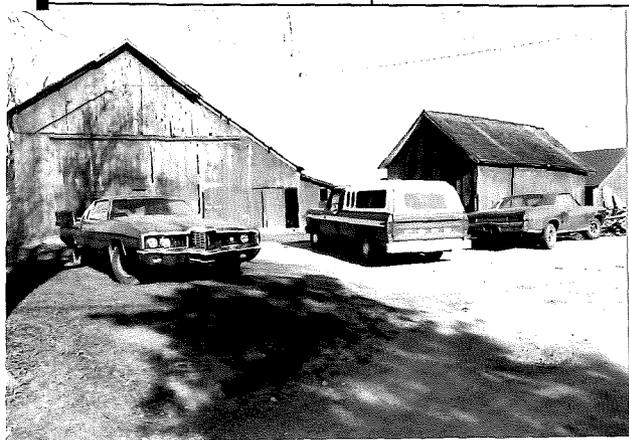
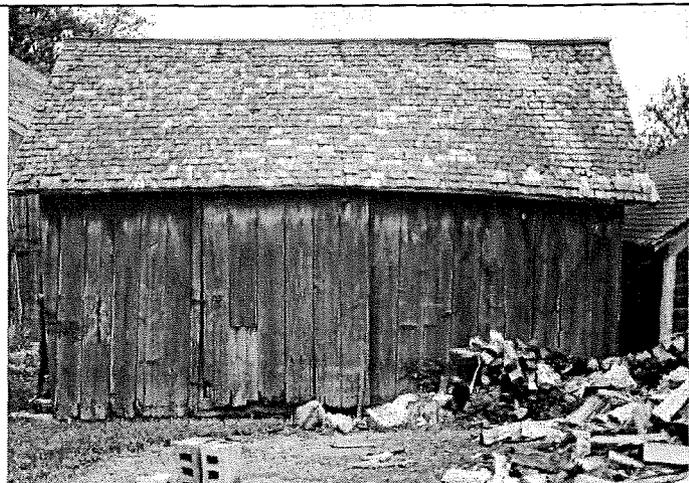
**Roll No./Neg.No.:** CL 35

<b>Function:</b> Shed	<b>Vernacular Type:</b>	<b>Arch. Style:</b>	<b>Alterations:</b>
<b>Circa:</b> 1890 - 1910	<b>Condition:</b> Poor	<b>Integrity:</b> Excellent	
<b>Source:</b>	<b>Landmark Evaluation:</b> TBD		
<b>Architect/Builder:</b> Unknown	<b>Individual:</b> <b>Criteria:</b>	<b>Farmstead:</b> /14	<b>National Register:</b> <b>Local:</b> (See reverse side of criteria listing)
<b>Materials:</b>  <b>Foundation:</b> Block <b>Walls:</b> Vertical plank <b>Roof:</b> Wood shingle <b>Porch:</b>	<b>HISTORY:</b>  Wide : vertical, wood shingle, block foundation  Gable roof  Note metal ridge cap

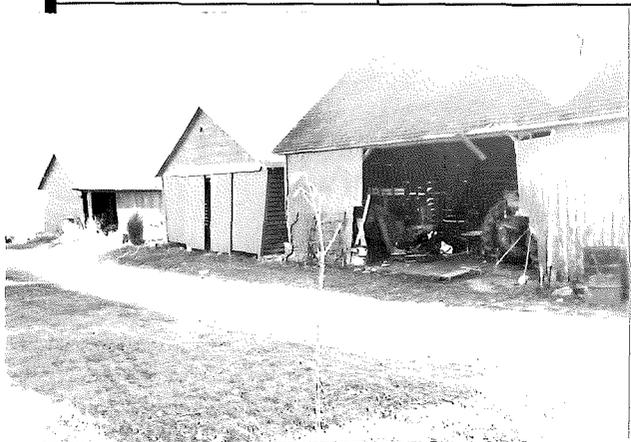
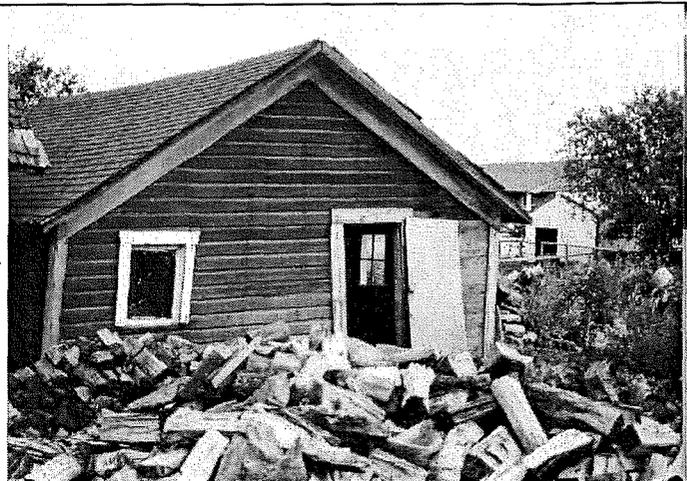
**Roll No./Neg.No.:** CL 36

<b>Circa:</b> 1920 - 1940	<b>Condition:</b> Poor	<b>Integrity:</b> Excellent
------------------------------	---------------------------	--------------------------------

<b>Materials:</b>	<b>HISTORY:</b>  Gable roof
<b>Foundation:</b> Block	
<b>Walls:</b> Beveled clapboard	
<b>Roof:</b> Asphalt shingle	
<b>Porch:</b>

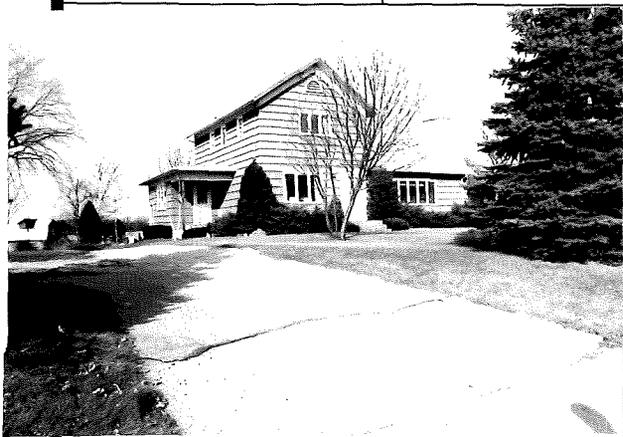
**Roll No./Neg.No.: CL 5**

<b>Circa:</b> 1860-188.0	<b>Condition:</b> Excellent	<b>Integrity:</b> Fair
-----------------------------	--------------------------------	---------------------------

<b>Materials:</b>	<b>HISTORY:</b>
<b>Foundation:</b> Was field stone	Brick chimney
<b>Walls:</b> Asbestos	Wing & upright
<b>Roof:</b> Asphalt shingle	Gable roof
<b>Porch:</b>	2 story
	Previous survey=4733 Photo from 1986 survey is more revealing

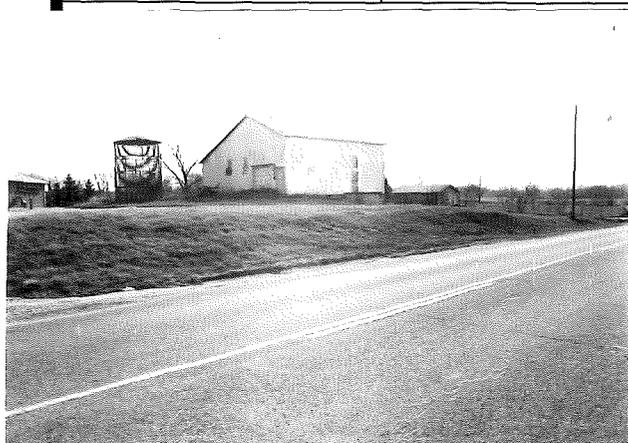
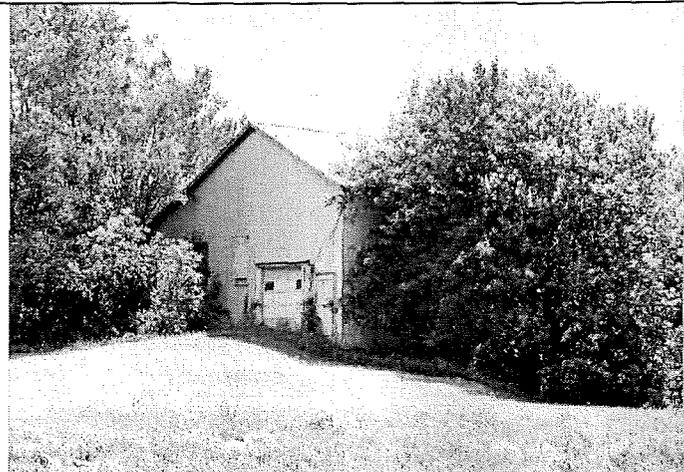
**Roll No./Neg.No.: CL 7**

<b>Circa:</b> 1860-1910	<b>Condition:</b> Good	<b>Integrity:</b> Excellent
----------------------------	---------------------------	--------------------------------

<b>Materials:</b>	<b>HISTORY:</b>
<b>Foundation:</b> Stone	From aerial, barn is on 15-17-276-003
<b>Walls:</b> Metal covered wood	Gable roof
<b>Roof:</b> Metal	The metal siding takes away from the appearance, but not the form of the building
<b>Porch:</b>	Previous site = 4733

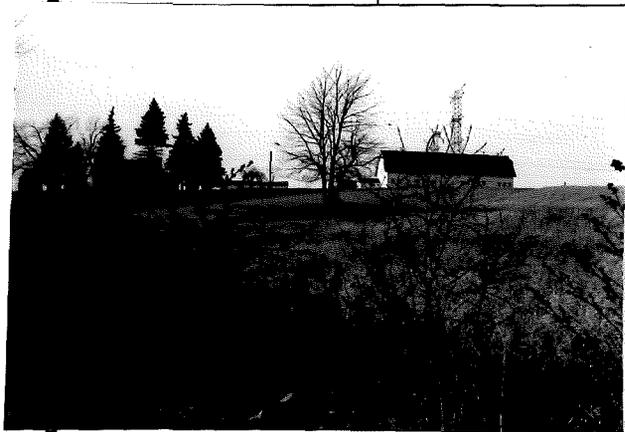
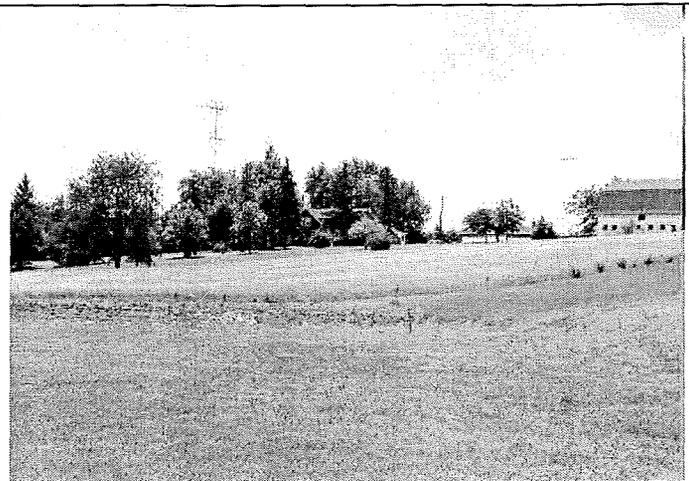
**Roll No./Neg.No.:** CL 9

<b>Circa:</b> 1860-1910	<b>Condition:</b> Good	<b>Integrity:</b> Fair
----------------------------	---------------------------	---------------------------

<b>Materials:</b>	<b>HISTORY:</b>
<b>Foundation:</b> Concrete	Previous survey says house is very altered
<b>Walls:</b> Vertical plank	Gable roof
<b>Roof:</b> Asphalt shingle	1 ½ stories
<b>Porch:</b>	Subdivision construction prevented a closer inspection
	<i>Previous site = 4735</i>

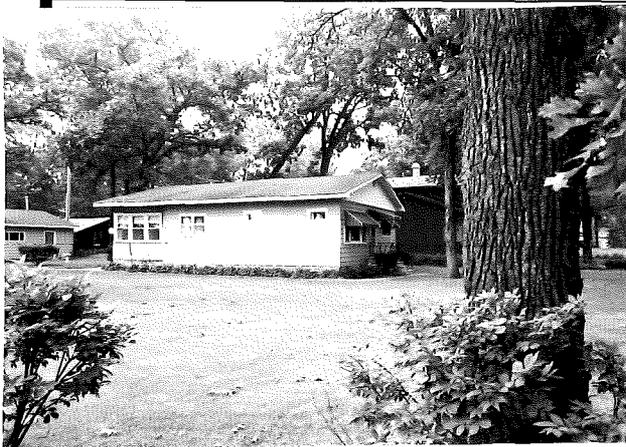
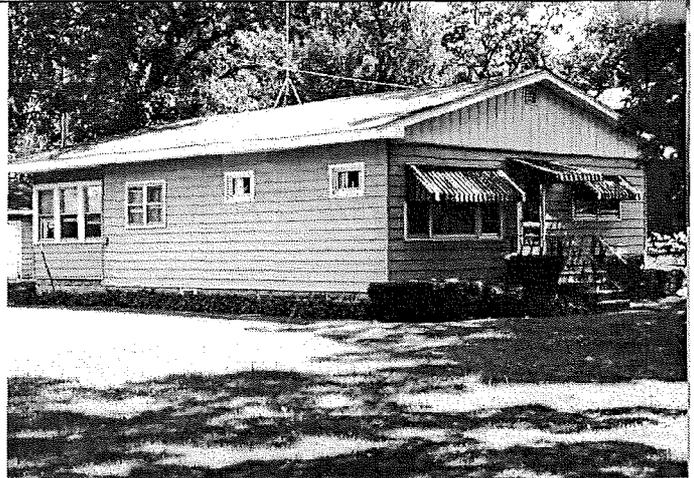
**Roll No./Neg.No.: CL 10**

<b>Circa:</b> 1930-1945	<b>Condition:</b> Excellent	<b>Integrity:</b> Excellent
----------------------------	--------------------------------	--------------------------------

<b>Materials:</b>	<b>HISTORY:</b>
<b>Foundation:</b> Block	
<b>Walls:</b> Metal	
<b>Roof:</b> Asphalt shingle	
<b>Porch:</b>	
Previous site = 2605

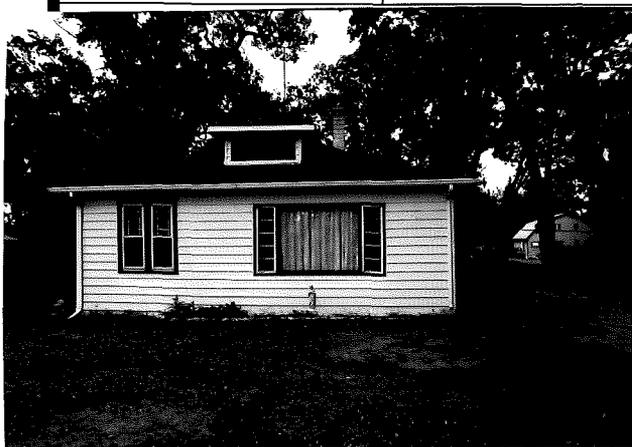
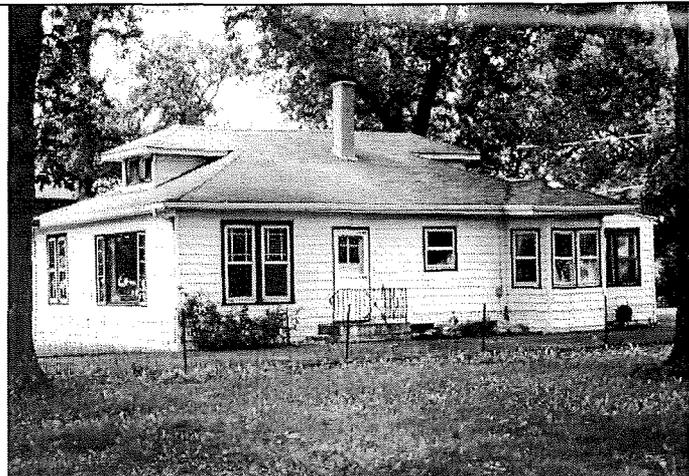
**Roll No./Neg.No.: CL 8**

<b>Circa:</b> 1910-1945	<b>Condition:</b> Excellent	<b>Integrity:</b> Excellent
----------------------------	--------------------------------	--------------------------------

<b>Materials:</b>	<b>HISTORY:</b>  1 ½ story  Matching front and back dormer; inside block chimney          Previous site = 2604
<b>Foundation:</b> Block	
<b>Walls:</b> Metal	
<b>Roof:</b> Asphalt shingle	
<b>Porch:</b>

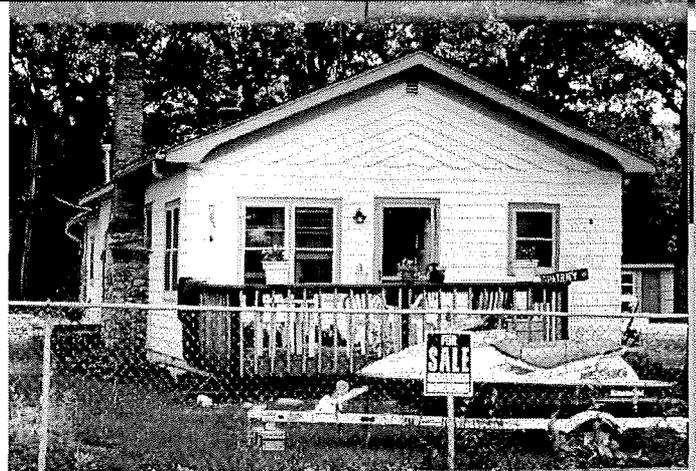
**Roll No./Neg.No.: CL 6**

<b>Circa:</b> 1930-1945	<b>Condition:</b> Good	<b>Integrity:</b> Good
----------------------------	---------------------------	---------------------------

<b>Materials:</b>	<b>HISTORY:</b>
<b>Foundation:</b> Block	Outside stone & brick chimney at left side
<b>Walls:</b> Asbestos	Gable roof
<b>Roof:</b> Asphalt shingle	1 story
<b>Porch:</b> Deck with railing	
	Previous site = 2602

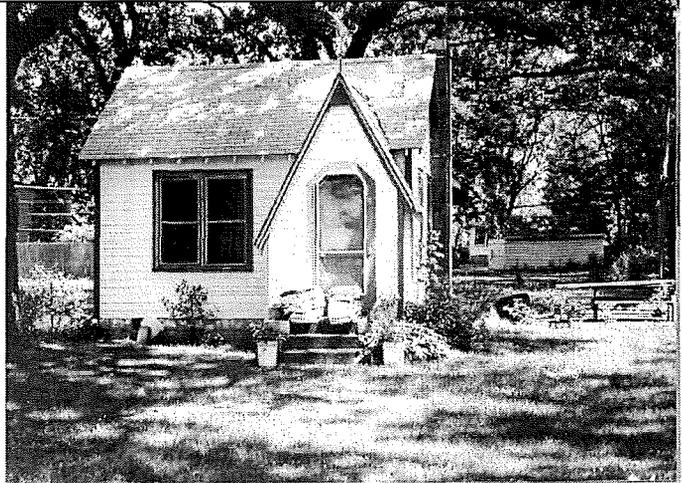
**Roll No./Neg.No.:** CL 7

<b>Circa:</b> 1910-1945	<b>Condition:</b> Good	<b>Integrity:</b> Excellent
----------------------------	---------------------------	--------------------------------

<b>Materials:</b>	<b>HISTORY:</b>
<b>Foundation:</b> Block	Gable roof
<b>Walls:</b> Clapboard	Block chimney on right side
<b>Roof:</b> Asphalt shingle	1 story
<b>Porch:</b> Gabled entryway	A-frame entryway/porch
	Previous site = 2603

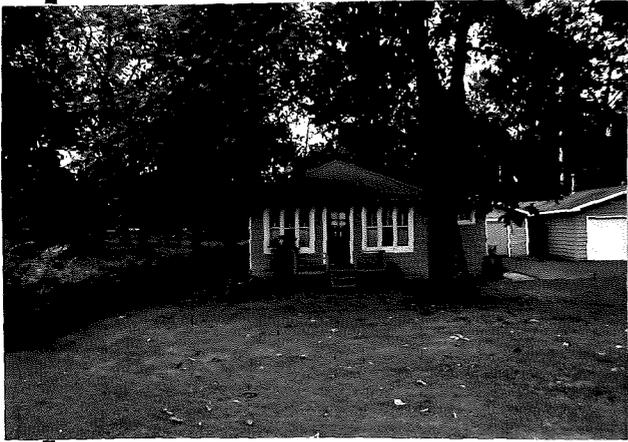
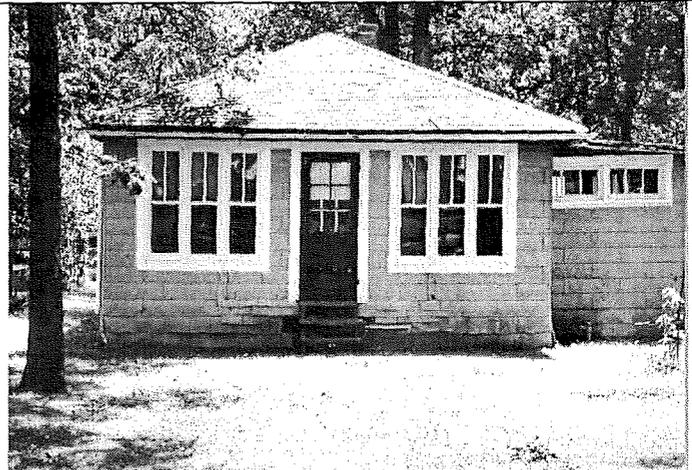
**Roll No./Neg.No.:** CL 12

<b>Circa:</b> 1930-1945	<b>Condition:</b> Poor	<b>Integrity:</b> Good
----------------------------	---------------------------	---------------------------

<b>Materials:</b>	<b>HISTORY:</b>
<b>Foundation:</b> Block	Hipped roof
<b>Walls:</b> Asbestos	Block chimney
<b>Roof:</b> Asphalt shingle	1 story
<b>Porch:</b>	
	Previous site = 2606

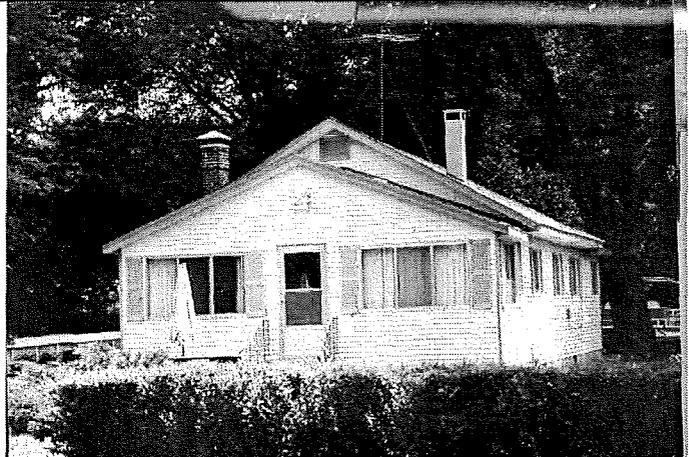
**Roll No./Neg.No.:** CL 04

<b>Circa:</b> 1930-1945	<b>Condition:</b> Excellent	<b>Integrity:</b> Excellent
----------------------------	--------------------------------	--------------------------------

<b>Materials:</b>	<b>HISTORY:</b>
<b>Foundation:</b> Block	House resided in vinyl
<b>Walls:</b> Clap board	Brick chimney, vent
<b>Roof:</b> Asphalt shingle	1 story
<b>Porch:</b>	
	Previous site = 2600

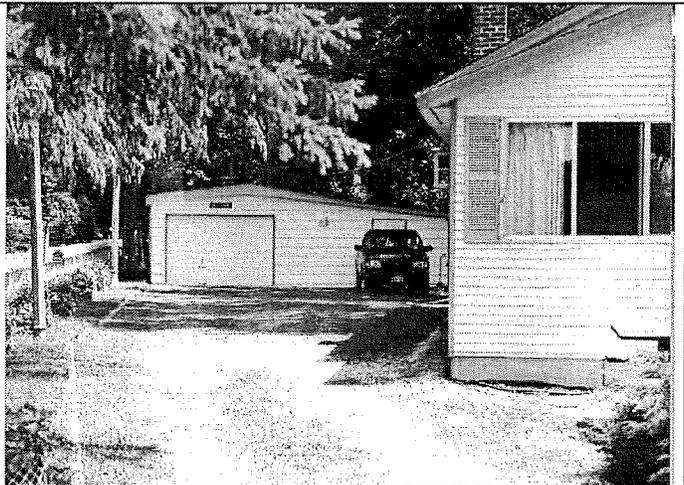
**Roll No./Neg.No.:** CL 05

<b>Circa:</b> 1930 - 1945	<b>Condition:</b> Excellent	<b>Integrity:</b> Excellent
------------------------------	--------------------------------	--------------------------------

<b>Materials:</b>	<b>HISTORY:</b>  Single door
<b>Foundation:</b> Poured	
<b>Walls:</b> Wide clapboard	
<b>Roof:</b> Asphalt shingle	
<b>Porch:</b>

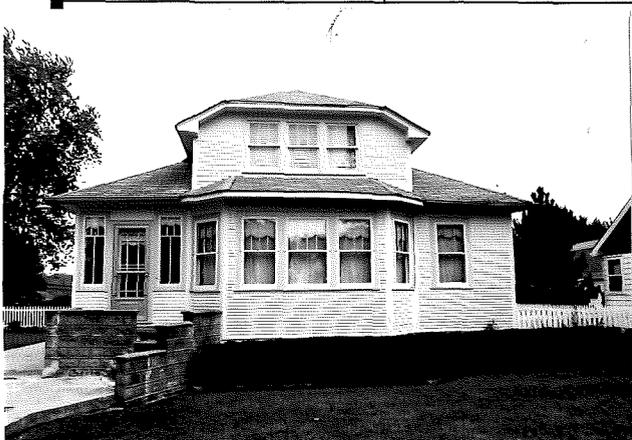
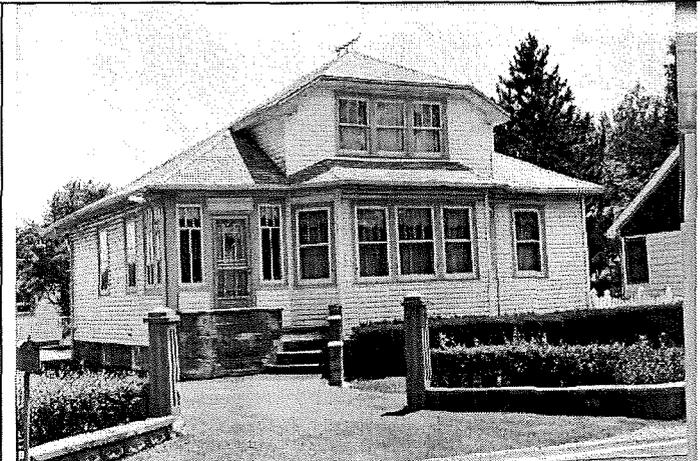
**Roll No./Neg.No.:** CL 3

<b>Circa:</b> 1930-1945	<b>Condition:</b> Excellent	<b>Integrity:</b> Excellent
----------------------------	--------------------------------	--------------------------------

<b>Materials:</b>	<b>HISTORY:</b>
<b>Foundation:</b> Block	1 ½ stories
<b>Walls:</b> Beveled clapboard	Hipped roof
<b>Roof:</b> Asphalt shingle	Front dormer has clipped gable
<b>Porch:</b>	Central front bay
	Previous site-2599

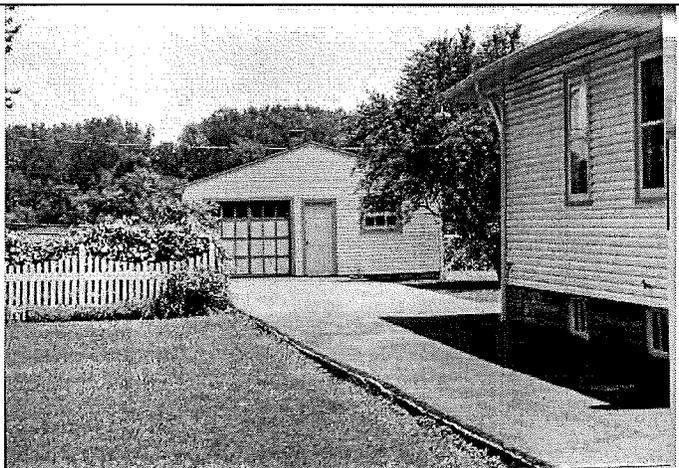
<b>Circa:</b> 1930 – 1945	<b>Condition:</b> Excellent	<b>Integrity:</b> Excellent
------------------------------	--------------------------------	--------------------------------

<b>Materials:</b>	<b>HISTORY:</b>
<b>Foundation:</b> Block	
<b>Walls:</b> Clapboard	
<b>Roof:</b> Asphalt shingle	
<b>Porch:</b>

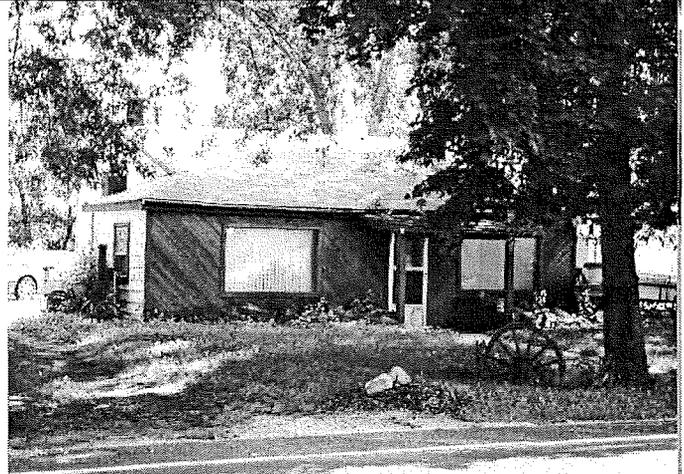
**Roll No./Neg.No.: CL 14**

<b>Circa:</b> 1910-1945	<b>Condition:</b> Good	<b>Integrity:</b> Poor
----------------------------	---------------------------	---------------------------

<b>Materials:</b>	<b>HISTORY:</b>
<b>Foundation:</b> Poured	Diagonal pine on front addition
<b>Walls:</b> Metal and pine	Gable roof over addition
<b>Roof:</b> Asphalt shingle	1 story
<b>Porch:</b>	
	Previous survey = 2597

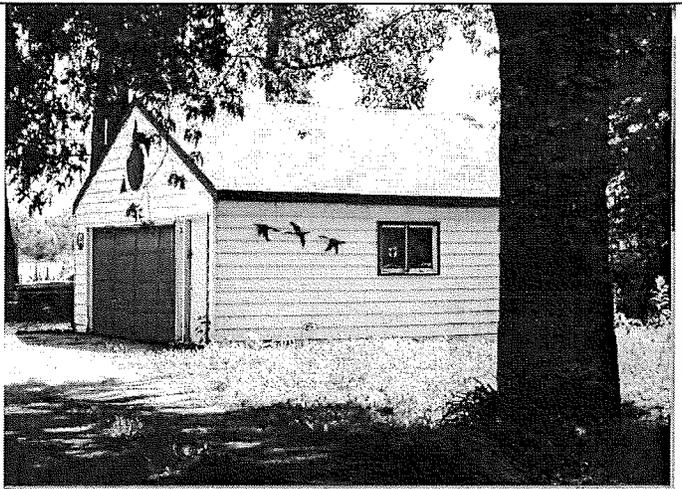
<b>Circa:</b> 1930 - 1945	<b>Condition:</b> Good	<b>Integrity:</b> Excellent
------------------------------	---------------------------	--------------------------------

<b>Materials:</b>	<b>HISTORY:</b>
<b>Foundation:</b> Block	Single door
<b>Walls:</b> Wide clapboard	Gable
<b>Roof:</b> Asphalt shingle	
<b>Porch:</b>

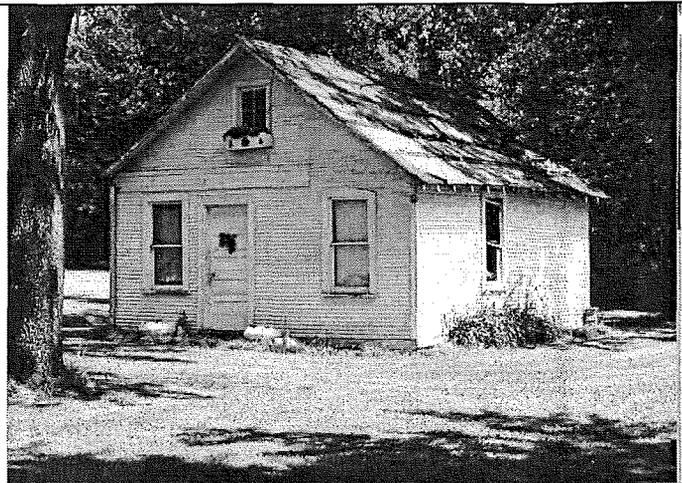
**Roll No./Neg.No.:** CL 16

<b>Circa:</b> 1900 - 1920	<b>Condition:</b> Poor	<b>Integrity:</b> Excellent
------------------------------	---------------------------	--------------------------------

<b>Materials:</b>	<b>HISTORY:</b>
<b>Foundation:</b> Block	Roof-holes in it block chimney/vent
<b>Walls:</b> Clapboard	1 ½ story
<b>Roof:</b> Tar paper	porch is off
<b>Porch:</b>	
	Previous site = 2598

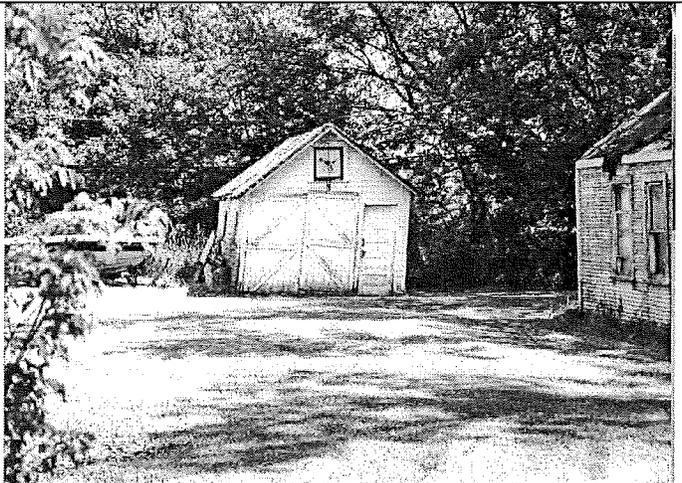
<b>Circa:</b> 1920 - 1940	<b>Condition:</b> Poor	<b>Integrity:</b> Excellent
------------------------------	---------------------------	--------------------------------

<p><b>Materials:</b></p> <p><b>Foundation:</b> Block</p> <p><b>Walls:</b> Clapboard</p> <p><b>Roof:</b> Asphalt shingle and tar paper</p> <p><b>Porch:</b></p>	<p><b>HISTORY:</b></p> <p>Gable roof, swing out doors</p>
--	---

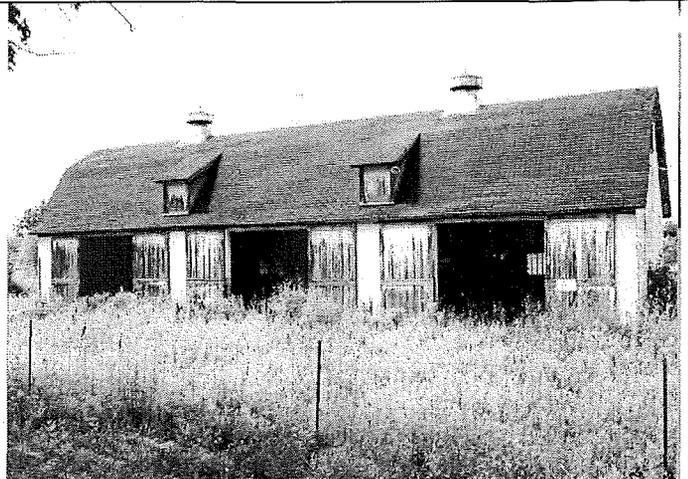
**Roll No./Neg.No.:** CL 21

<b>Circa:</b> 1910-1945	<b>Condition:</b> Poor	<b>Integrity:</b> Excellent
----------------------------	---------------------------	--------------------------------

<p><b>Materials:</b></p> <p><b>Foundation:</b> Poured</p> <p><b>Walls:</b> Block</p> <p><b>Roof:</b> Asphalt shingle</p> <p><b>Porch:</b></p>	<p><b>HISTORY:</b></p> <p>Cidnet puts <i>it</i> as MCCD property</p> <p>Wooden doors</p> <p>Gambrel shaped roof</p> <p>Double vented</p> <p>2 lightning rods, 2 dormers</p> <p>Previous site = 2594</p>
---	---

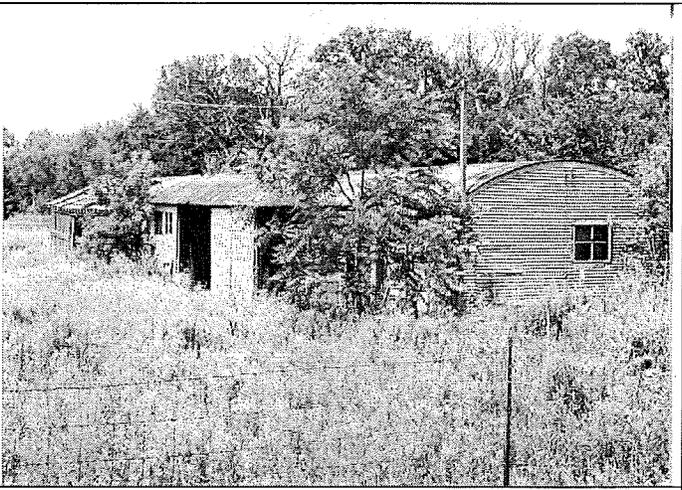
<b>Circa:</b> 1930 - 1945	<b>Condition:</b> Poor	<b>Integrity:</b> Poor
------------------------------	---------------------------	---------------------------

<b>Materials:</b>	<b>HISTORY:</b>  Extension at back with vertical boards  Holes in roof, plywood  Modified quonset storage shed
<b>Foundation:</b>	
<b>Walls:</b> Metal	
<b>Roof:</b> Metal	
<b>Porch:</b>

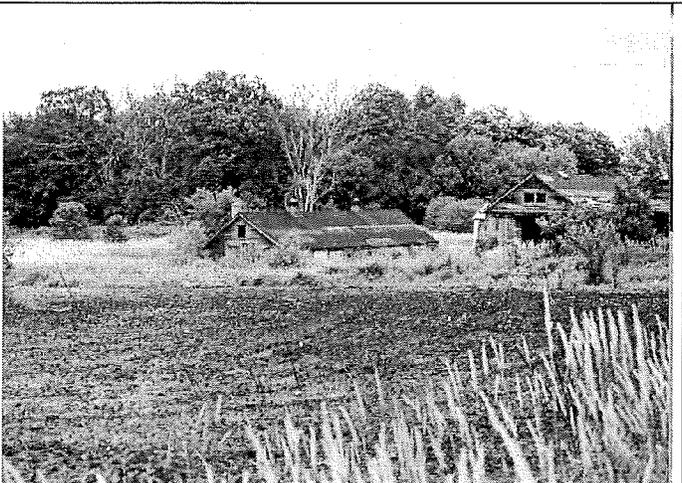
<b>Circa:</b> 1900 - 1930	<b>Condition:</b> Poor	<b>Integrity:</b> Excellent
------------------------------	---------------------------	--------------------------------

<b>Materials:</b>	<b>HISTORY:</b>
<b>Foundation:</b> Concrete	<b>Double vented</b>
<b>Walls:</b> Clapboard	<b>Brick chimney</b>
<b>Roof:</b> Rolled asphalt roofing	<b>On left in photo</b>
<b>Porch:</b>

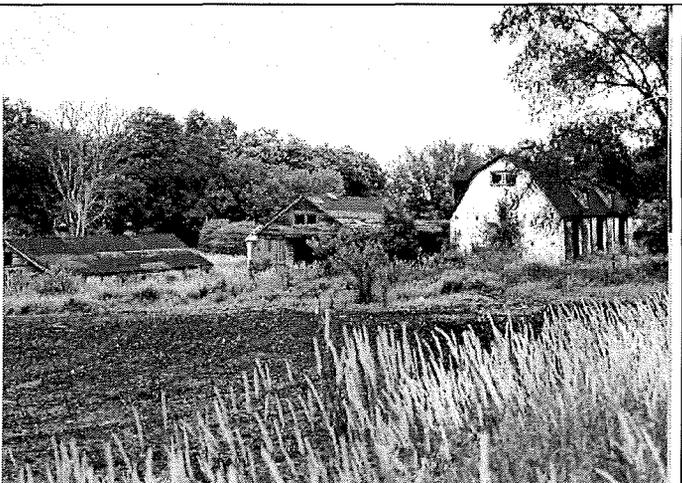
**Roll No./Neg.No.:** CL 24

<b>Circa:</b> 1920 - 1945	<b>Condition:</b> Poor	<b>Integrity:</b> Good
------------------------------	---------------------------	---------------------------

<b>Materials:</b>	<b>HISTORY:</b>  Corn crib in middle of photo  Corn crib is transverse aisle style  Barn has a gambrel shaped roof
<b>Foundation:</b>	
<b>Walls:</b> Clapboard	
<b>Roof:</b> Rolled asphalt roofing	
<b>Porch:</b>

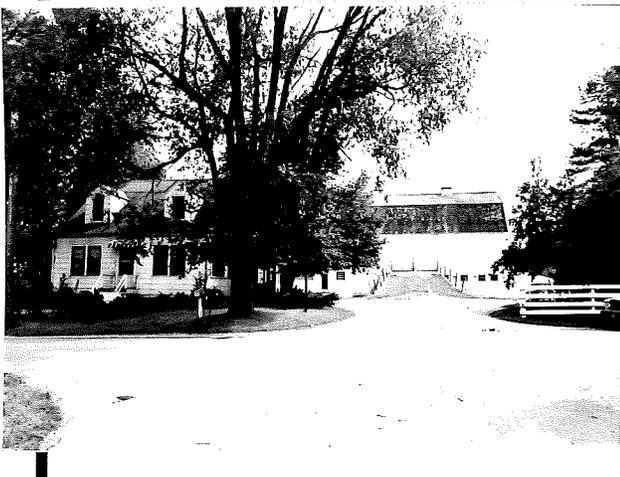
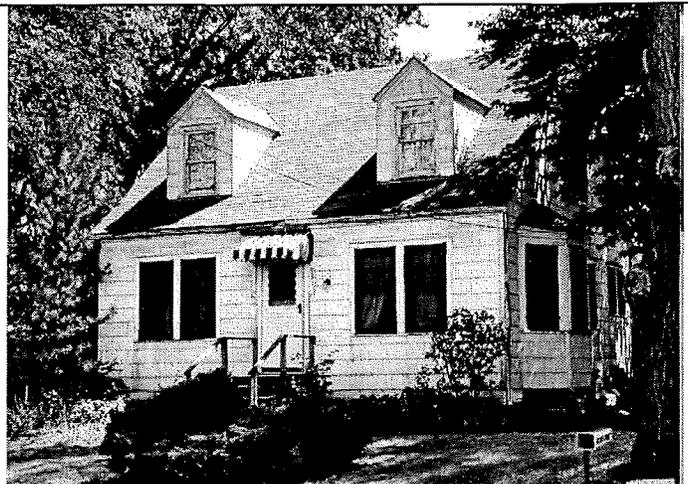
**Roll No./Neg.No.:** CL 18

<b>Circa:</b> 1910 - 1945	<b>Condition:</b> Good	<b>Integrity:</b> Good
------------------------------	---------------------------	---------------------------

<b>Materials:</b>	<b>HISTORY:</b>
<b>Foundation:</b> Poured	House number is 931
<b>Walls:</b> Asbestos	Gable, 2 dormers
<b>Roof:</b> Asphalt shingle	1 ½ stories
<b>Porch:</b>	
	Previous site = 2595

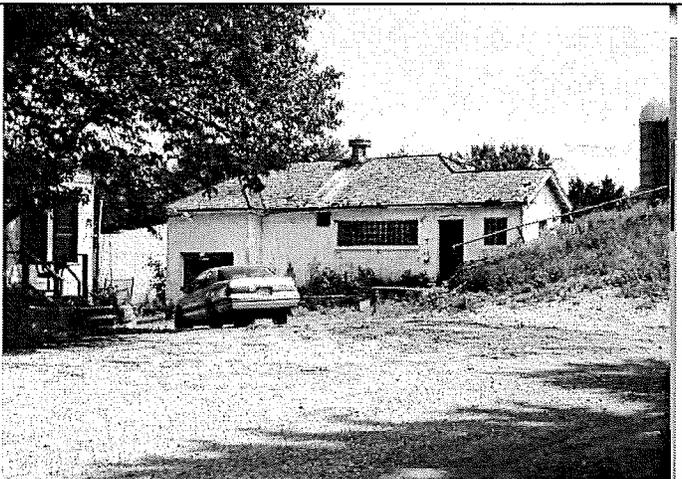
**Roll No./Neg.No.: CL 19**

<b>Circa:</b> 1910 - 1940	<b>Condition:</b> Poor	<b>Integrity:</b> Poor
------------------------------	---------------------------	---------------------------

<b>Materials:</b>	<b>HISTORY:</b>  Gable single vent
<b>Foundation:</b> Poured	
<b>Walls:</b> Stucco	
<b>Roof:</b> Wood shingle	
<b>Porch:</b>

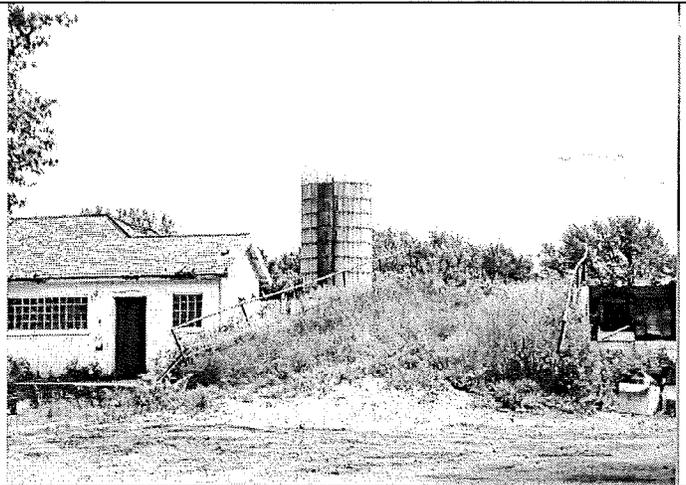
**Roll No./Neg.No.: CL 20**

<b>Circa:</b> 1910 - 1930	<b>Condition:</b> Good	<b>Integrity:</b> Excellent
------------------------------	---------------------------	--------------------------------

<b>Materials:</b>	<b>HISTORY:</b>  Concrete staved  Round metal roof
<b>Foundation:</b>	
<b>Walls:</b> Concrete staved	
<b>Roof:</b> Metal dome	
<b>Porch:</b>
