McHenry County

Hebron Township

McHenry County Intensive Rural Structures Field Survey Form

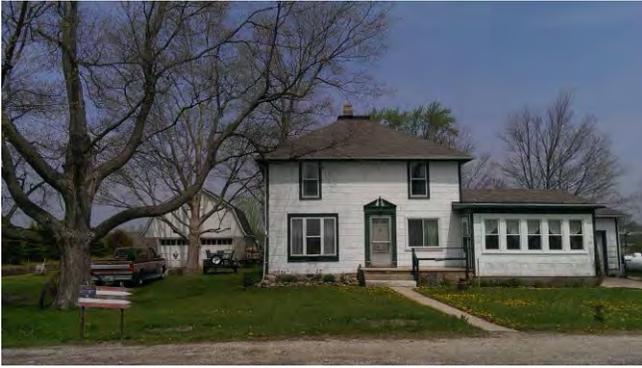
HE-10-3: 10310 Seaman Road – Residence, Barn

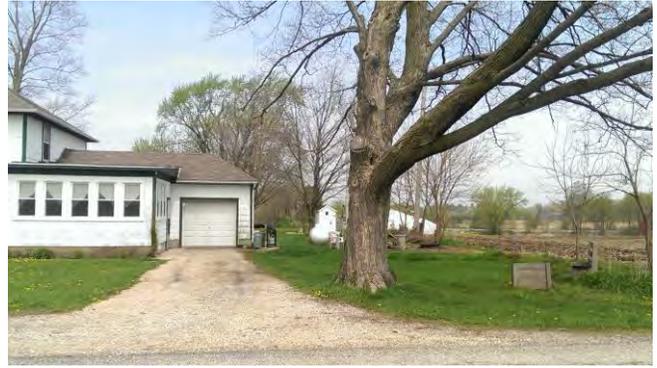
HE-10-3: 10310 Seaman Road - Sheds

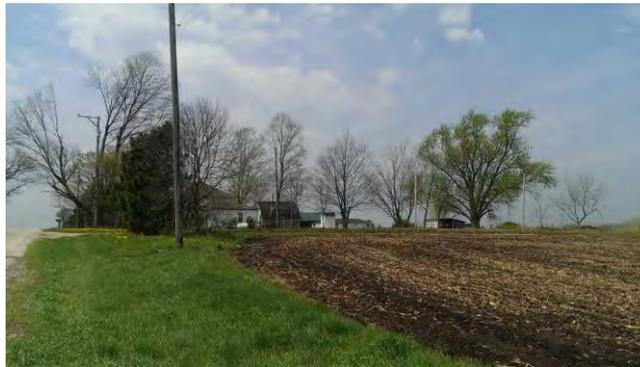
HE-10-3: 10310 Seaman Road – Machine Shed

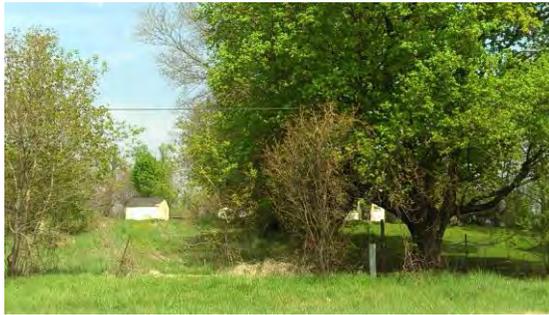
HE-10-4: 10818 Illinois Route 173 – Shed

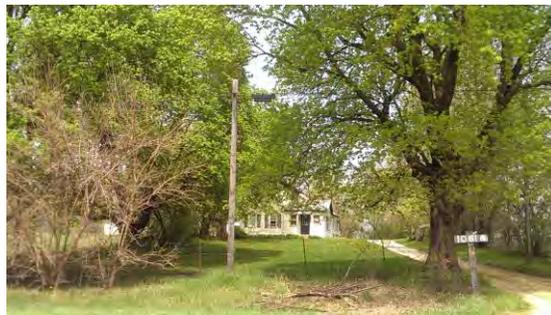
HE-10-4: 10818 Illinois Route 173 – Residence

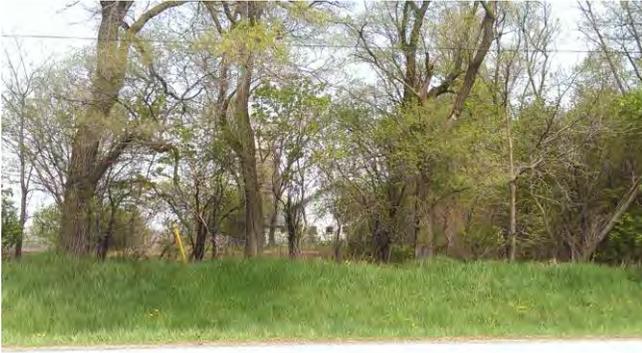
HE-10-5: Illinois Route 173 – Barn, Silo

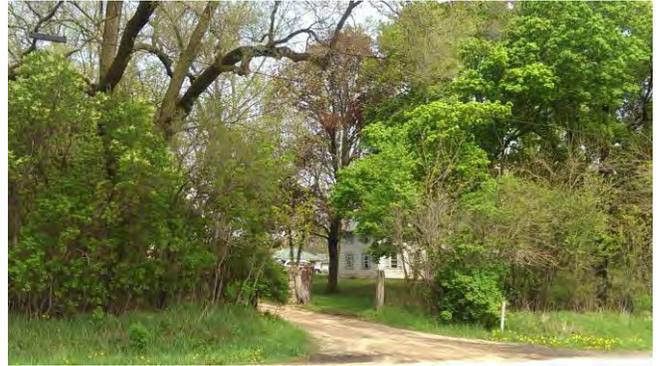
HE-10-5: Illinois Route 173 - Barn

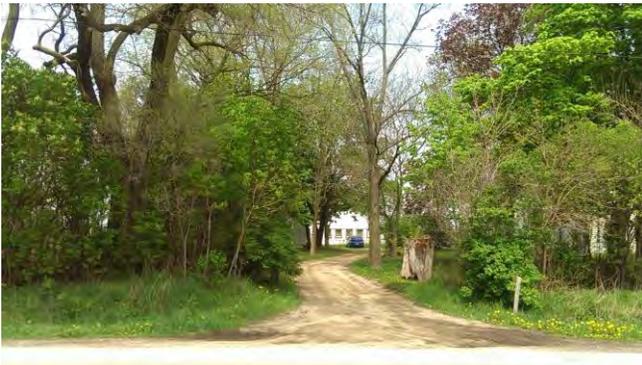
HE-10-5: Illinois Route 173 - Garage

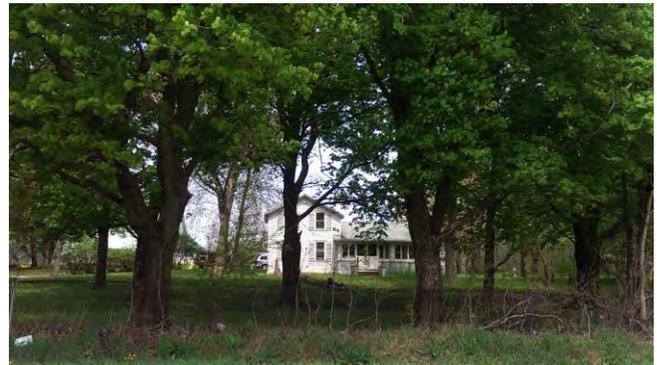
HE-10-5: Illinois Route 173 - Residence

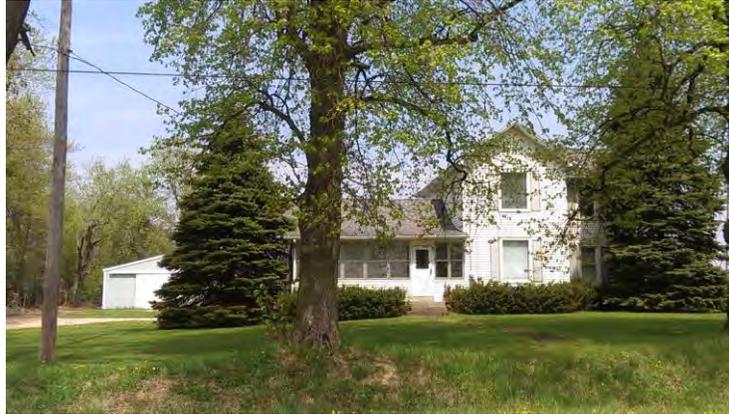
HE-10-6: 10708 Illinois Route 173 – Residence, Pole Building

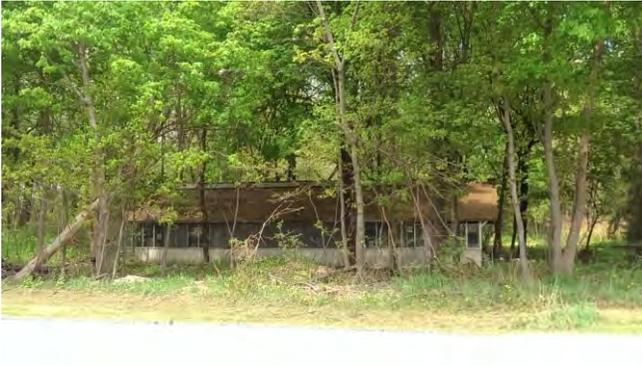
HE-10-7: 10507 Illinois Route 173 – Outbuilding

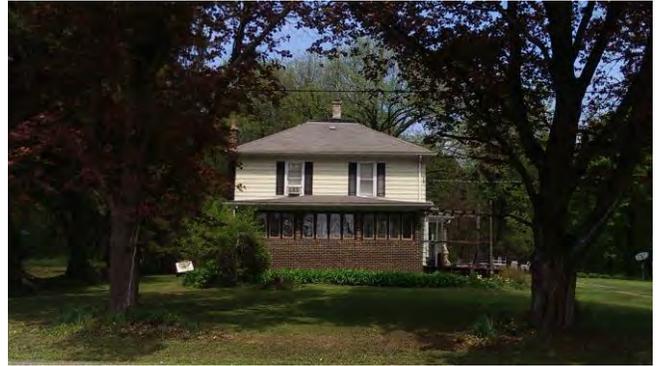
HE-10-7: 10507 Illinois Route 173 – Residence

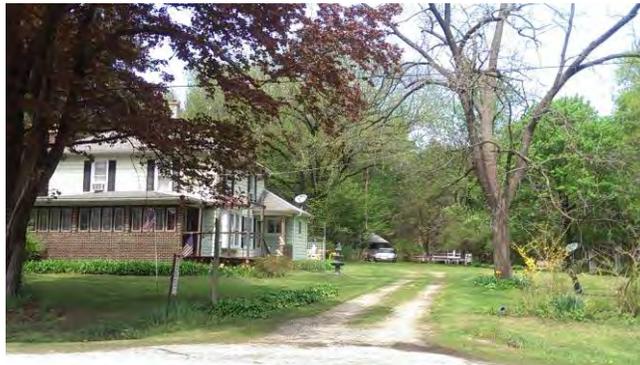
HE-10-7: 10507 Illinois Route 173 – Shed/Garage

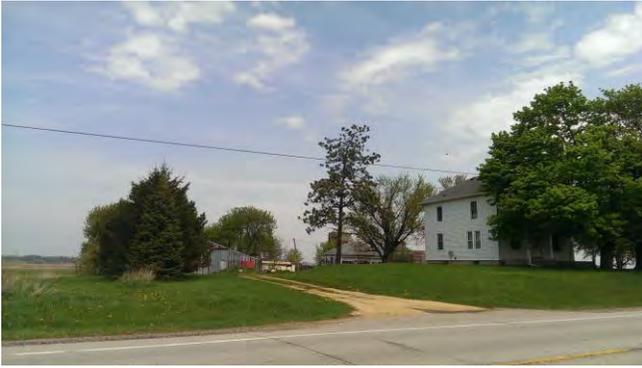
HE-10-8: Illinois Route 173 – Garage, Shed

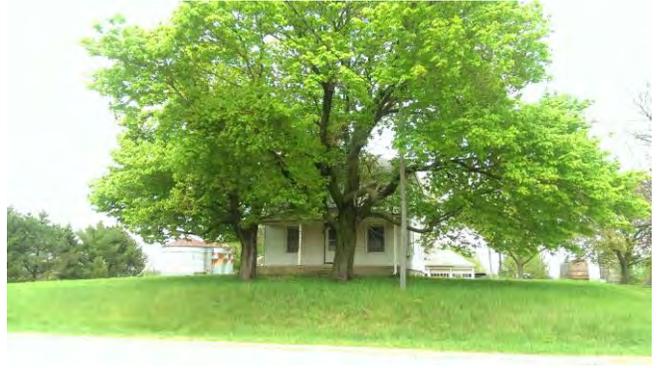
HE-10-8: Illinois Route 173 – Residence, Bins

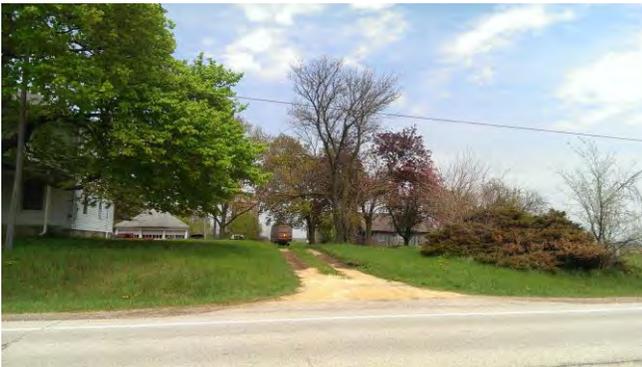
HE-10-8: Illinois Route 173 – Silos, Sheds

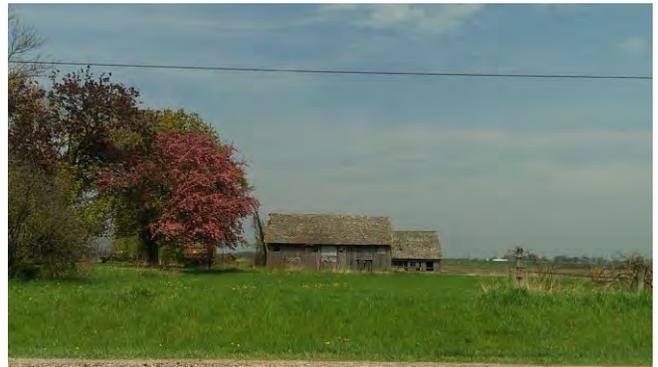
HE-10-8: Illinois Route 173 – Barn, Shed

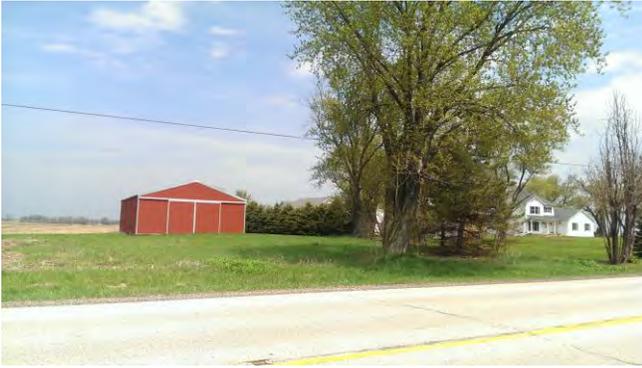
HE-11-1: 9316 Lange Road - Shed

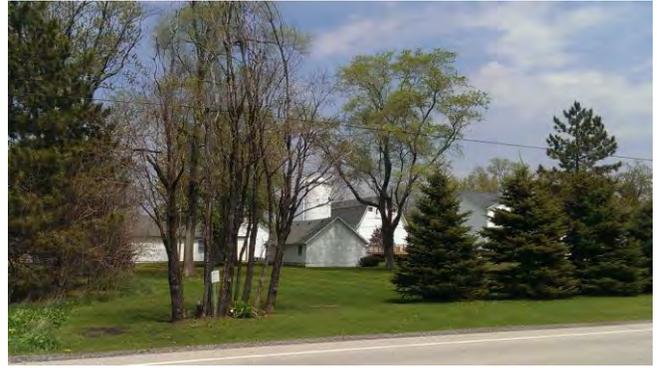
HE-11-1: 9316 Lange Road - Outbuildings

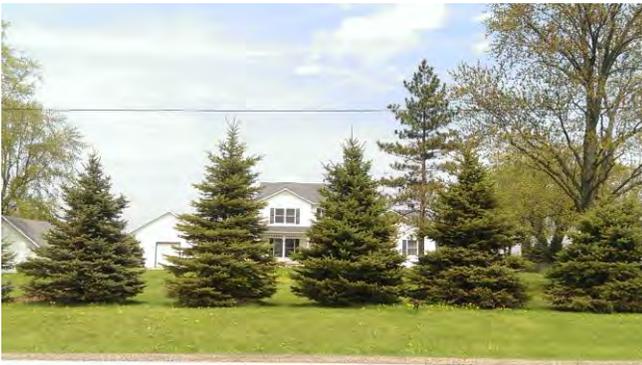
HE-11-1: 9316 Lange Road – Residence with Garage

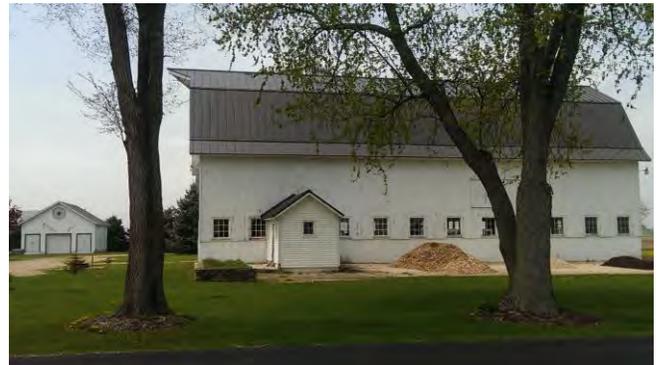
HE-11-1: 9316 Lange Road – Barn, Garage

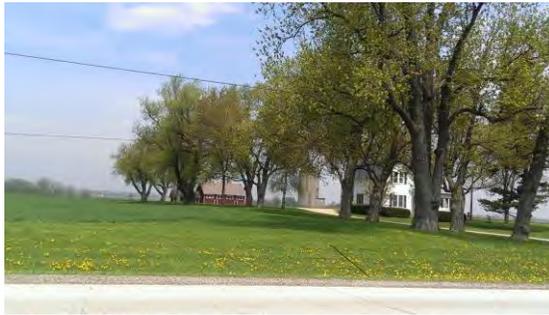
HE-11-2: 9114 Illinois Route 173 – Silo, Shed

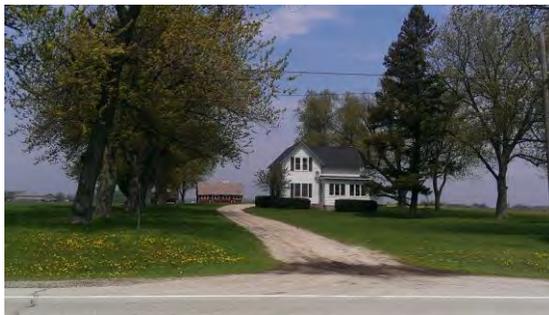
HE-11-2: 9114 Illinois Route 173 – Residence, Sheds

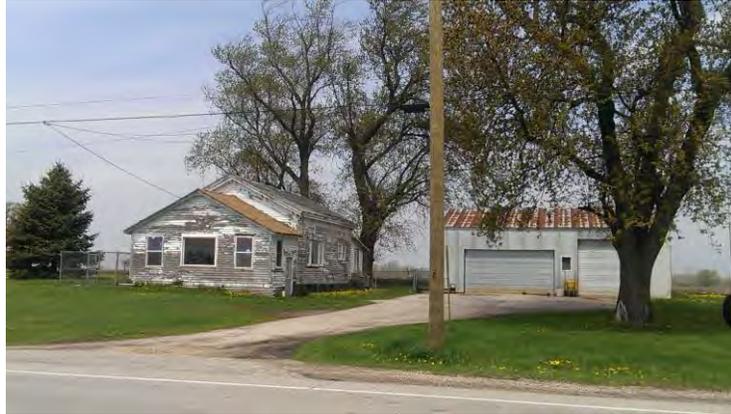
HE-11-3: Illinois Route 173 – Residence, Garage

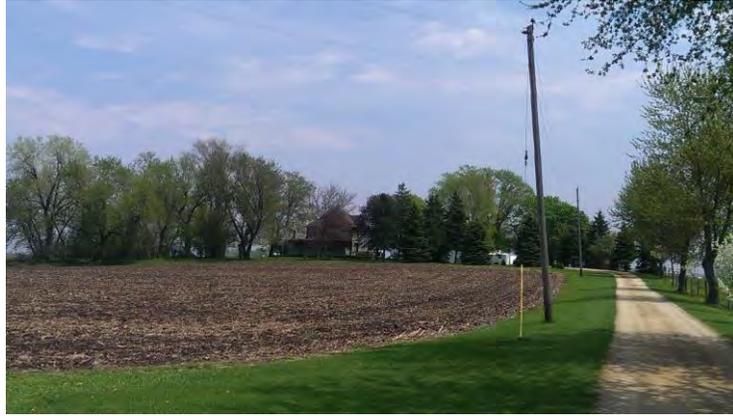
HE-11-4: Lange Road – Buildings

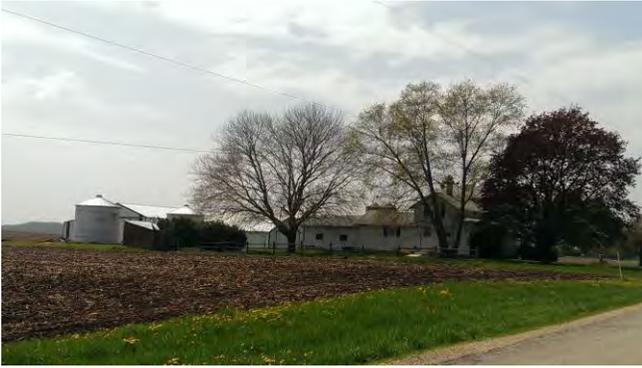
HE-11-5: 9905 Burgett Road - Outbuildings

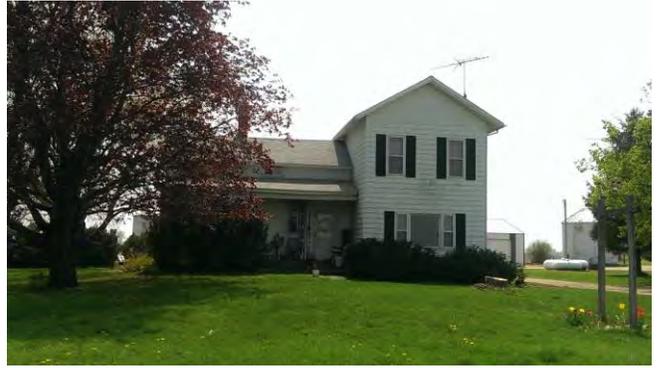
HE-11-5: 9905 Burgett Road - Residence

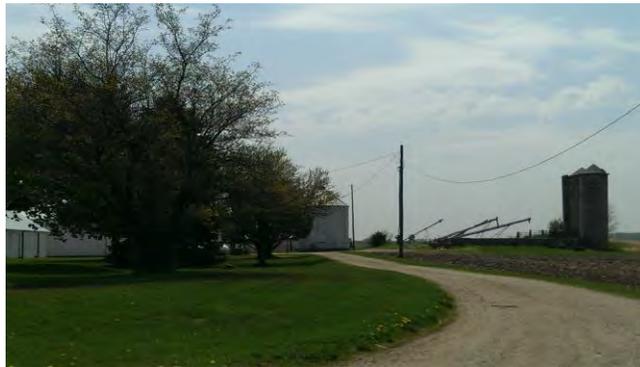
HE-11-5: 9905 Burgett Road – Silos, Bins

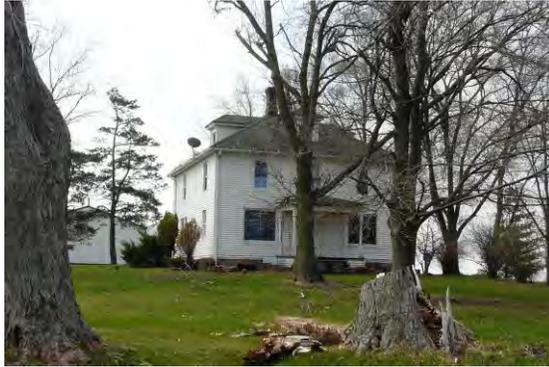
HE-12-1: 8803 Burgett Road – Residence

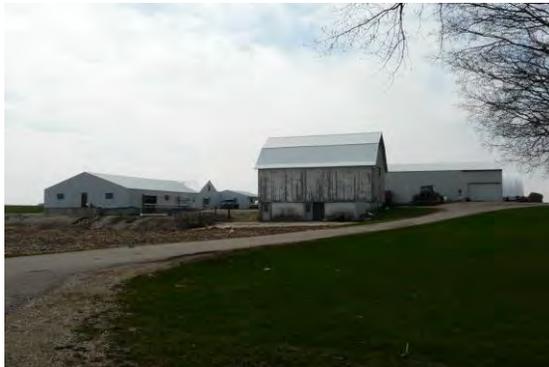
HE-12-1: 8803 Burgett Road – Shed, Barn, Pole Buildings

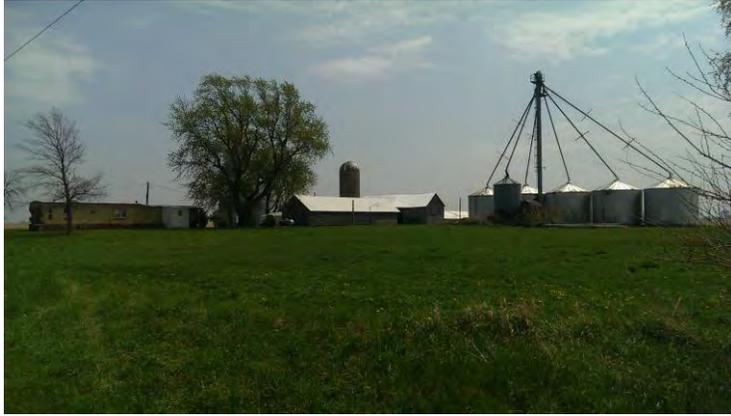
HE-12-2: Burgett Road – Residence, Sheds, Silo Complex,
Silo, Bins

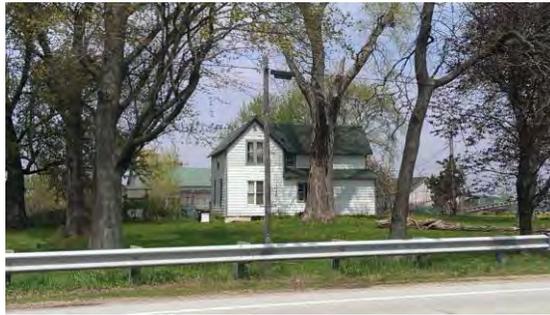
HE-12-3: 8710 Illinois Route 173 – Residence

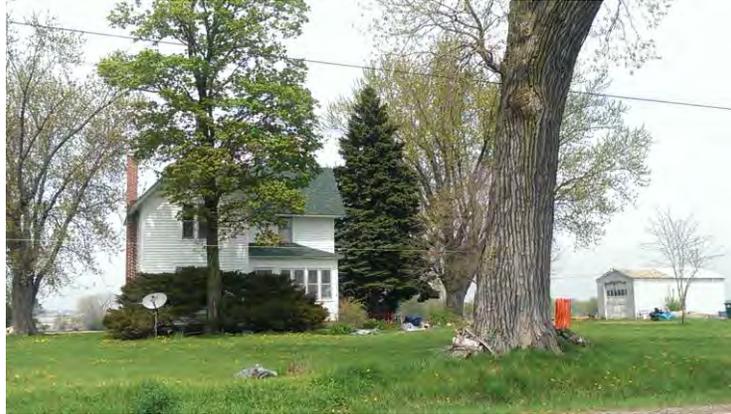
HE-12-4: Illinois Route 173 – Residence, Garage

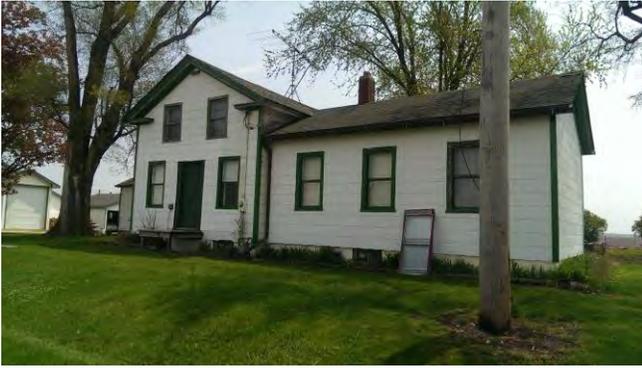
HE-13-1: 8201 Illinois Route 173 - Residence

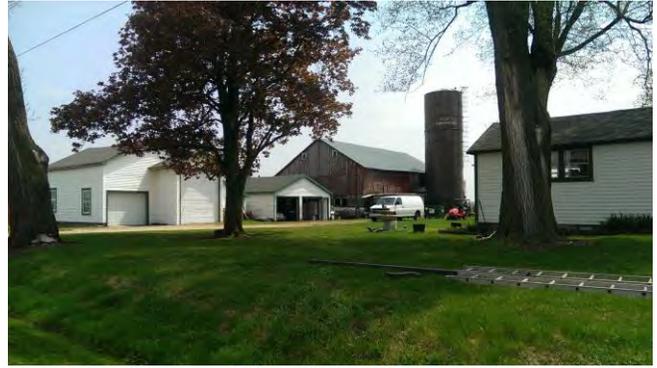
HE-13-1: 8201 Illinois Route 173 – Barn, Silos, Garage, Shed

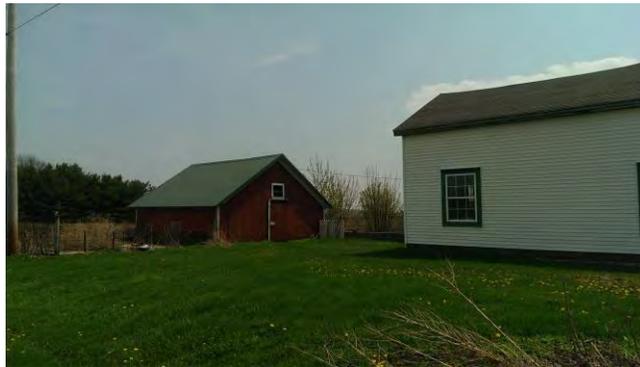
HE-13-1: 8201 Illinois Route 173 - Shed

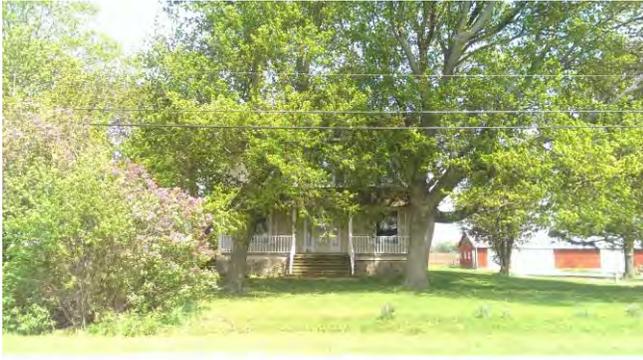
HE-21-2: 11902 Vanderkarr Road – Residence,
Shed

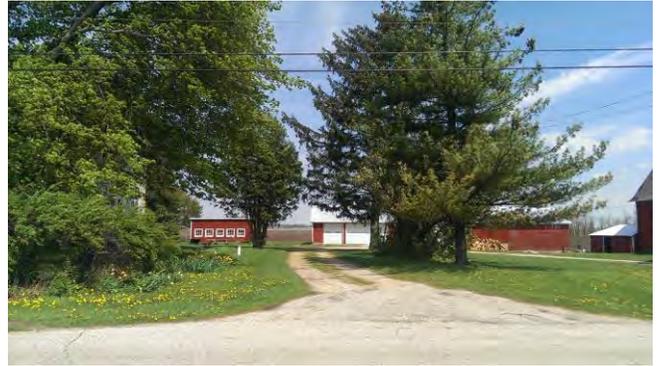
HE-21-2: 11902 Vanderkarr Road – Shed, Garage

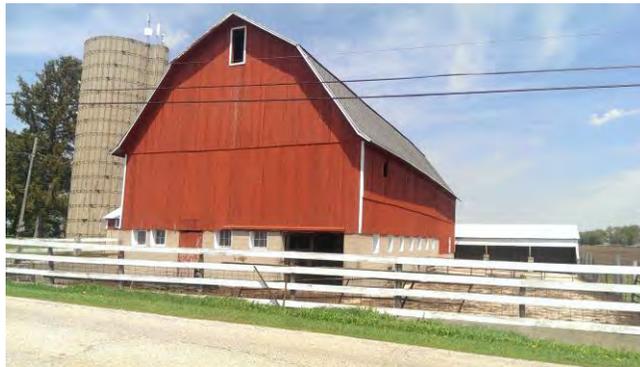
HE-21-2: 11902 Vanderkarr Road – Barn, Silo,
Coop

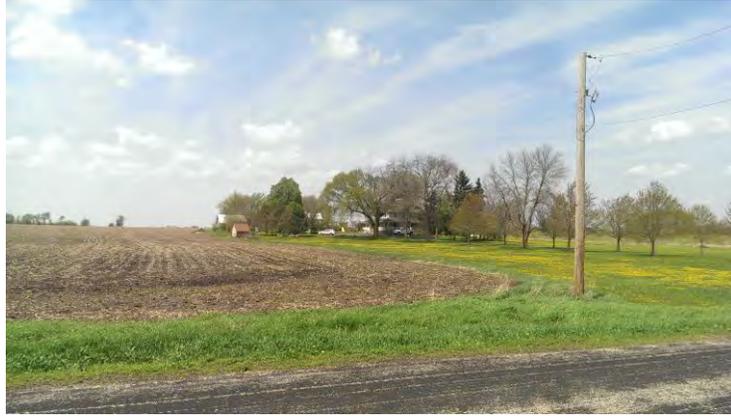
HE-21-3: 8915 Kenman Road – Residence, Garage, Pole
Barn, Sheds

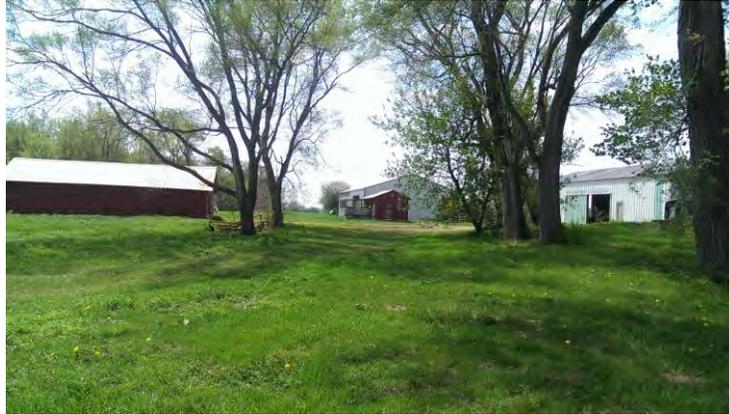
HE-22-1: 10603 Okeson Road – Garage, Shed, Pole Barns

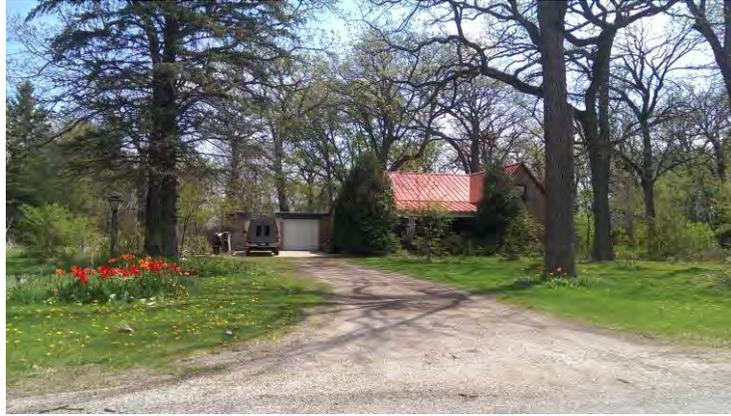
HE-22-2: 9812 Stewart Road – Residence, Garage

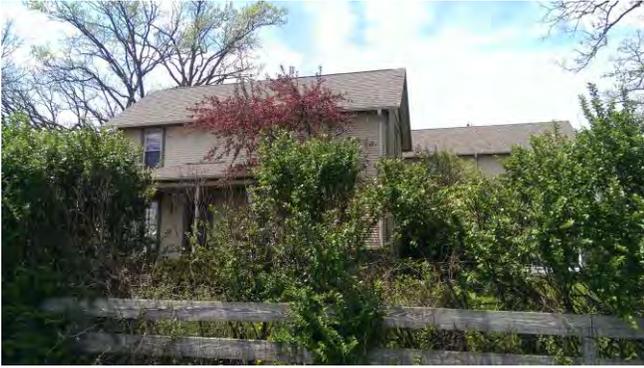
HE-22-3: 8915 Kenman Road - Residence

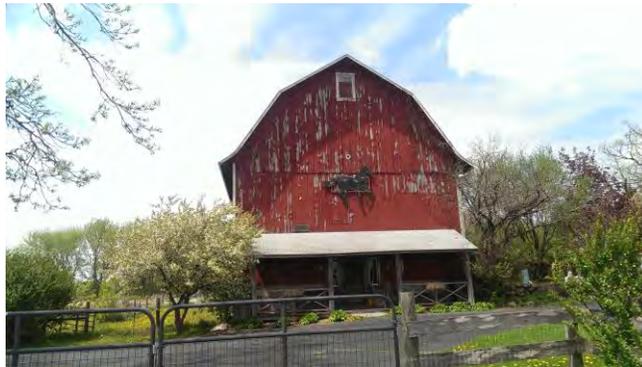
HE-22-3: 8915 Kenman Road - Barn

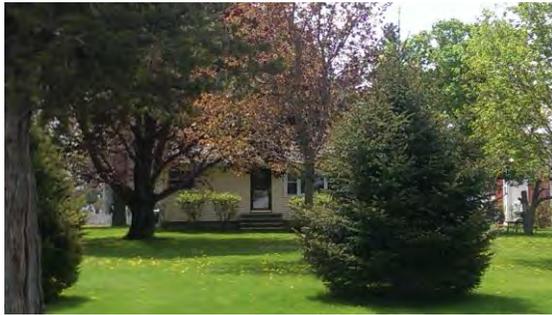
HE-23-1: 9715 Okeson Road – Residence, Pole Barn

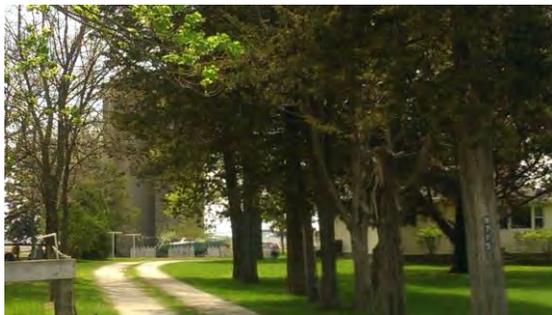
HE-23-1: 9715 Okeson Road – Silos

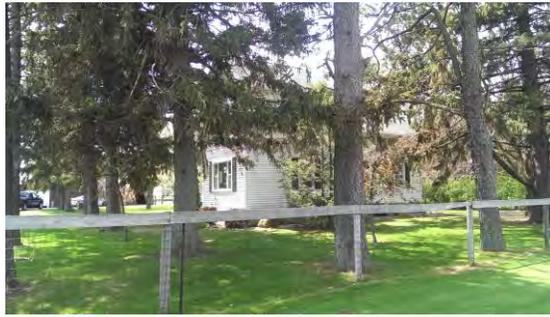
HE-23-2: 9713 Okeson Road – Residence

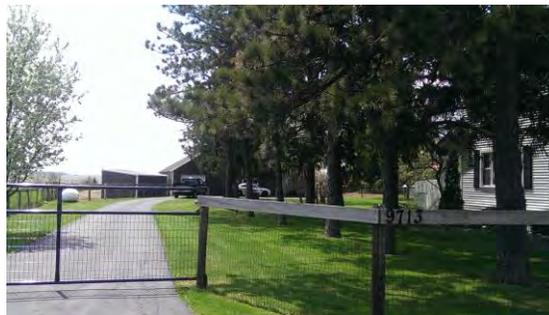
HE-23-2: 9713 Okeson Road – Garage, Shed

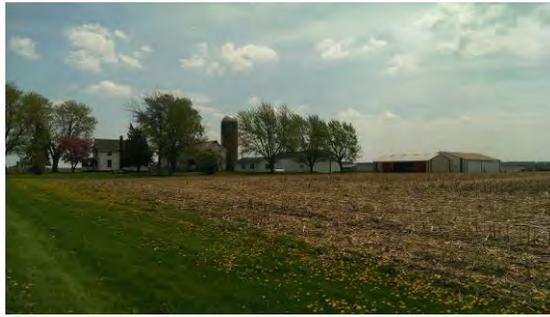
HE-23-3: 9617 Okeson Road – Silo, Pole Barns, Silo

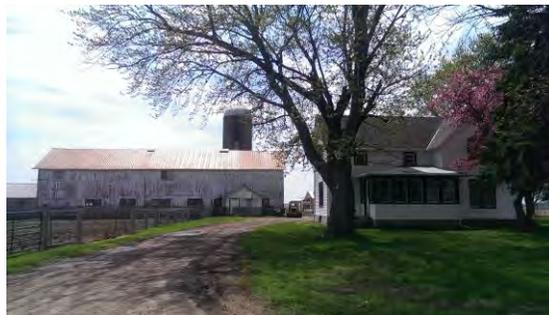
HE-23-3: 9617 Okeson Road – Shed, Garage

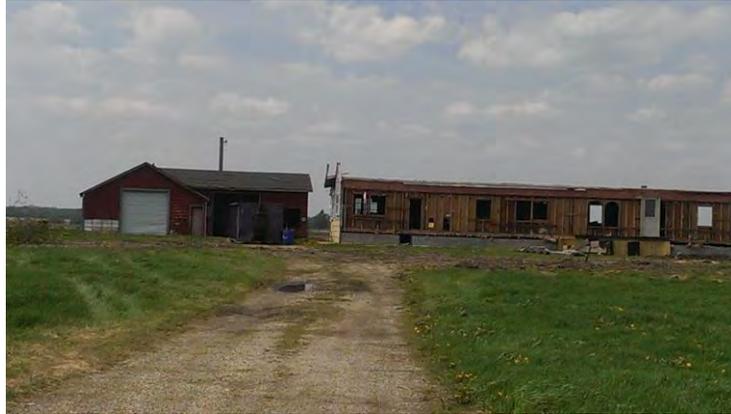
List Observed Structures: (A) trailer home residence; (B) wood-sided shed/garage in process of demolition_____

HE-23-4: 8909 Greenwood Road – Residence, Shed

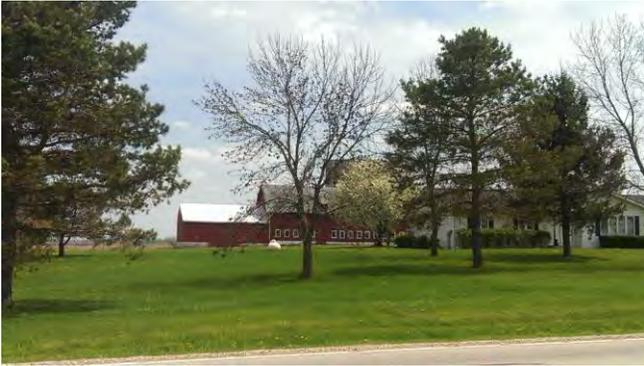
HE-24-1: 9007 Greenwood Road – Barn, Silo

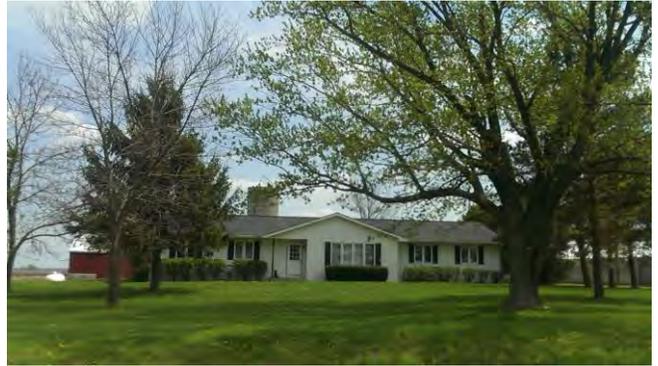
HE-24-1: 9007 Greenwood Road – Residence

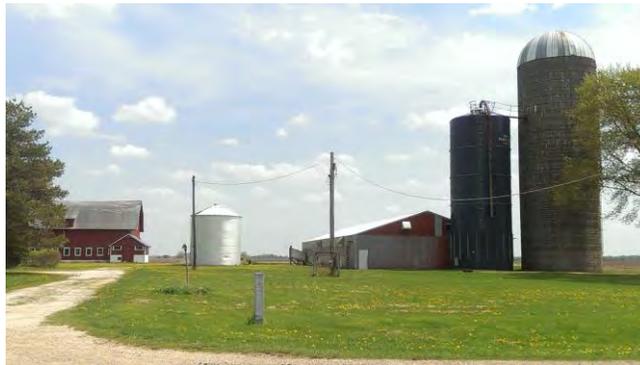
HE-24-1: 9007 Greenwood Road – Shed, Silos

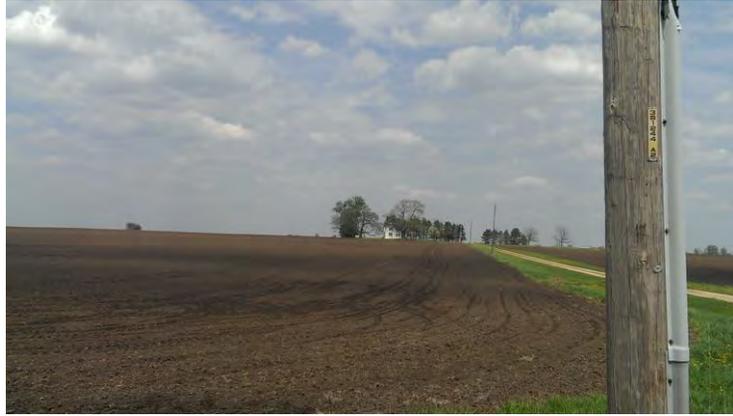
HE-24-2: Regnier Road – Residence

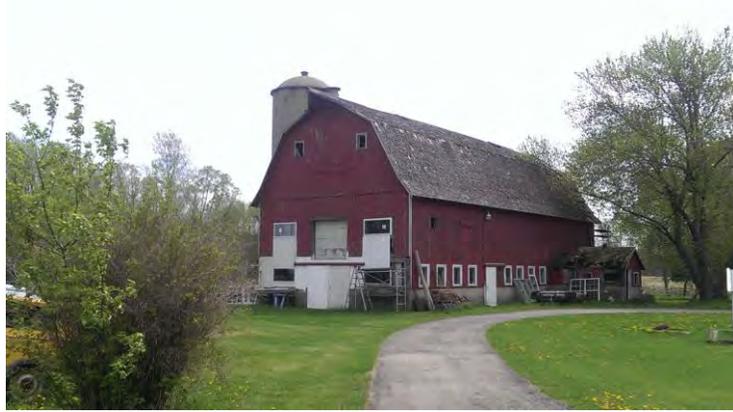
HE-25-1: Regnier Road – Barn, Silo

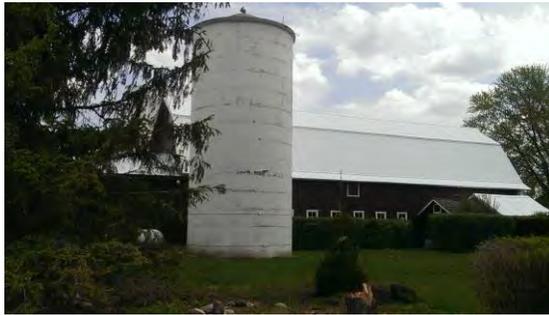
HE-25-2: 7614 Greenwood Road – Barn, Silo

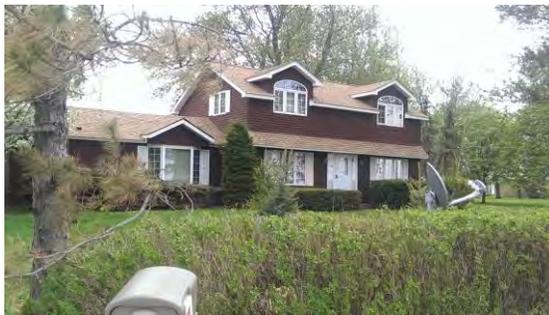
Any obvious Additions/Alterations
replaces original farmhouse, or original has been drastically changed

HE-25-2: 7614 Greenwood Road – Residence

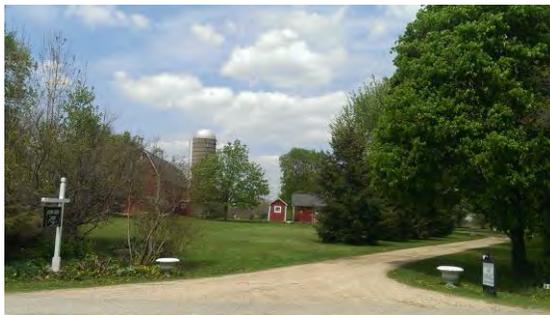
HE-25-3: 8914 Tryon Grove Road – Barn, Silo, Sheds

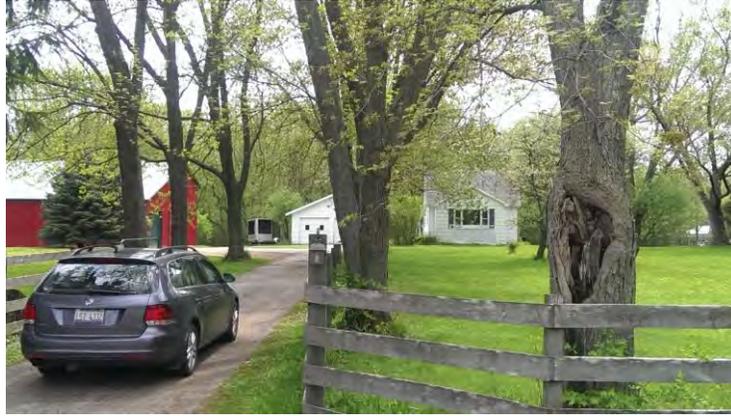
HE-25-4: 8901 Tryon Grove Road – Residence, Garage,
Pole Barn

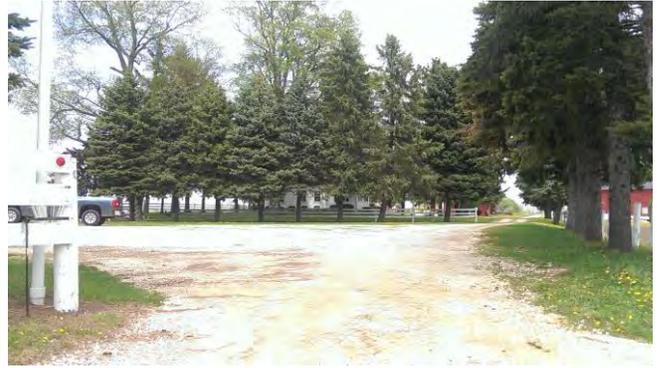
HE-25-5: 8702 Tryon Grove Road – Residence, Shed

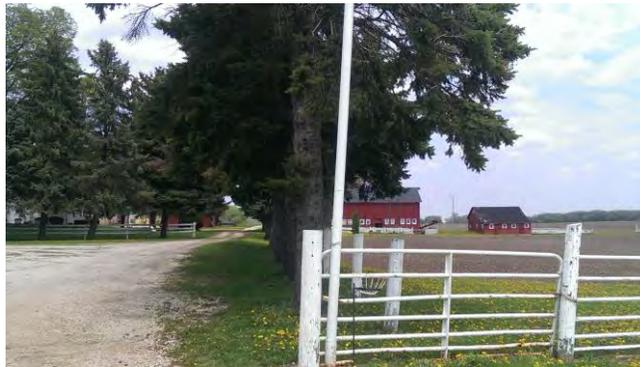
HE-25-5: 8702 Tryon Grove Road – Barn, Silos, Shed, Windmill

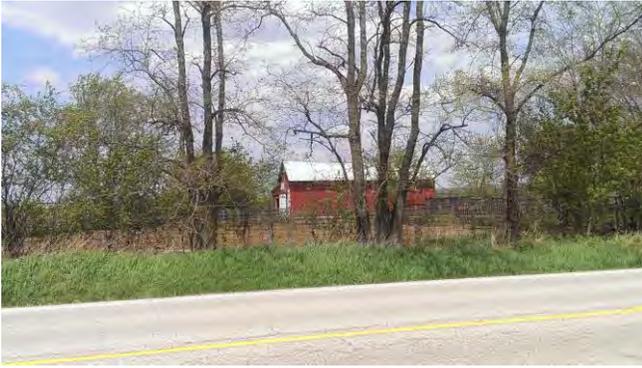
HE-25-6: 8214 Tryon Grove Road – Shed

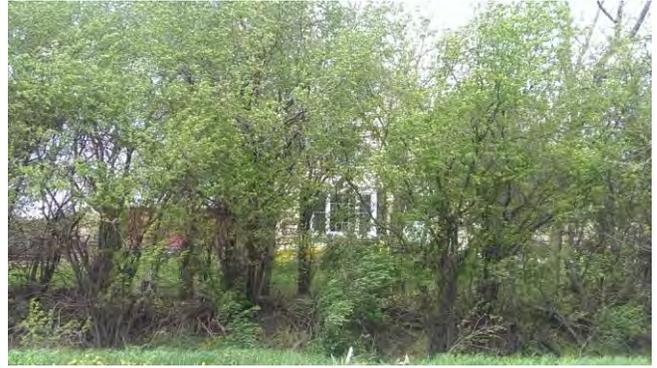
HE-25-6: 8214 Tryon Grove Road – Residence

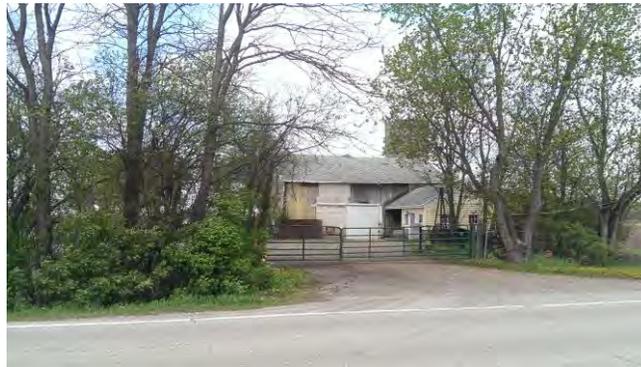
HE-25-6: 8214 Tryon Grove Road – Barn, Silo

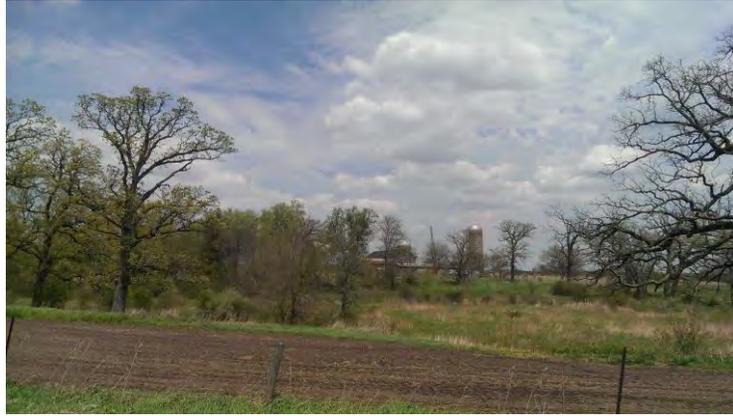
HE-25-7: 8308 Barnard Mill Road – Silos, Barn

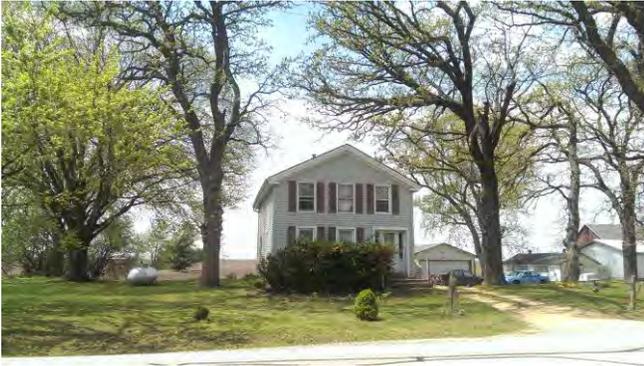
HE-26-1: 7213 Greenwood Road – Residence, Garage

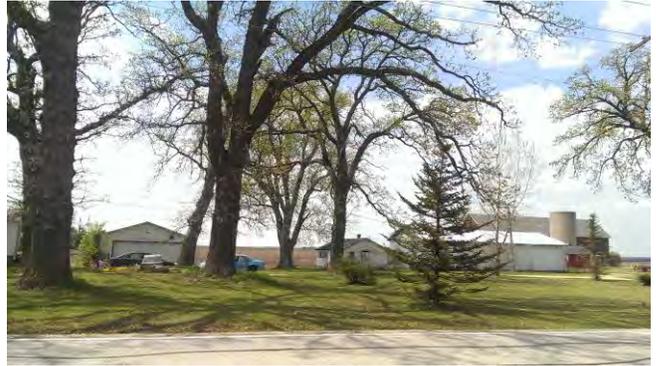
HE-26-1: 7213 Greenwood Road – Shed, Pole Building

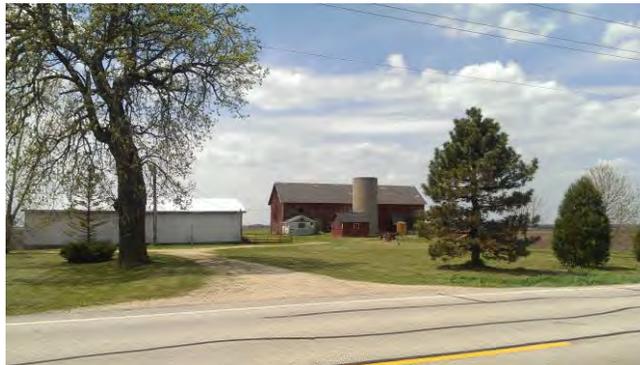
HE-26-1: 7213 Greenwood Road – Barn, Silo, Sheds
